Departmental investigation
into the alleged collision between
an unidentified trading ship
and the Australian fishing vessel
JAY DEE
off Southport, Queensland
on 31 December 1995

Report 88

Navigation Act 1912
Navigation (Marine Casualty) Regulations
investigation into the alleged collision between
an unidentified trading vessel
JAY DEE
off Southport, Queensland
on 31 December 1995
No88

Published: August 1996

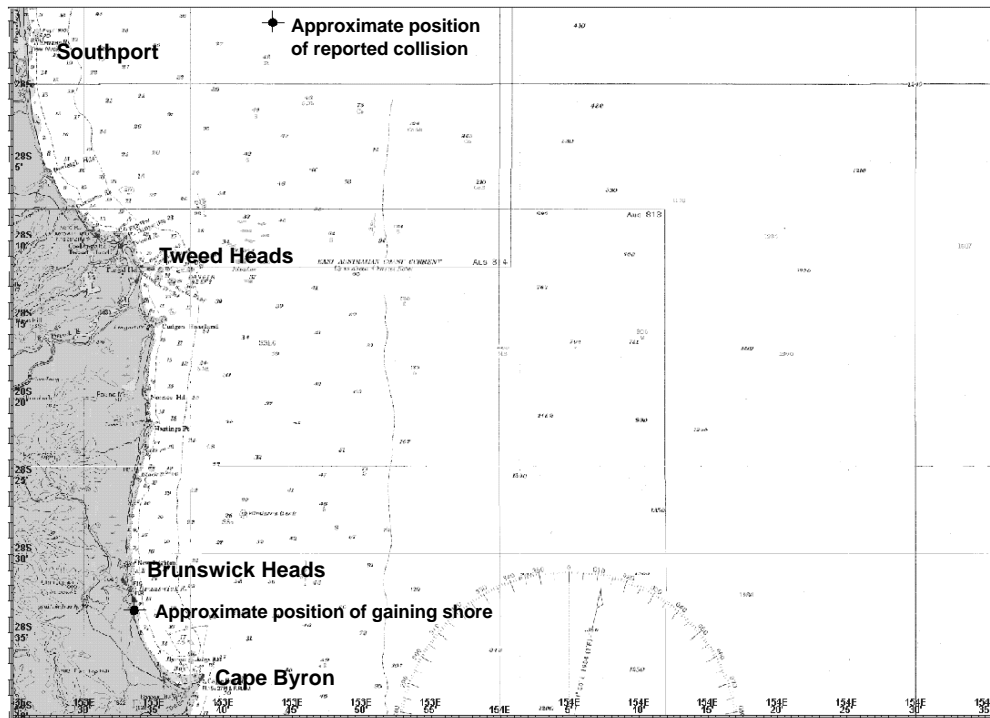
Portion of chart Aus344 showing position of reported incident

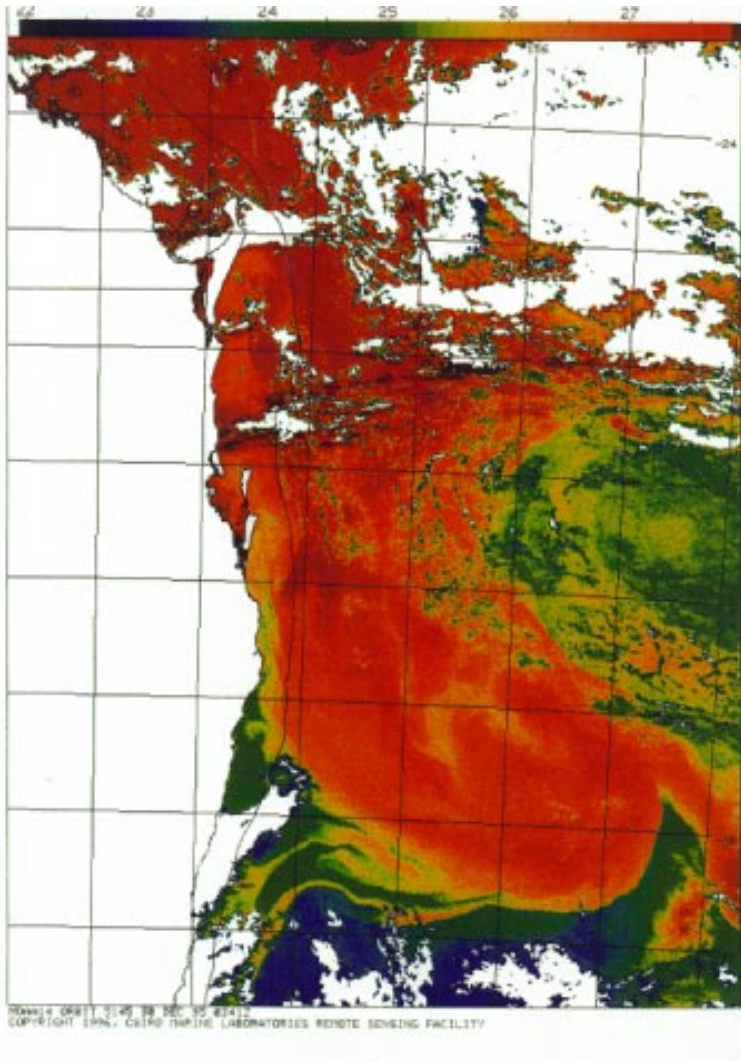
Map of Sea Temperatures - East coast of Australia 30 December 1995
reproduced by kind permission by the Department of Oceanography CSIRO

The story of the Skipper's survival and perseverance is quite remarkable. He was fortunate that the water temperature in the south going current was between 25.5° and 26.5°, a temperature at which hypothermia would not be a problem. The wind was from the north-

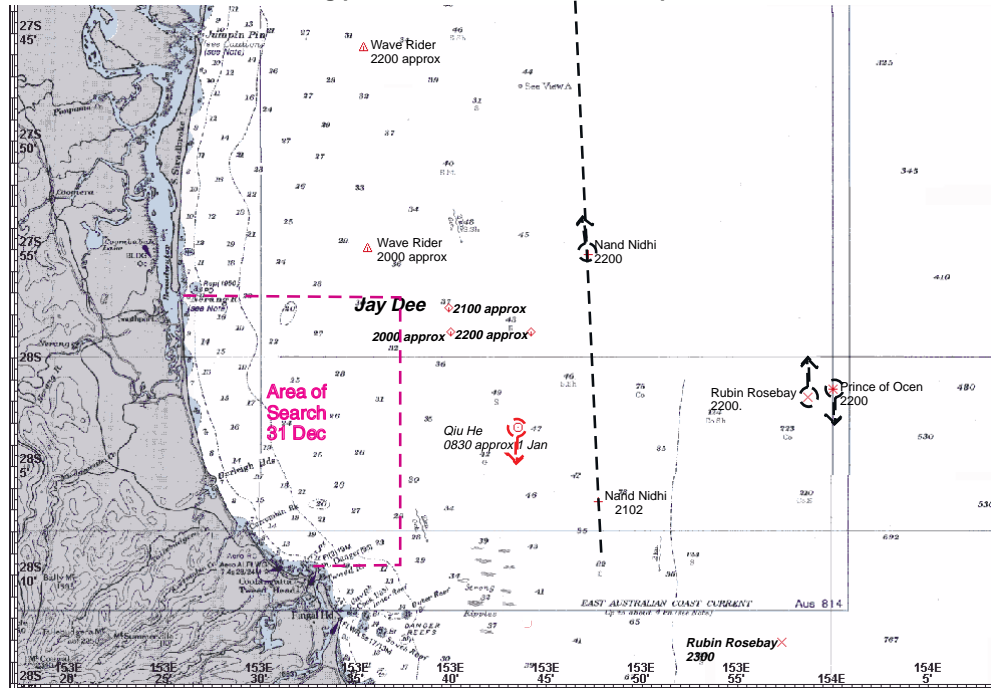
Portion of chart Aus344 showing position of vessels in area of reported incident

In all, three ships were identified as being within 20 miles of Jay Dee's probable position at 2200 on 31 December. One, Prince Ocean, berthed in Bell Bay, was inspected by the Harbour Master on 3 January and boarded by both an AMSA surveyor and a Unit investigator on 4 January. It was established that this ship had been about 14 miles to seaward of Jay Dee. The Master stated that he did not see anything unusual and the watchkeeping officer confirmed that he saw no flares and could not recall seeing any other ships.

From information gained from the owners and cross checked from the MRCC plot, it is evident that the Panamanian ship Rubin Rosebay passed about 13 miles to seaward of Jay Dee at about 2200, on passage to Japan. Prince of Ocean and Rubin Rosebay should have passed within a few miles of each other at about 2200, however, because of the time lapse and the routine nature of sighting other ships, it is not too surprising that an officer could not recall sighting another ship.

The third ship, Nand Nidhi, an Indian bulk carrier passed about three miles to seaward of Jay Dee's estimated easterly position, on passage to Papua New Guinea. There is no evidence that this ship was involved in the incident and those on board could not recall sighting any flares or seeing or hearing anything unusual. Further, it was northbound and, from the Skipper's evidence, the probability is that the vessel involved was southbound, having struck Jay Dee on the port side while the fishing vessel was on an easterly course.
