**Departmental investigation
into the machinery space fire aboard the
U.S. flag seismic research vessel
CASEY CHOUEST
off Thevenard Island, W.A.
on
31 January 1996**

Report No 89

Published: December 1996

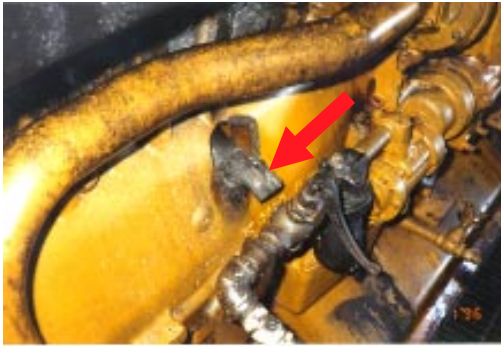
Side of Caterpillar D343 crankcase showing bottom of N0.4 connecting rod.

The generator sump was empty of oil and no. 4 unit connecting rod, (from the free end) was protruding through the side of the crankcase. Subsequent examination by contractors who removed the damaged engine from the vessel, revealed that the crankshaft was not broken, but the crankpin of this unit was badly gouged after the bottom end bearing cap had come off. The bottom end bolts had necked and failed under tension. There were indications (severe blueing) that both no.3 and no.4 bottom ends had been overheating and were likely to have seized at any time. It was ascertained from evidence given by those on board the vessel that the piston rings and cylinders were in poor condition and the crankcase was pressurised to the point where the dipstick sometimes used to be blown out. The crankcase breather appeared to be in satisfactory condition.

5. The sudden load thrown on to the D343 Caterpillar diesel engine by the short circuit, on an engine in very poor condition caused the failure of no.4 bottom end bearing and the subsequent damage to the side of the crankcase.

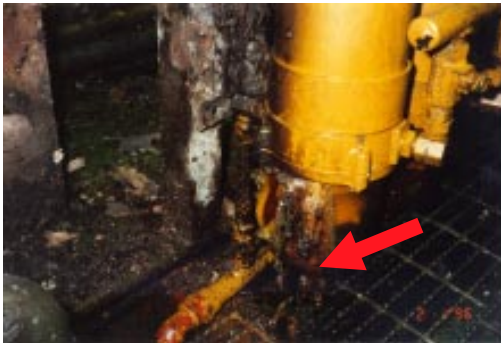
Melted polycarbonate fuel filter bowl on standard D399 compressor engine.

8. The oil self-ignited on the turbo-charger casing of the D399 engine.
9. Burning oil in the bilge melted the polycarbonate bowl of the for'd fuel filter on the D399, allowing fuel under pressure to escape and spray over the engine and into the bilge thus adding to the fire.
10. Because of the trim of the vessel and the slight list to starboard the burning fuel in the bilge flowed to the starboard aft corner of the space underneath the space in the reel-room where large numbers of oil filter elements in cardboard cartons were stored.
11. These stores were ignited by the heat conducted through the uninsulated steel bulkhead.

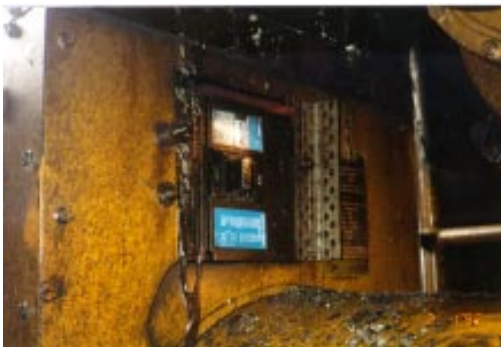
Circuit breaker fitted to seismic generator.

This circuit breaker has two adjustable settings, a thermal trip for the setting of normal full load current, and a magnetic trip for the setting of fault, or short circuit protection. The thermal trip was found, after the fire, to have been set on approximately 95%, or 600 amps. The magnetic trip, for fault condition, was set on the maximum scale setting of 10. From the manufacturer's data this setting equates to a prospective fault current level of 5,000 amps (5 kA). There was no knowledge on board as to when, or by who, these trips had been set at these levels.

It can be seen that the thermal trip, set at 600 amps would not operate at 390 amps, the full load current of the generator. Similarly, the magnetic trip, set at 5 kA, would offer no protection against the short circuit current of the generator at 1.56 kA and, indeed, the circuit breaker was found after the fire, not to have tripped.

4. A lack of appropriate supervision in fitting the circuit breaker and the incorrect trip settings (thermal and magnetic) rendering it unable to protect the cable or the generator under either full load current condition or under fault conditions.

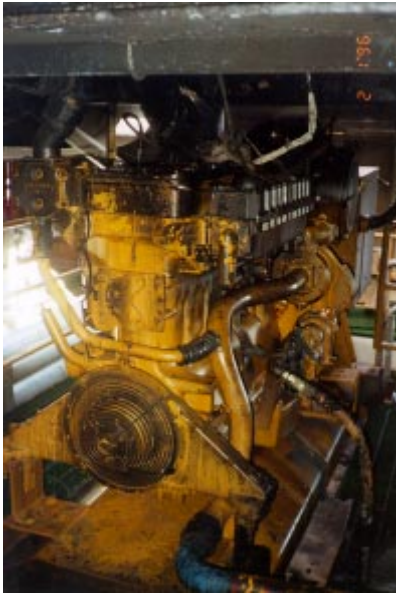
D343 Caterpillar seismic generator set.

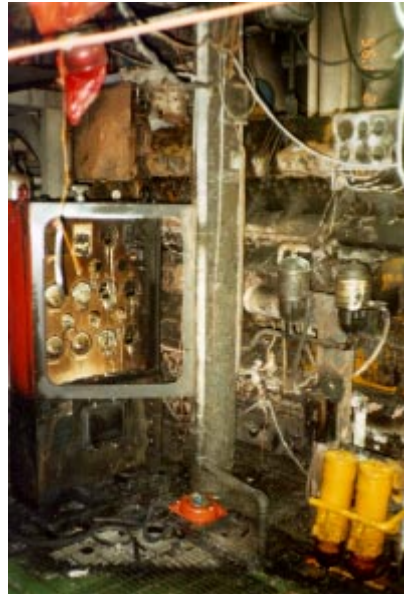
Fire damage to starboard D399 Caterpillar engine and control panel.

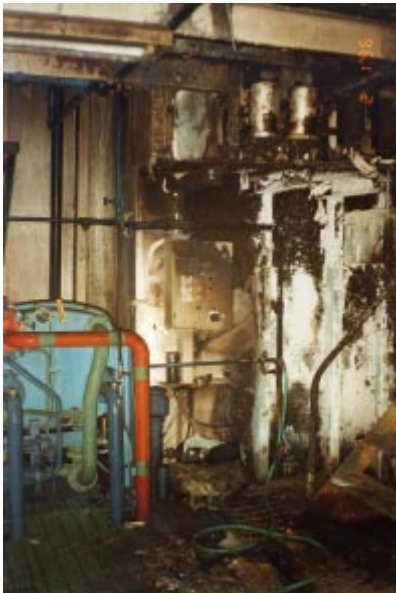
Examination of the fire scene showed that the fire in the seismic compressor room started when a connecting rod on the Caterpillar D343 engine punched a hole in the side of the crankcase and oil sprayed from the hole onto the hot exhaust surfaces of the starboard Caterpillar D399 engine and ignited. The burning oil melted the forward polycarbonate fuel filter bowl on the starboard D399 engine and, with no remote fuel shut off, the oil provided a continuing source of fuel for the fire which spread through the bilges, with the trim of the vessel, to the aft starboard corner of the space.

Starboard aft corner of seismic machinery space after the fire.

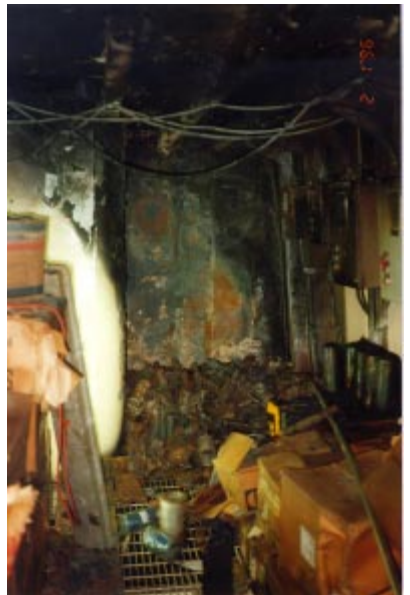
The burning fuel in the bilge flowed to the starboard aft corner of the seismic machinery room, against the space in the reel-room where large numbers of oil filter elements were stored in cardboard cartons. These stores were ignited by heat conducted through the uninsulated steel bulkhead.

Starboard forward upper corner of reel room after the fire had spread to stored filters in cardboard boxes.

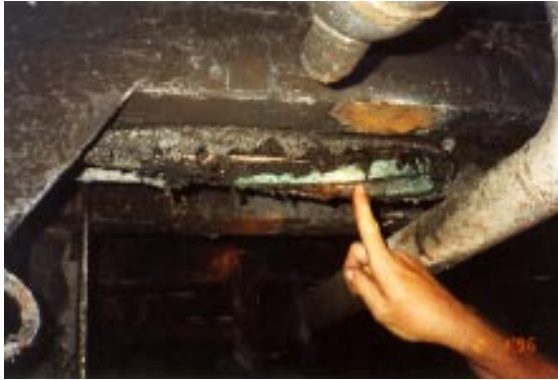
Damage to cable caused by short circuit between phases.

At the end of the four metre run, just before the bracket where the cable was next supported, there had been a massive short between phases. Just beyond that, at the supporting bracket, it was found that an earth had occurred between one of the phases and the loose half of the bracket (or cable clamp). Two or three of the cable strands had welded to the bracket. The loose half of the bracket was found to be a larger radius than the fixed half, thus bearing only on the centre of the cable and compressing it badly (see page 14). The cable was distorted and its rubber sheathing under the armouring was reduced in cross-sectional thickness. This sheathing was ineffective as supplementary insulation for the three insulated conductors within the cable.

At the point where the cable had been destroyed by the short circuit between phases, the conductors were found to be heavily oxidised and coated with verdigris following a gradual breakdown of the cable insulation (see page 15). It is evident that this process had been continuing for a considerable length of time, at least some months, and this, together with the earth through the bracket, would account for persistent voltage fluctuations which had been reported by the ship's staff since they had joined the vessel and the cause of which had not been traced.

Electrical Inspectors from the ACT Building, Electrical and Plumbing Control, examined photographs of the length of cable taken from the area of the short circuit. In their opinion, the general condition of the cable in this area, and the significant degree of verdigris, indicated that the insulation had broken down over a lengthy period of time. Most probably, the fault started where the cable was squashed in the bracket, reducing the thickness of the insulation (see page 14). This eventually resulted in an earth fault which increased gradually over weeks and months, with the resultant heat build-up causing further deterioration of the insulation to a point where salt-laden moisture entered and accelerated the process of ionisation and the formation of acids. The insulation finally failed totally on 31 January 1996.

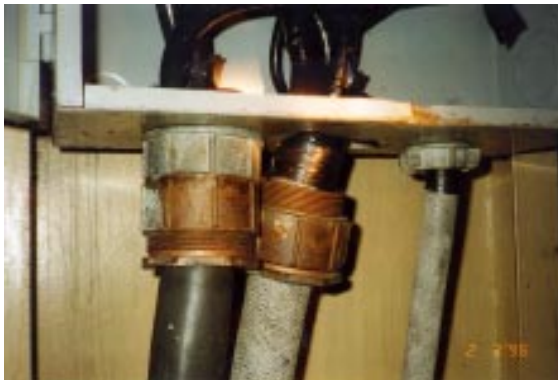
Aft end of same cable at seismic supply changeover switch showing poor standard of installation.

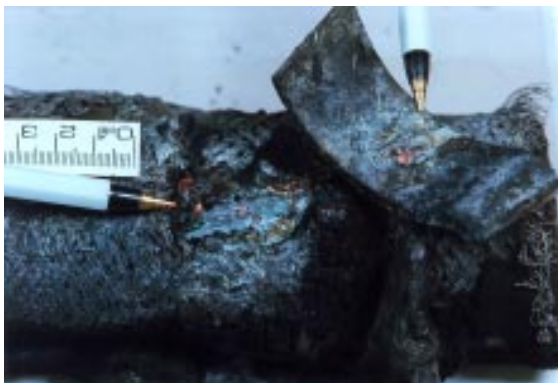
Section of damaged cable showing insulation compressed by clamp and conductors which had welded to the clamp.

bracket. The poor insulation resistance between the copper conductors and the earthed metal of the bracket permitted leakage current to flow from the conductor to earth.

2. This earth may have existed for a long time and would have caused heating of the cable conductors in the section of cable adjacent to the bracket. This would have caused a breakdown of the cable insulation. The Full Load Current (thermal) trip of the circuit breaker was set too high to offer any effective protection under these circumstances.
