**Departmental investigation into the
contact with “Old Man Rock”,
Darwin Harbour
by the Singaporean livestock carrier
CARABAO 1
on 21 January 1996**

Report No 90

**Navigation Act 1912
Navigation (Marine Casualty) Regulations
investigation into the
contact with “Old Man Rock”,
Darwin Harbour
by the Singaporean livestock carrier
CARABAO 1
on 21 January 1996**

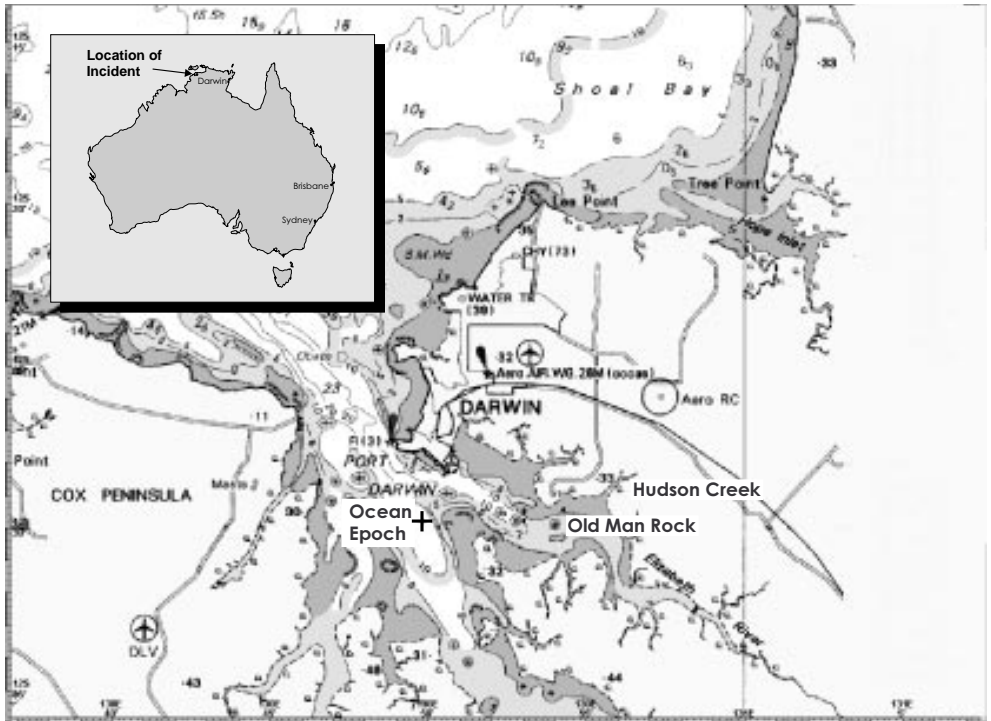
Portion of chart Aus309 showing location of incident

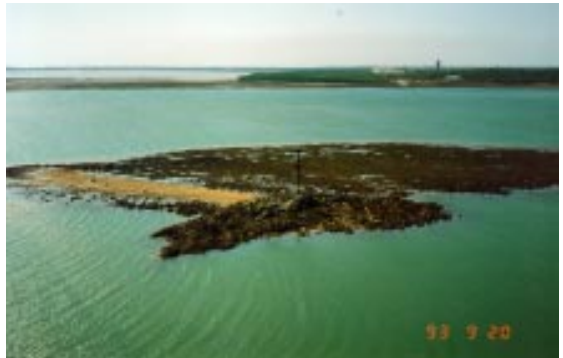
Old Man Rock is the pinnacle of an ironstone and quartz ridge, running north and south and extending about 25 m southward of the pinnacle, at the southeast point of a flat, rock strewn shoal. The shoal has a drying height of about one metre above datum, while Old Man Rock has a drying height of 5 m above datum.

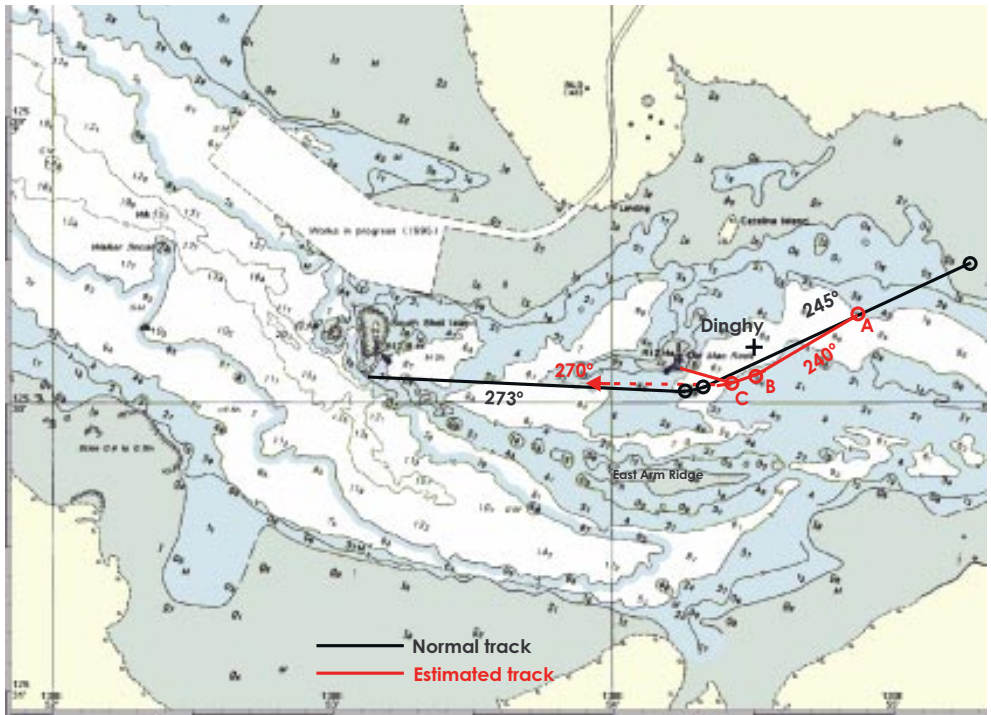
Portion of chart Aus 28 showing estimated track of Carabao 1

Based on the limited information available, it is probable that the Harbour Master commenced the starboard turn at about 1733:30, at position (B) shortly after the two beacons were in transit, and that he steadied the vessel on the westerly heading at about 1733:55, at position (C). In this position, on a heading of 270°, South Shell beacon would lie 5° on the starboard bow, and Ocean Epoch 1.5° on the starboard bow.

Position (C) is 320 metres east and about 125 metres south of the beacon. For Carabao 1 to contact Old Man Rock required a north

flowing current of just under three knots. When Carabao 1 passed South Shell beacon, 1.06 miles to the west, a few minutes after the incident, the Harbour Master estimated the tidal rate as being more than 3.5 knots. It is improbable that Carabao 1 would have been any further south than this (C) position.

It is considered the Harbour Master commenced the turn after the transit of Old Man Rock and South Shell beacons, but before Carabao1 had reached the normal relative bearing of Old Man Rock beacon forward of the starboard beam. This early start of the turn, combined with the quicker turn, resulted in Carabao 1 being north of the normal track and in such a position that it would pass Old Man Rock some 80 to 100 metres closer than normal, if the tidal flow conditions were those normally experienced.
