Departmental investigation  
into the accommodation fire aboard the  
bulk carrier  
**DOCEBAY**  
off the coast of Queensland  
on  
13 May 1996

**Navigation Act 1912  
Navigation (Marine Casualty) Regulations  
investigation into the into the  
accommodation fire aboard the  
bulk carrier  
DOCEBAY  
off the coast of Queensland  
on  
13 May 1996**

**Report No 92**

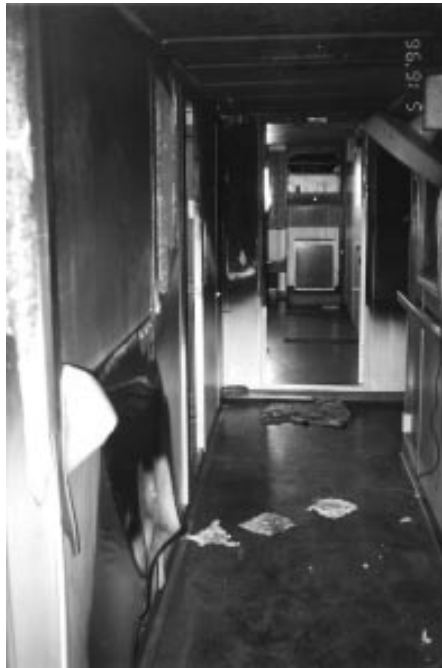
The Second Engineer's cabin had been gutted by the fire. The Upper Bridge Deck port side alleyway sustained considerable heat damage in the area adjacent to the Second Engineer's cabin, with charring of the laminate panels and melted fittings. Smoke damage on that deck extended around to the starboard side alleyway. The First Engineer's cabin suffered some damage due to heat transfer through the common bulkhead. Most of the other cabins on that deck sustained extensive smoke damage and the conference room, immediately opposite the Second Engineer's cabin, and the Electrician's cabin, both of which had their doors held open by holdbacks, were significantly damaged by the heat. There was no fire damage to any compartment either above or below the Upper Bridge Deck.

**Heat and smoke damage in alleyway outside  
2nd Engineer's cabin**

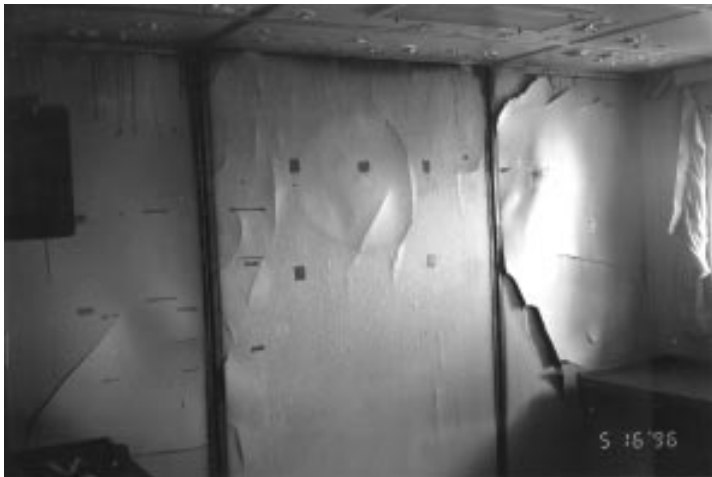
**View from 1st Engineer's cabin of bulkhead between 2nd and 1st Engineers'  
cabins showing effect of heat transfer**

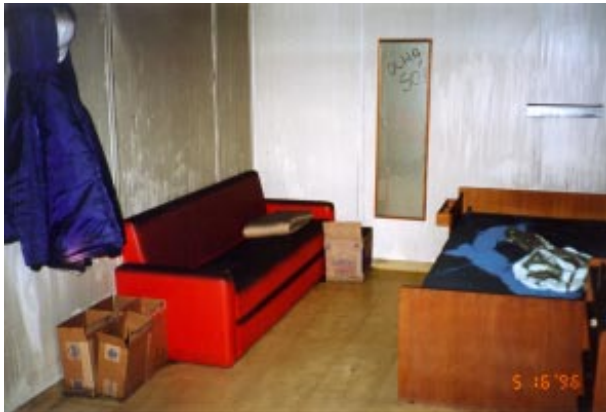
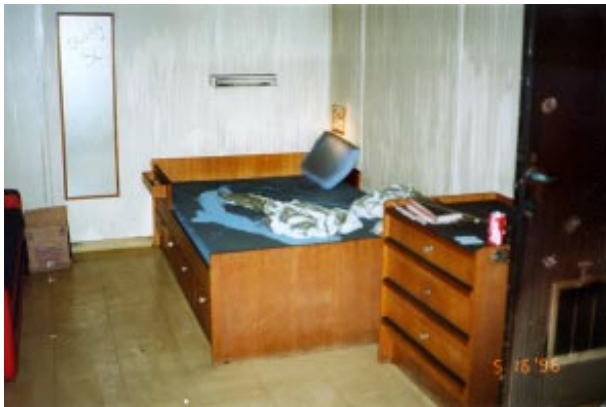
The cabins are somewhat austere furnished. (See photos page 19). There is no carpet or matting on the decks, which have a covering of vinyl tiles. The desks, chests of drawers and wardrobes are constructed of laminate-covered chipboard and the sofas and chairs are upholstered in vinyl-covered polyurethane foam. There are a pair of short curtains over the two windows which appeared to be of cotton/polyester material. The bunk mattresses are of polyurethane

**2 views of typical cabin furnishings**

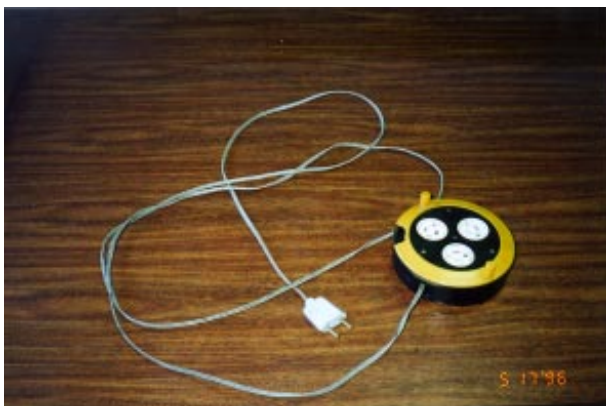
**Extension lead and power board as used in 2nd Engineers' cabin**

The extension lead consisted of 5 metres of two-core “figure of eight” flex on a reel, with three two-pin sockets in the centre of the reel. The extension lead was not earthed and also had the standard U.S. type, 2-pin plug on the free end. The cross sectional area of the conductors was approximately  $0.75^2$  mm. There was no outer sheath to the cable which has only a single layer of PVC insulation on the two cores.

The reel itself, or power board, is constructed of a polystyrene, non-impact-resistant plastic (see the photograph on page 20 where a piece can be seen broken out of the side of the reel). This type of plastic readily burns. The end of the cable, in the sample viewed during the investigation, was not properly secured before the point where it joined onto the terminals on the back of the sockets. The reel is designed in a form similar to a fishing reel, where one half can be held (in the left hand, for example) and the other half rotated using small handles (with the right hand) to wind the cable into the reel.

This type of cable, having no earth, no outer sheath and conductors of cross sectional area less than  $1 \text{ mm}^2$ , would not meet the Australian standards for an extension lead. The current-carrying capacity of such a cable would be in the order of 7.5 amps. The average current drawn, however, by a television set and VCR similar to those in the Second Engineer’s cabin, when operating normally, would be approximately 2 amps at 110 volts, so it is considered unlikely that an overload of the cable was a factor.

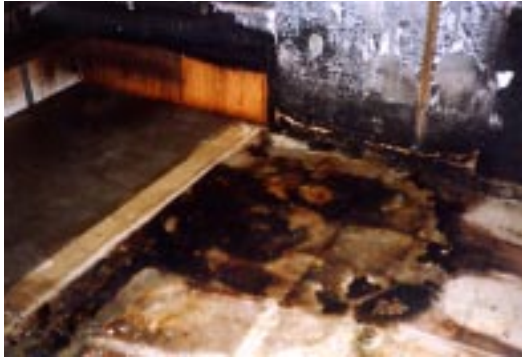
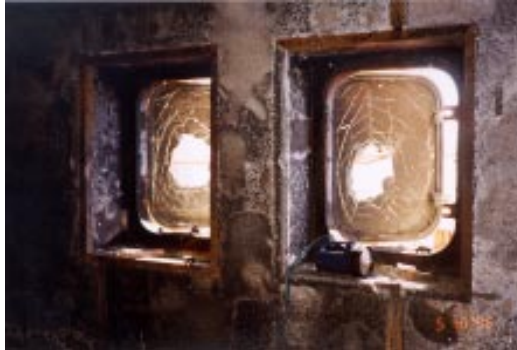
**Burned area of vinyl deck tiles adjacent to 2nd Engineers bunk**

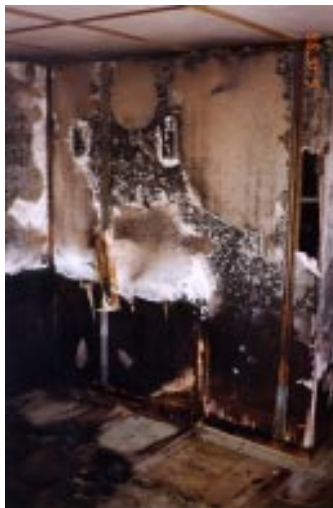
**Fire damage to cabin windows and bulkheads**

After the fire, it was found that both the laminated glass cabin windows had been shattered by the heat. It is uncertain at what stage of the fire this occurred, but if this had occurred in the early stages, the supply of outside air admitted to the cabin would also help to explain the speed with which the fire gained a hold.
