Departmental investigation into  
a fall from aloft  
aboard the  
**STS LEEUWIN**  
on 12 June 1996

Report No 93

**Navigation Act 1912**  
**Navigation (Marine Casualty) Regulations**  
**investigation into a fall from aloft**  
**aboard the**  
**STS LEEUWIN**  
**on 12 June 1996**  
**Report No 93**

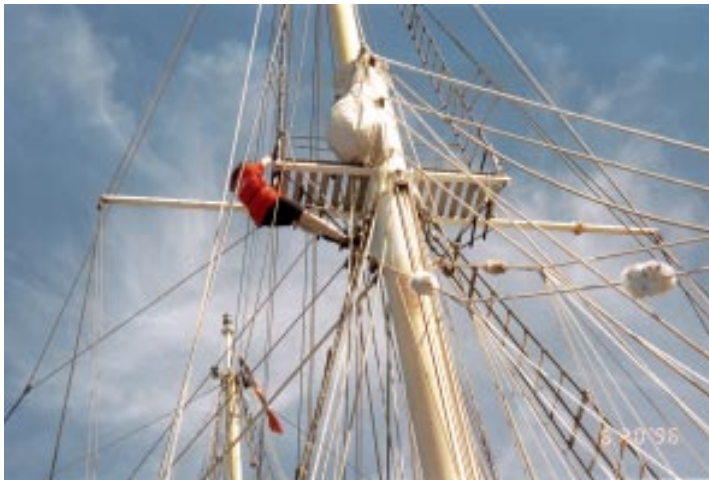
**Negotiating the mainmast futtock shrouds**

her safety line onto the safety rail, placing her left arm around the shrouds for security as she did so. Looking down, she became frightened and wanted to climb down and, instead of

climbing up the futtock shrouds, she tried to climb in behind them, first from the forward side, then from the after side. Encouraged and guided by the others, she was eventually in the correct position for climbing them, but then took a short rest, hooking both her arms over one of the ratlines.

Although she volunteered to go aloft that third morning, the fear was still present and was heightened when she looked down when at the top the shrouds. The situation would have been exacerbated during her efforts trying to climb in behind the futtock shrouds. This

manoeuvring about the futtock shrouds would also have sapped both her energy and her strength, in fact after being guided into the correct position by the others, she had to rest, hooking both her arms over one of the futtock shroud ratlines.

Before any trainee is allowed to climb either the main or mizzen masts, the Inspector considers that an individual should first be required to ‘prove’ him or herself by climbing the foremast rigging which is less demanding.

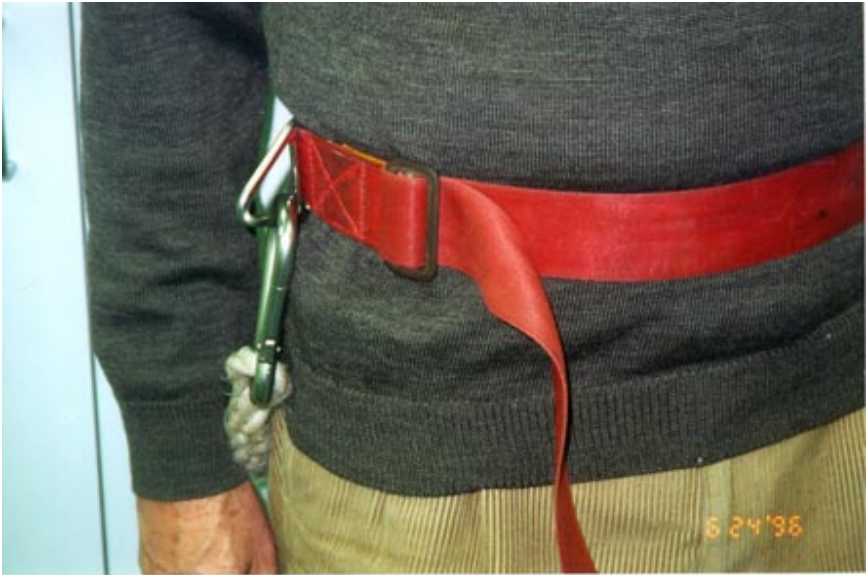
**Correctly fastened**

The young woman’s fall should have been arrested by her safety line and belt, after a fall of no more than one metre. Although she had clipped the snap-link of her safety line on to the futtock shroud safety rail and although her fall was checked momentarily, the belt rapidly became undone. This should not occur unless the belt has not been fastened correctly by passing the free end back through the buckle.

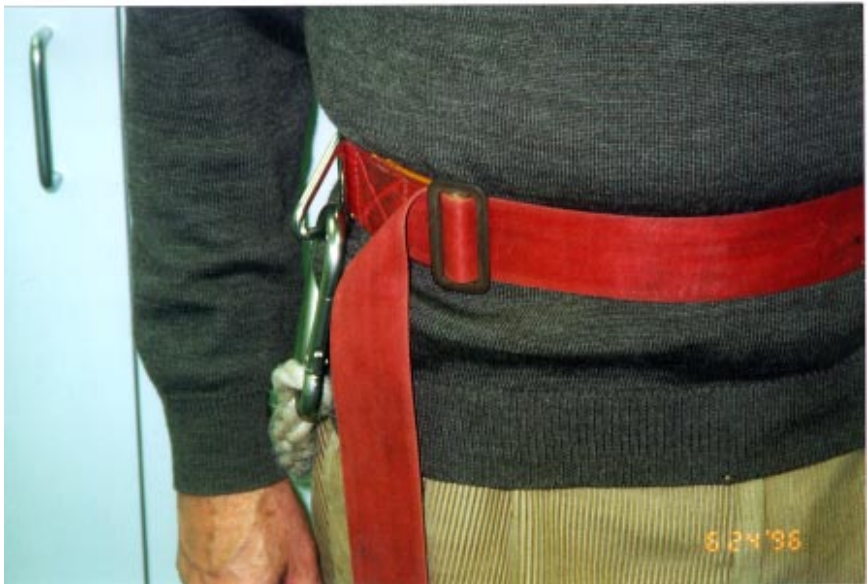
**Incorrectly fastened**

The safety belt worn by the trainee was tested at the Road Transport Authority Crash Laboratory at Rosebery, NSW. The testing, witnessed by the investigating officer, involved drops, similar to that experienced by the trainee, using a dummy used in testing safety harnesses for the Standards Association of Australia. Correctly fastened, the belt held, the webbing slipping 5 mm through the buckle, which was well within the 25 mm allowed under AS 2227<sup>1</sup>. Incorrectly fastened, the belt rapidly came undone, with no restraining effect on the fall.

It is also considered that the shiny surface of the well-worn, fine-weave webbing created difficulty in the tight fastening of the safety belt, which may have contributed to the trainee not fastening the belt correctly.

The Inspector considers that a “buddy” system, whereby each trainee is checked by a peer, would not be contrary to the philosophy of increasing the individual’s responsibility. The Fire Service has a “touch-check” system, whereby a wearer’s harness is checked by someone else, every time a harness is put on. Touching each fastening and item of equipment concentrates the checker’s attention on the task in hand and guards against a cursory glance, which may overlook something that is wrong.

After this particular incident, the Master and the Mate introduced a “buddy” system on the next voyage, to ensure non-occurrence of this type of incident. It is considered that it would be appropriate for the Foundation’s instruction manuals to include this procedure, to ensure that it is maintained after changes of personnel.
