**Departmental Investigation into the
collision between the
Australian bulk ship
RIVER EMBLEY**

**and the Queensland fishing vessel
BRONZE WING
off Cairns, at about 0135 on 10 July 1996**

Report No 94

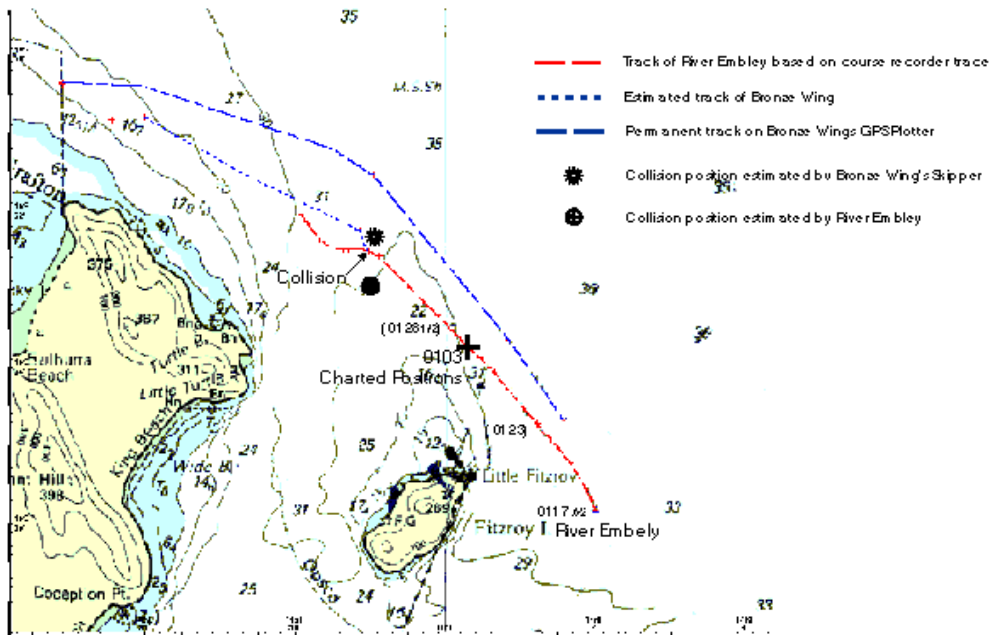
Collision Reconstruction

swing, the bulk carrier was turning to port at the rate of 40°/min and was on a heading of about 284° when the first impact occurred on its starboard side at about 0134:20.

Given a heading of River Embley of about 284° , it is probable that Bronze Wing struck the hull of the bulk carrier at an angle of between 40° and 60° to the hull, on a heading between 140° and 160° , to account for the bowsprit being pushed to port and the subsequent starboard to starboard contact. However, given the dynamics involved with interaction, the smaller vessel would have been subject to a number of conflicting forces and no firm assessment, based on the damage sustained, can be made of Bronze Wing's course in the period immediately before the collision.

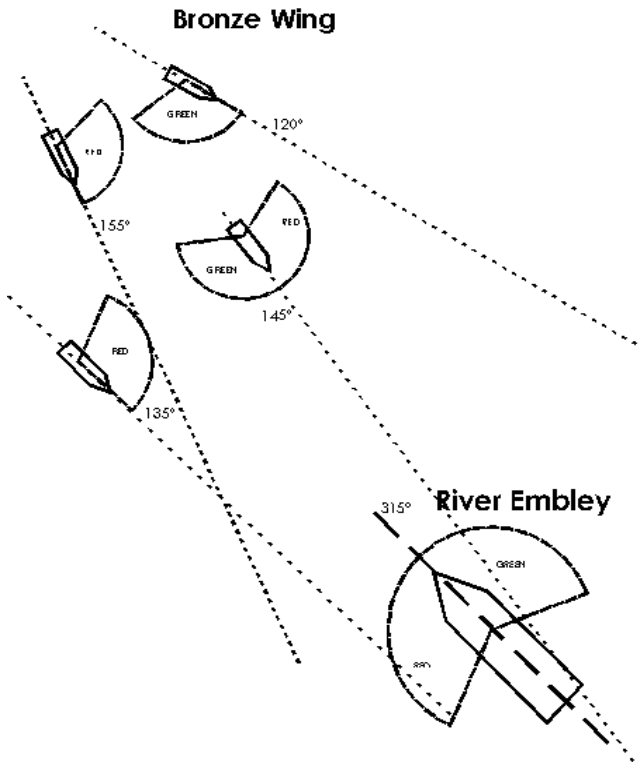
NAVIGATION LIGHTS - SIDE LIGHT SECTORS

0126, showing a green light. The theoretical maximum angle on River Embley's starboard bow would have occurred at 0130 at 5°. If this is correct and Bronze Wing had maintained course, the CPA would have been about 2 cables, 370 m starboard to starboard and her speed would have been about 6.5 knots. The Second Mate maintained that the fishing vessel reached an angle on the starboard bow of 22° or 33°, though he did not use the gyro compass repeater to measure the angle. The Inspector, based on the simulation and manual plotting of the incident based on various speeds for the fishing vessel, believes that the fishing vessel could not have reached an angle of more than 12° on the starboard bow.

The Bronze Wing's Deckhand stated that at about one mile, three minutes before the collision the green light faded out. For this to have occurred, Bronze Wing must have been very close to the River Embley's line of advance and the two vessels would have passed within 250 m of each other.
