Departmental investigation  
into the  
grounding of the Panamanian flag  
refrigerated cargo vessel  
**PEACOCK**  
on Piper Reef, in the Great Barrier Reef,  
on 18 July 1996

**Report 95**

**Navigation Act 1912**  
**Navigation (Marine Casualty) Regulations**  
**into the grounding of the Panamanian flag**  
**refrigerated cargo vessel**  
**PEACOCK**  
**on Piper Reef, in the Great Barrier Reef,**  
**on 18 July 1996**

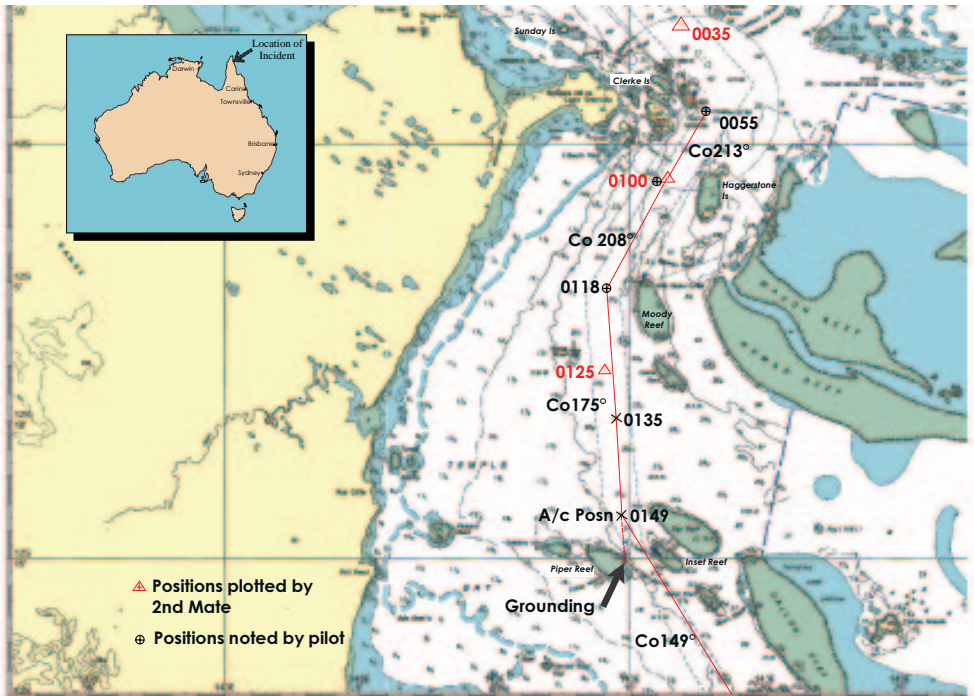
At about 0155 on 18 July 1996, the vessel grounded on Piper Reef at full speed, in a position 100 metres eastward of the light beacon. Initial attempts to refloat the vessel by going astern on the engine were unsuccessful.

**Portion of chart Aus835 showing course of Peacock**

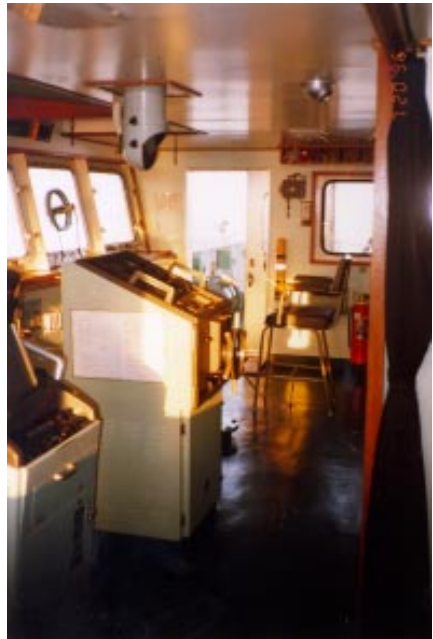
However, in sitting in the pilot chair at 0135 and particularly in cupping his chin in his hand, the pilot caused the muscular activity switch to move to the “off” position, making himself more susceptible to sleep. Also, by supporting his head in his hand, his head could not fall forward as he relaxed and a basic warning mechanism was lost.

**Photograph of interior of Peacock wheelhouse showing position of pilot chair**
