**Investigation into the grounding
of the Indonesian vessel
NIAGA 46
on North West Point, Christmas Island,
on 9 August 1996**

Report No 96

COMMONWEALTH DEPARTMENT OF
TRANSPORT AND REGIONAL
DEVELOPMENT

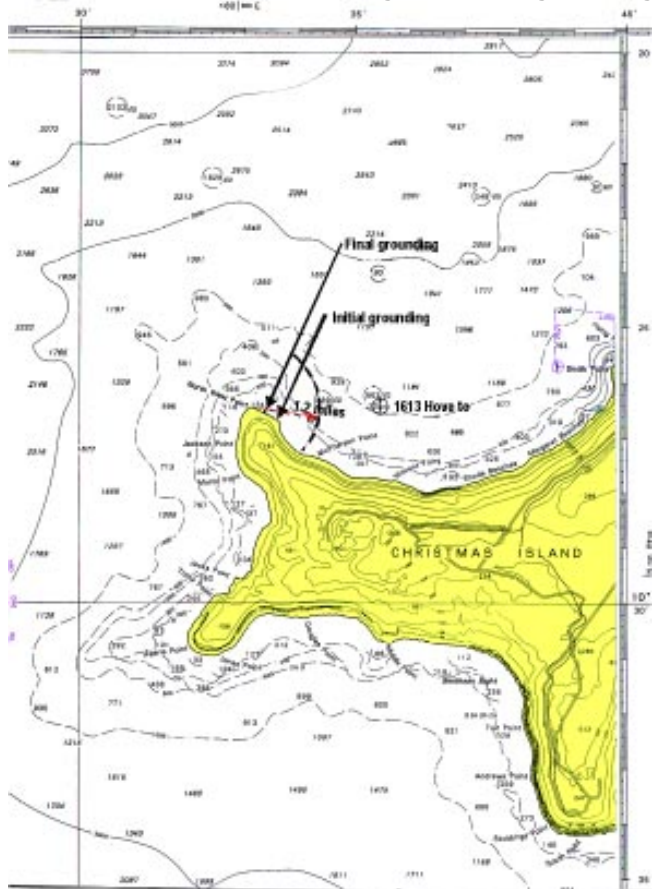
Portion of chart Aus 608 showing position of grounding

The ship grounded on a westerly heading close east of North West Point at 0047, with the tide, based on tidal predictions, 1.1 m above datum and ebbing.
