Departmental investigation
into the fatality aboard the
containership
MATILDA BAY
in the Great Australian Bight
on
17 August 1996

Report No 97

Navigation Act 1912
Navigation (Marine Casualty) Regulations
investigation into the fatality
aboard the containership
MATILDA BAY
in the Great Australian Bight
on
17 August 1996
Report No 97

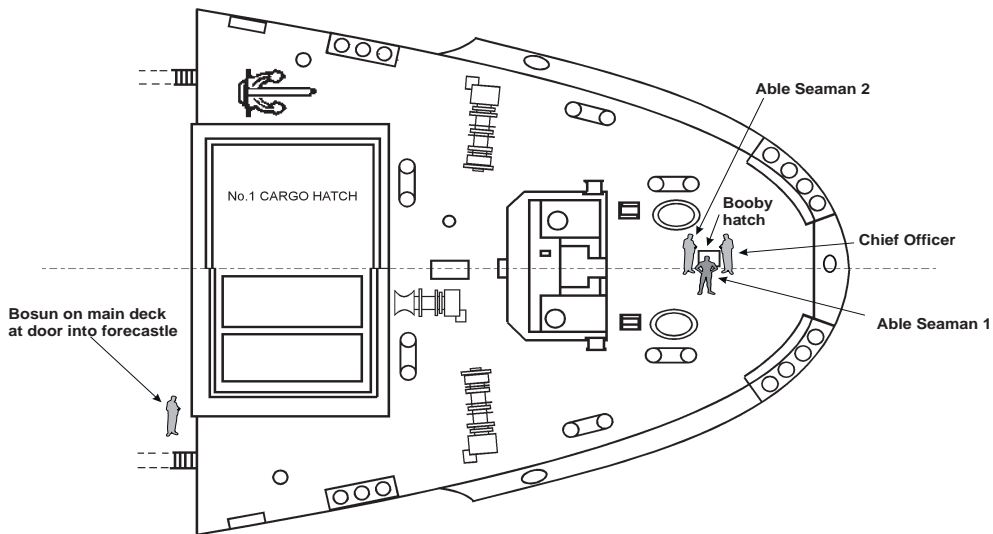
MATILDA BAY - Forecastle Deck
 Showing positions of personnel immediately before wave struck

forestay and carried him bodily over the top of the anchor windlass, throwing him against the centre-line mooring winch immediately forward of no.1 cargo hatch. The other AB was swept against the front of the anchor windlass on the port side. The Chief Officer was swept underneath the windlass.

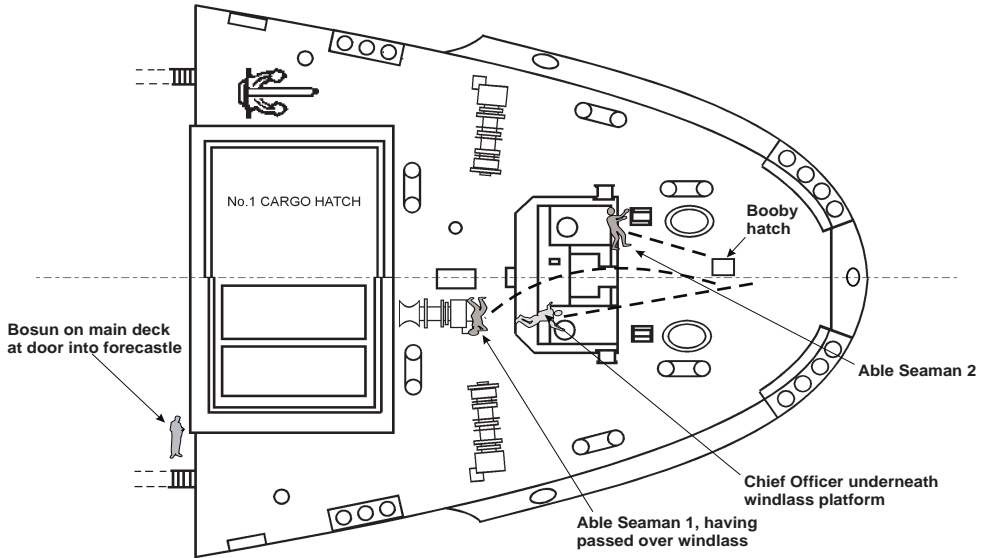
MATILDA BAY - Forecastle Deck

Showing positions of personnel immediately after wave struck

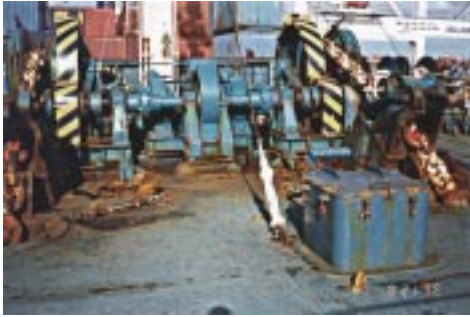
View of windlass from forecastle head

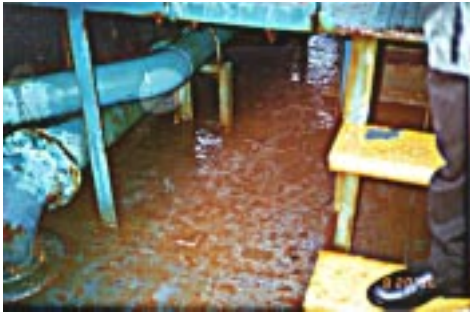
Position under windlass platform where Chief Officer was found

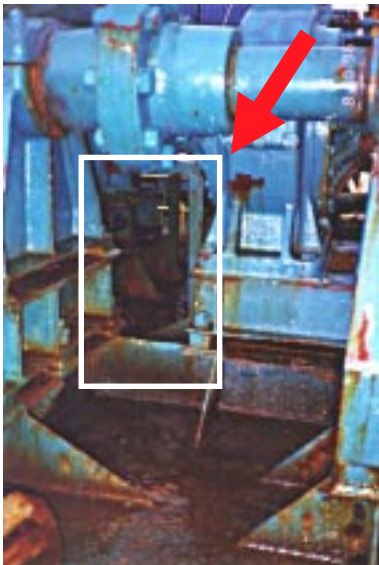
View from front of windlass showing opening through which Chief Officer passed

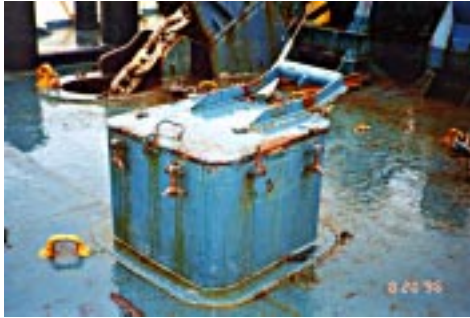
The hatch cover (see photograph page 27) had been seen, still in place, by the Bosun the previous afternoon (16 August), but it would appear to have been torn off by the weather, when the vessel was pitching heavily, at some time during the evening. If such a hatch cover, even in an exposed position like the forecandle head, had been properly secured by tightening the dogs correctly, it would be less likely to have been torn off by seas coming over the bow. If not done up

tightly, any slight movement would allow the cover to “work” up and down each time it was hit by a sea, weakening and damaging the hinges and dogs in the process, until it was torn off. This effect would be exacerbated by the fact that the hinges for the cover were on the after edge of the hatch coaming, thus the opening faced forward - into the oncoming seas.

The booby hatch on forecastle head

Following the death of the Chief Officer, the hatch cover was repaired when the ship was at Fremantle and it was rotated 180°, so that the hinges were on the forward edge of the coaming and the opening faces aft.

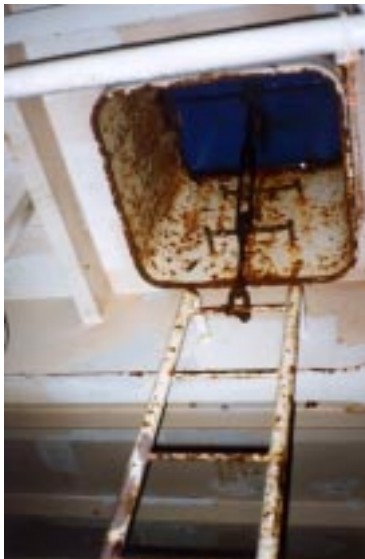
Booby hatch viewed from within the forecastle (bottlescrew in position)
