**Departmental investigation
into the collision between
the Australian fishing vessel
“GALAXY”
and the Malaysian flag bulk carrier
“ALAM TENGGIRI”
off High Peak Island, Queensland,
at about 0240 on 6 September 1996**

Report No 98

Published: April 1997

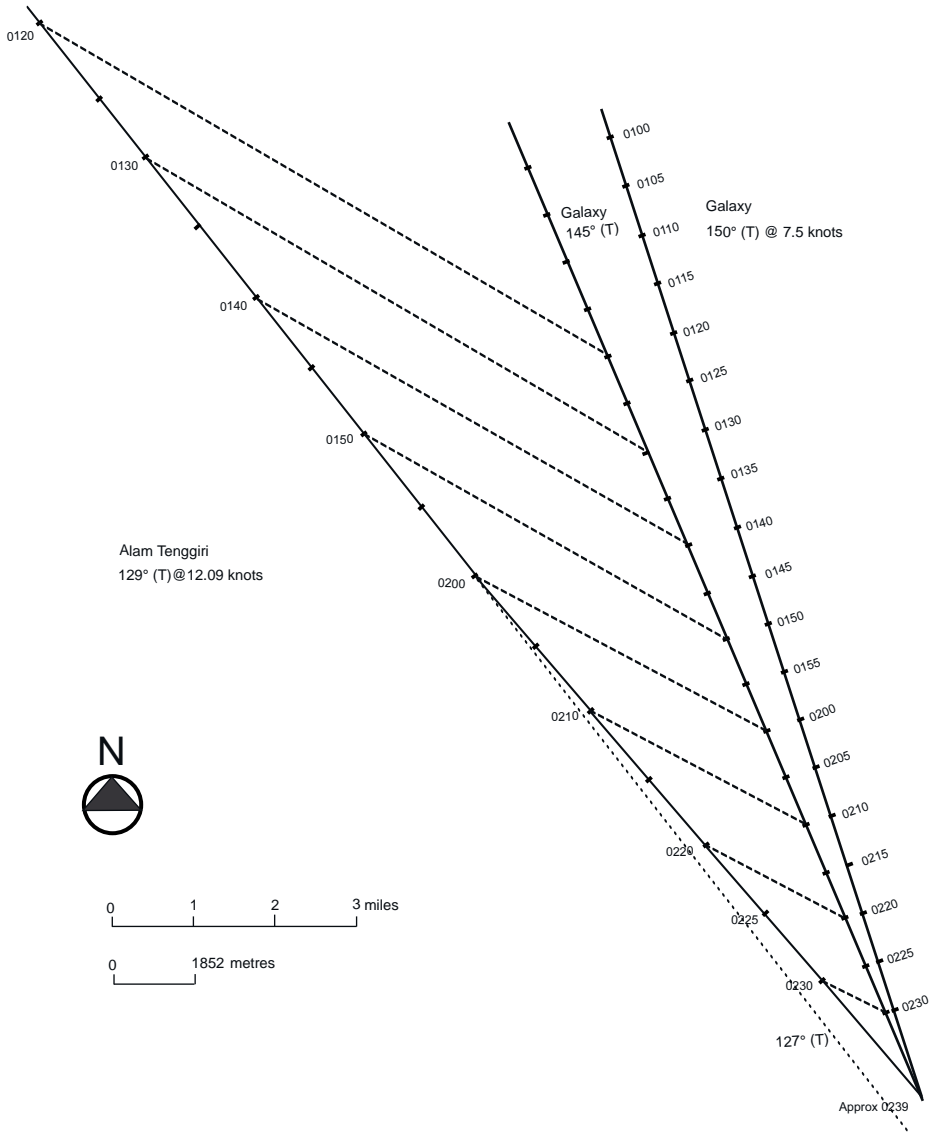
Relative positions Alam Tenggiri and Galaxy from 0120

Projecting Alam Tenggara's course and estimated speed back from the collision point and similarly projecting Galaxy's probable course and speed, the two vessels would have been about 8 miles apart at 0115, at about the time the Second Mate recalled first sighting the fishing vessel. Based on a speed of 8.6 knots, the fishing vessel would have been bearing about 095° from Alam Tenggara. The Second Mate recalled that the bearings of the other vessel taken after 0200 opened by 2° from 107° to 105° , 22° on the port bow. It is possible that the Second Mate read the compass card the wrong way and the bearings were in fact 93° and 95° . However, it is more probable that the Second Mate's bearings were accurate and Galaxy was making good a speed in the region of 7.5 knots.

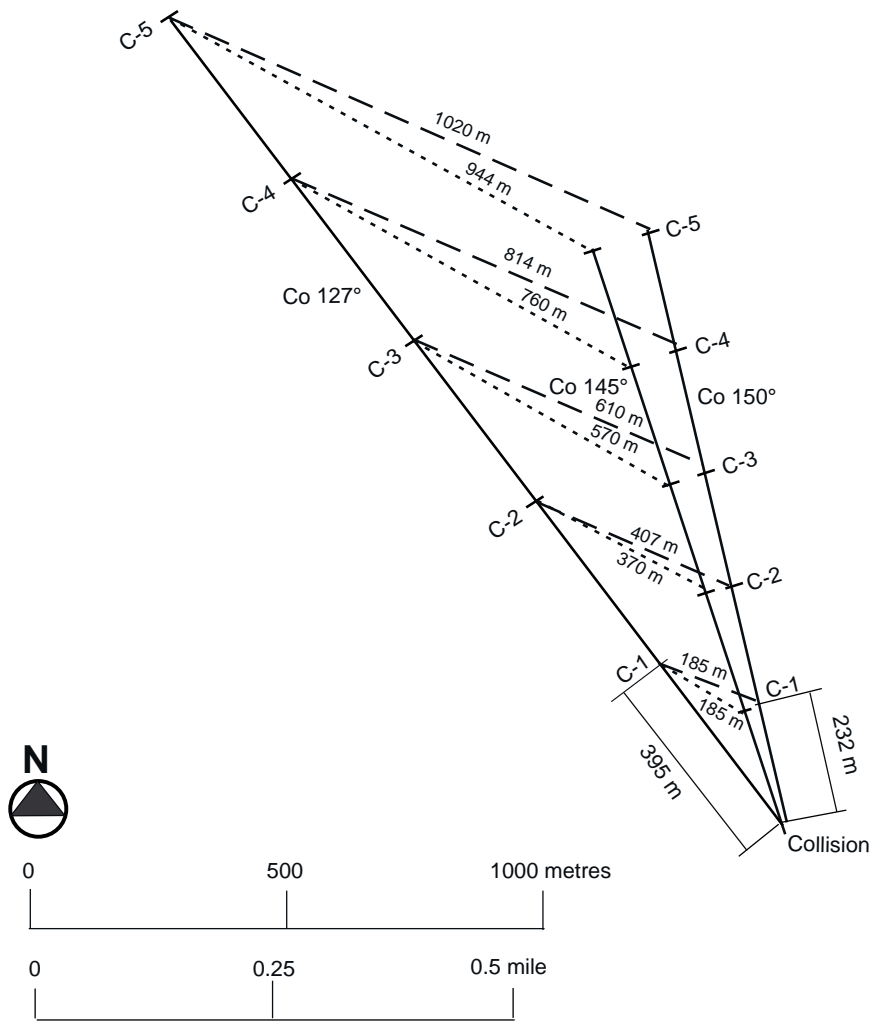
Relative positions
from about 0235 to Collision

Relative position at one minute intervals from about 0234-collision

A precise reconstruction is not possible in the absence of accurate times and bearings. A reconstruction of the collision, based on the known course and speed of Alam Tenggara and the estimated course and speed of Galaxy is at figure 1.
