**Departmental investigation
into the death of the Master of the
Danish flag vessel
ARKTIS GRACE
at Townsville on
12 October 1996**

Report No. 99

Navigation Act 1912
Navigation (Marine Casualty) Regulations
investigation into the death of the Master of the
Danish flag vessel
ARKTIS GRACE
at Townsville on 12 October 1996

Published: May 1998

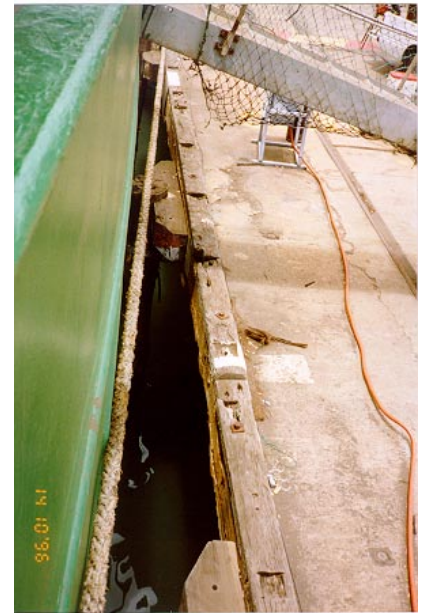
Gangway arrangement of Arktis Grace

Space between the ship and the wharf, into which the Master fell.

The gangway, which belongs to the vessel, is constructed of aluminium alloy and is 7.3 m in length with a width of 0.63 m. (See diagram, page 10) It is fitted with five stanchions on each side with hand-ropes running through eyes at the top and at mid-height. The stanchions are 1.29 m high, measured from the underside of the gangway. The end of the gangway which connects to the ship is fitted with two hooks which rest over a steel bar fitted across the bottom of the break in the bulwark. The hooks do not encircle the bar, so the gangway is free to lift off vertically. The other end of the gangway is fitted with a roller which rests on the wharf. The two sides of the gangway are enclosed by a net which runs underneath it and which is secured to the top hand-ropes along three quarters of the length of the gangway. The end of the gangway on board the vessel is secured by leading the ends of the hand-ropes over the bulwark and tying them off to eyes on the deck and to a scupper pipe. (See photo next page)

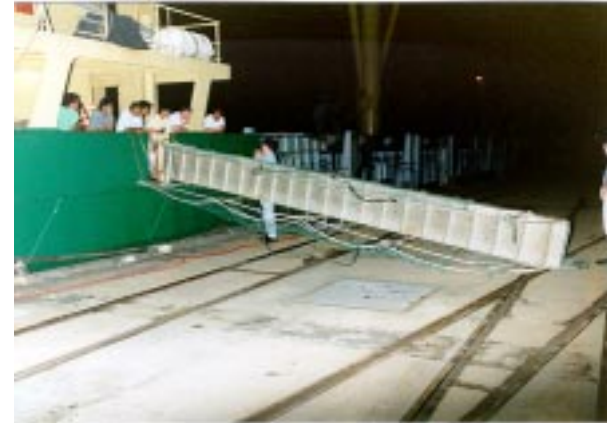
Tipped gangway shortly after the incident

The Chief Engineer boarded the ship first, while the Master paid the taxi driver. Shortly afterwards, the crew heard a loud crash and felt the ship shudder. The gangway was found tipped on its side and the Master was seen floating face down in the water between the ship's side and the wharf.

The Chief Engineer went out on deck to find the gangway tipped over and lying on its side. Knowing that the Master had been about to follow him on board, he looked down into the water, between the ship's side and the wharf, and saw the legs of the Master who was floating, face down, under the wharf. After taking off his trousers and shirt, he jumped in and turned the Master onto his back lifting his face above the surface. He shouted at the crew, who were gathering at the bulwark, to call for an ambulance.

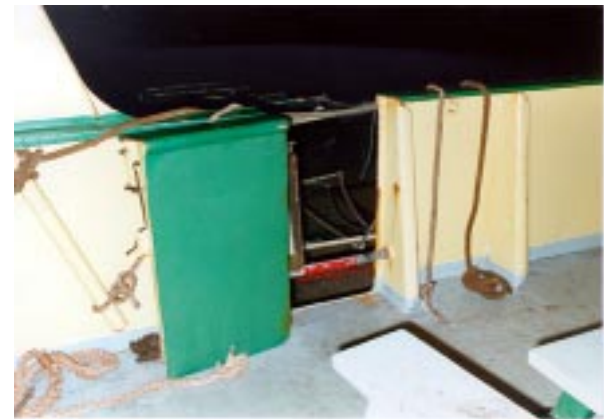
Gangway shortly after the incident

Showing slack handropes and the manner in which they were secured.

Assuming that the hand-ropes were quite taut at the highest tide and that no adjustments were made to take up the slack on succeeding lower tides, the difference in length, between the highest and lowest tides, of the upper hand-ropes amounts to some 0.64 metres. This dimension is the change in distance between the bulwark and the top of the first stanchion closest to it. This slack, however, would become distributed along the length of the gangway as the ropes were free to move through the eyes on the stanchions and, for this reason, it may not have been readily noticed by the deck watchkeepers.

Following on from the above estimations, the length of slack in the upper hand-ropes at a tide of 2.7 metres, such as existed at the time that the Master returned on board, would have been approximately 0.22 metres.

The ship had no standing orders relating to the duties of the deck watchkeepers, neither were there any written check lists. Instructions for the watchkeepers, when given, were verbal and very general in nature. It became apparent during the investigation that, although the deck watchkeepers were conscious of their responsibilities for checking and adjusting the vessel's six mooring lines, they were not conscious of similar responsibilities for the hand-ropes on the gangway and no evidence was found to suggest that these had been tended for a

In addition, evidence received during the investigation indicates that insufficient attention was paid to adjusting the gangway hand-ropes to allow for changes in tidal levels, as required under (g) above.

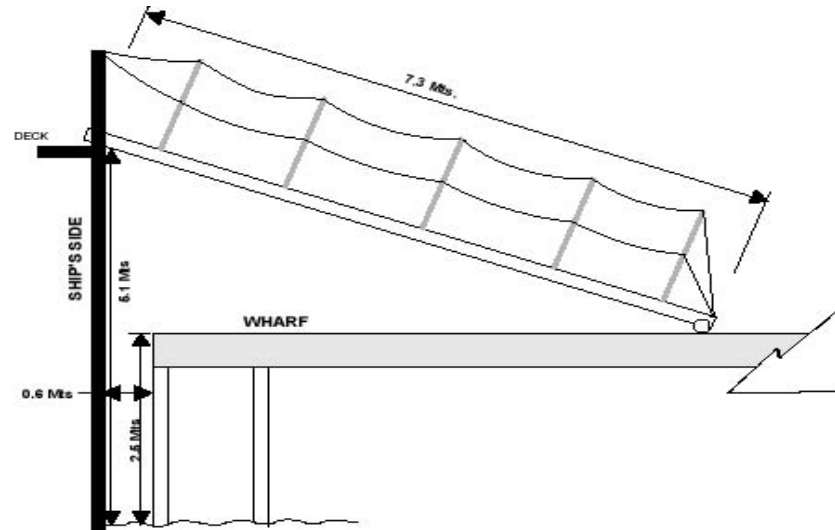
Dimension of gangway

A diagram showing the approximate geometry of the gangway, is shown on page 10. The dimensions given are as at 2145 on Saturday 12 October, when the Master and Chief Engineer returned on board. The state of the tide at that time was 2.7 metres above datum.

Arktis Grace gangway at Townsville as at 21.45 on Saturday 12 October 1996

The Master weighed approximately 140 kg and was 193 cm in height. The centre of gravity of the human body is at approximately $2/3$ height, (depending on the position of the arms), or in this instance at about 127 cms. This is approximately 23 cms higher than the height of the top of the stanchions, which are 129 cms high if measured

from the underside of the gangway. The width of the gangway, where it rests on the ship and on the wharf, is only 63 cms. Once a vertical line, drawn through his centre of gravity, moved outside the edge of the gangway, his weight would exert an unstable or capsizing moment which would tend to tip the gangway over.

With a length of slack measuring 0.22 metres in the upper hand-ropes and the stanchions 1.6 metres apart, the upper hand-ropes could be displaced 0.42 metres to one side before again becoming taut. This distance would allow the centre of gravity of the Master to move well outside the edge of the gangway.
