INTRODUCTION

AUTHORITY TO CONDUCT INVESTIGATION

COLLISION BETWEEN SS. RIVER BOYNE AND F.V. BABIRUSA

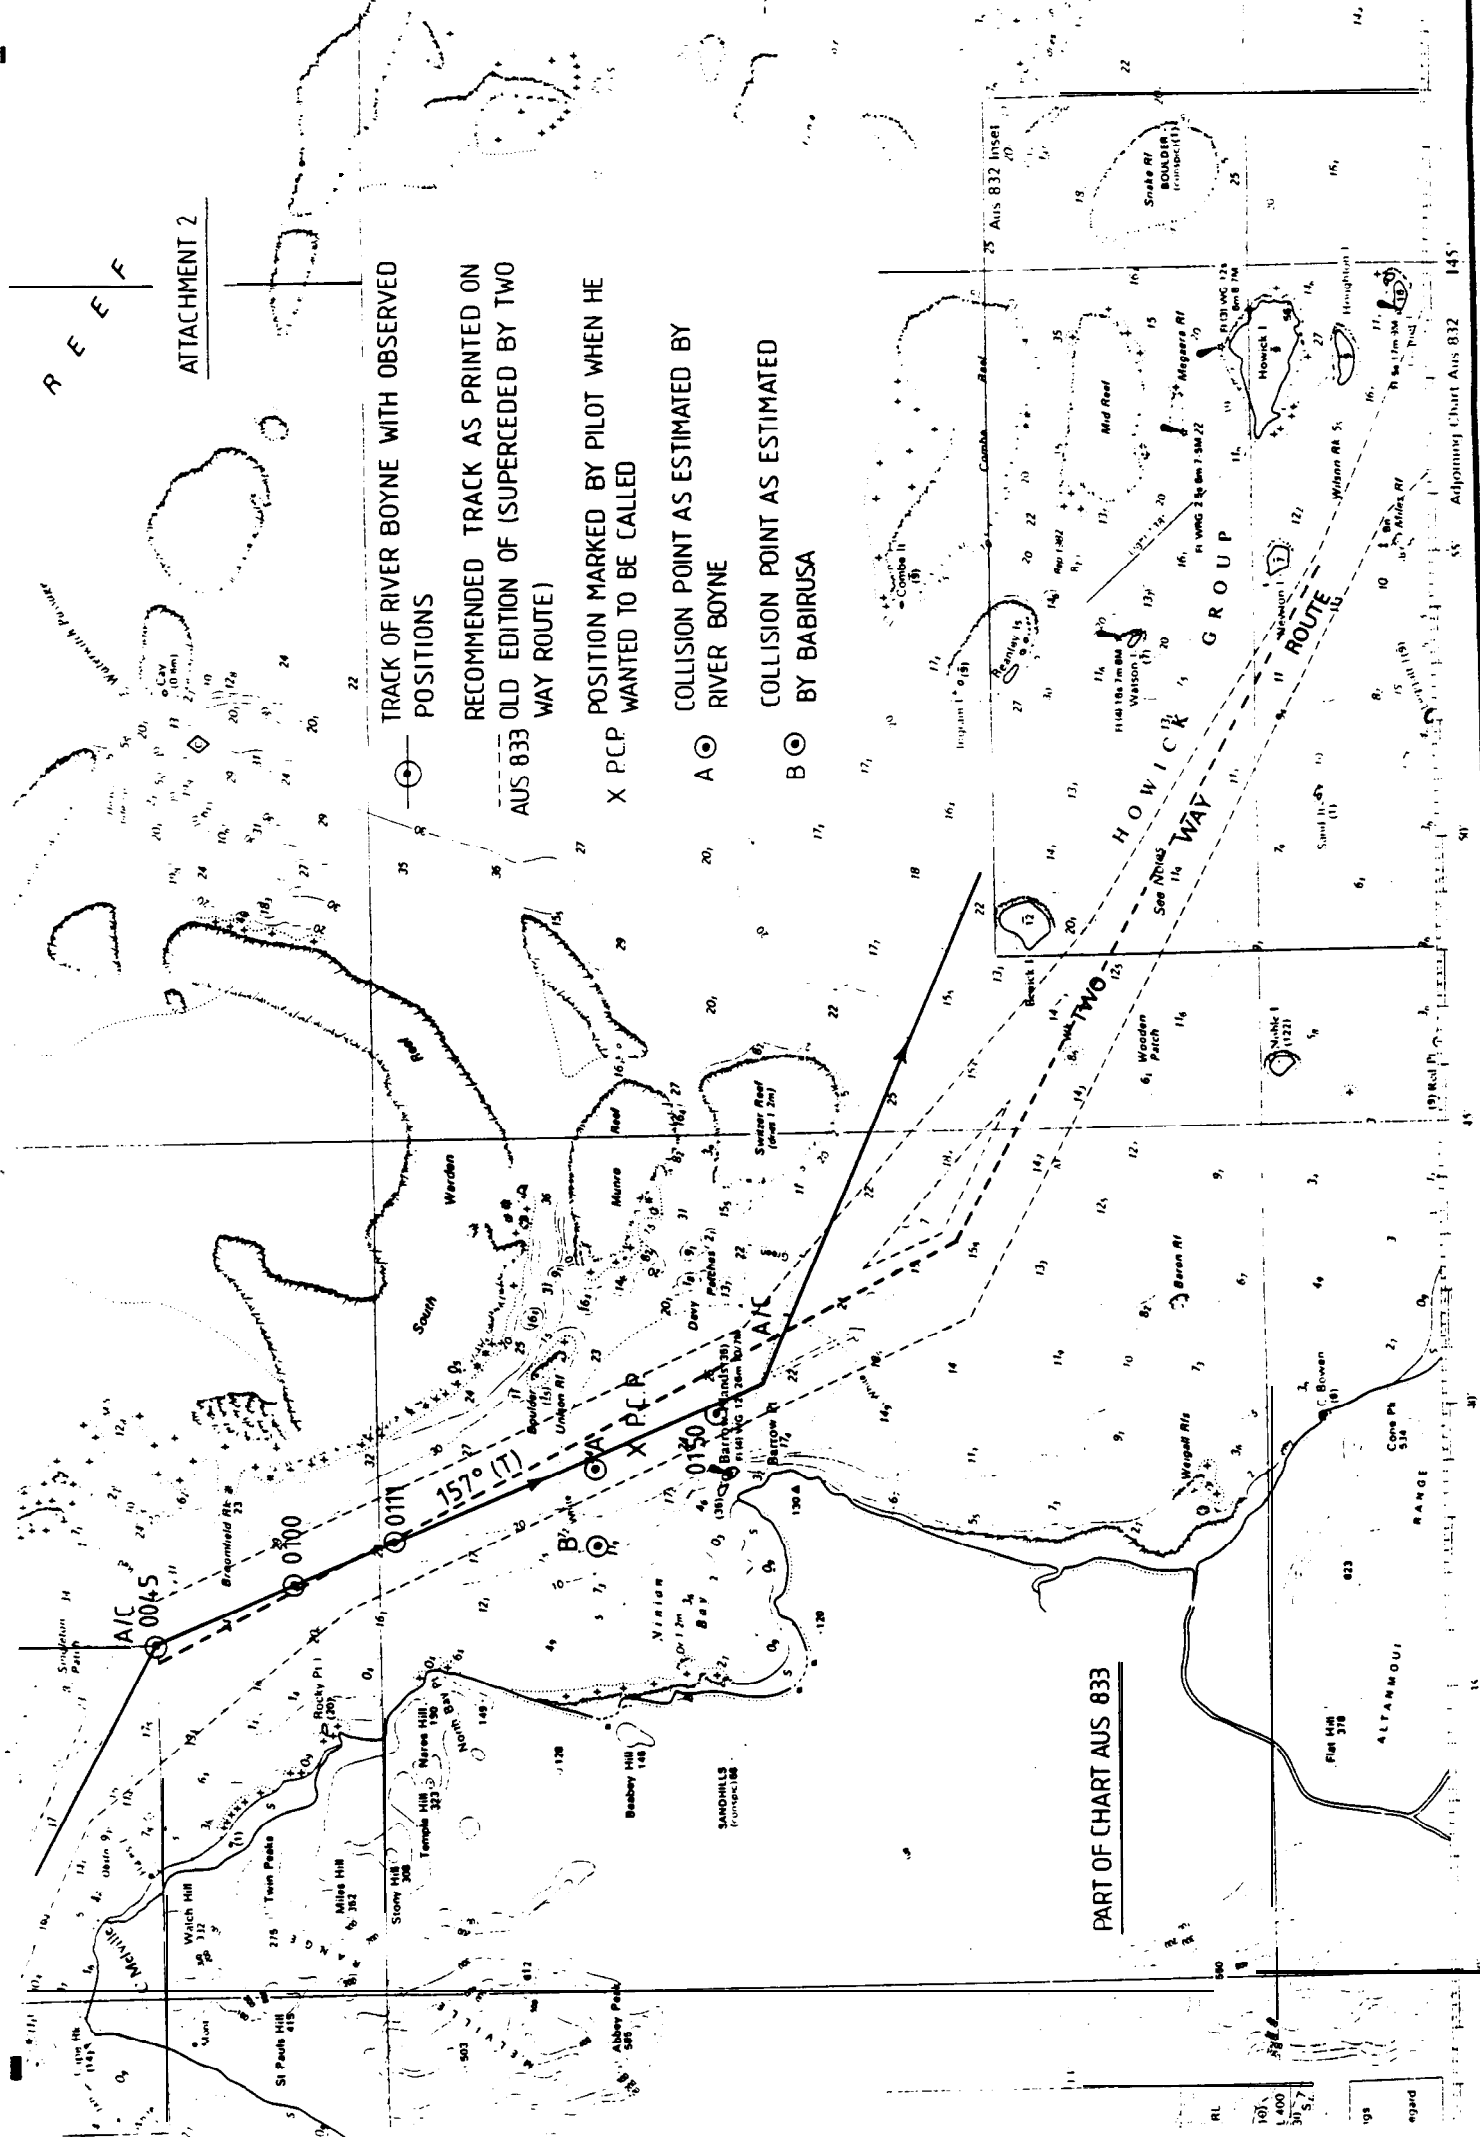
REEF
ATTACHMENT 2

TRACK OF RIVER BOYNE WITH OBSERVED POSITIONS

POSITION MARKED BY PILOT WHEN HE WANTED TO BE CALLED

COLLISION POINT AS ESTIMATED BY RIVER BOYNE

COLLISION POINT AS ESTIMATED BY BABIRUSA
