ATSB TRANSPORT SAFETY REPORT  
Marine Occurrence Investigation No. 268  
MO-2009-008  
Final

Independent investigation into the collision between  
the Australian registered yacht

**Ella's Pink Lady**

**Silver Yang**

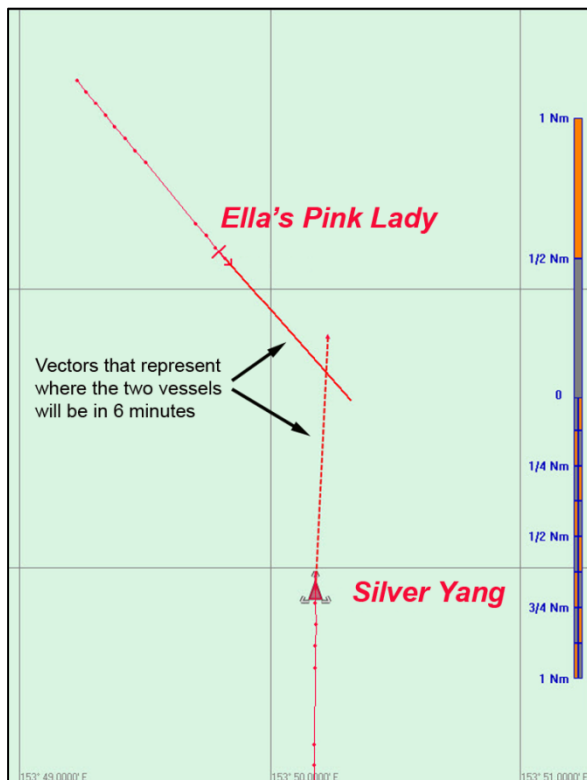
Figure 5: AIS image derived from the Point Lookout AIS base station showing the relative positions of the *Ella's Pink Lady* and *Silver Yang* at 0146

At about 0146, *Ella's Pink Lady's* skipper prepared for another catnap. The yacht was now making good a course of 144°(T) at a speed of 6.8 knots. The skipper checked the radar and noted that there was a vessel about 6 miles off the starboard quarter<sup>11</sup> (Figure 4). She could not see it visually, but she monitored its progress on the radar for about 1 minute. Once she had determined that it did not present a collision risk, she again set the radar guard-rings and alarm clocks before going to bed. By this time, *Silver Yang* was about 1 mile to the south-southeast of *Ella's Pink Lady's* position (Figure 5). However, the yacht's skipper had not detected the ship's presence.

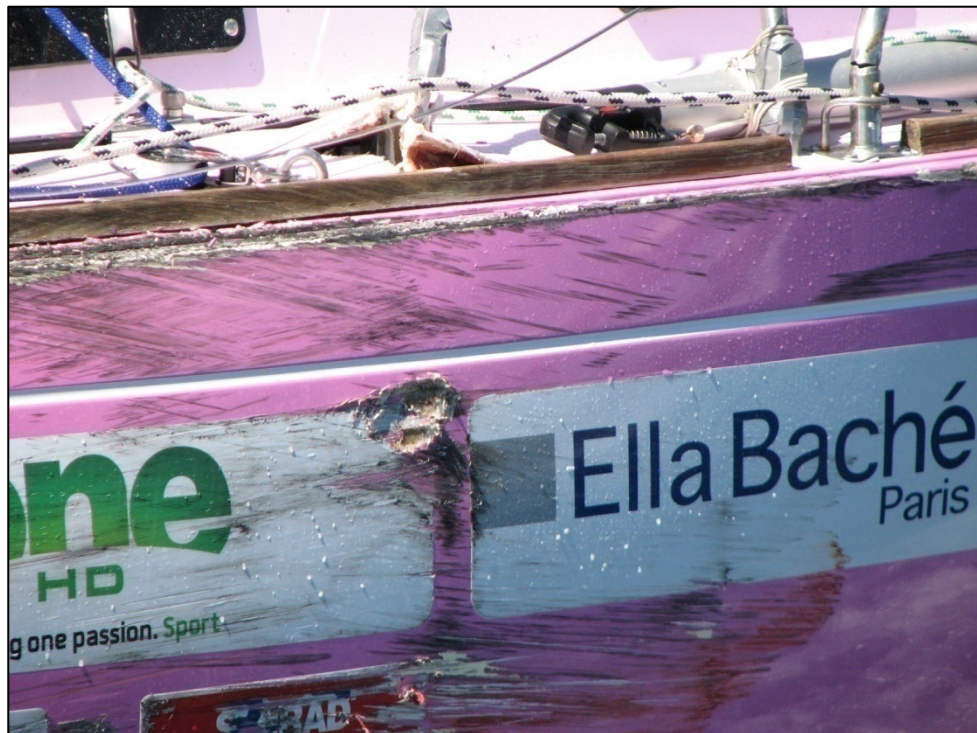
**Figure 7: *Ella's Pink Lady*'s damaged starboard side**

The impact of the collision pushed *Ella's Pink Lady*'s bow to port and the yacht's starboard side scraped along the port side of the ship. The collision woke the skipper and she climbed out of the cabin, grabbed the tiller and tried to steer the yacht. She looked upwards and thought that the yacht's rigging would probably become entangled with the ship and dismast her vessel, so she returned to the cabin. A few seconds later, the mast came crashing down.

Once *Ella's Pink Lady* had cleared the ship's stern, the skipper assessed the damage to her yacht (Figure 7). She found no ingress of water and, although the yacht's hull was damaged and it had been dismasted, the vessel appeared to be seaworthy. She then used the yacht's satellite telephone to call her parents. She spoke to her father and told him what had happened. While she was talking to her father, her mother telephoned the Australian Rescue Coordination Centre (RCC) in Canberra and reported the collision.

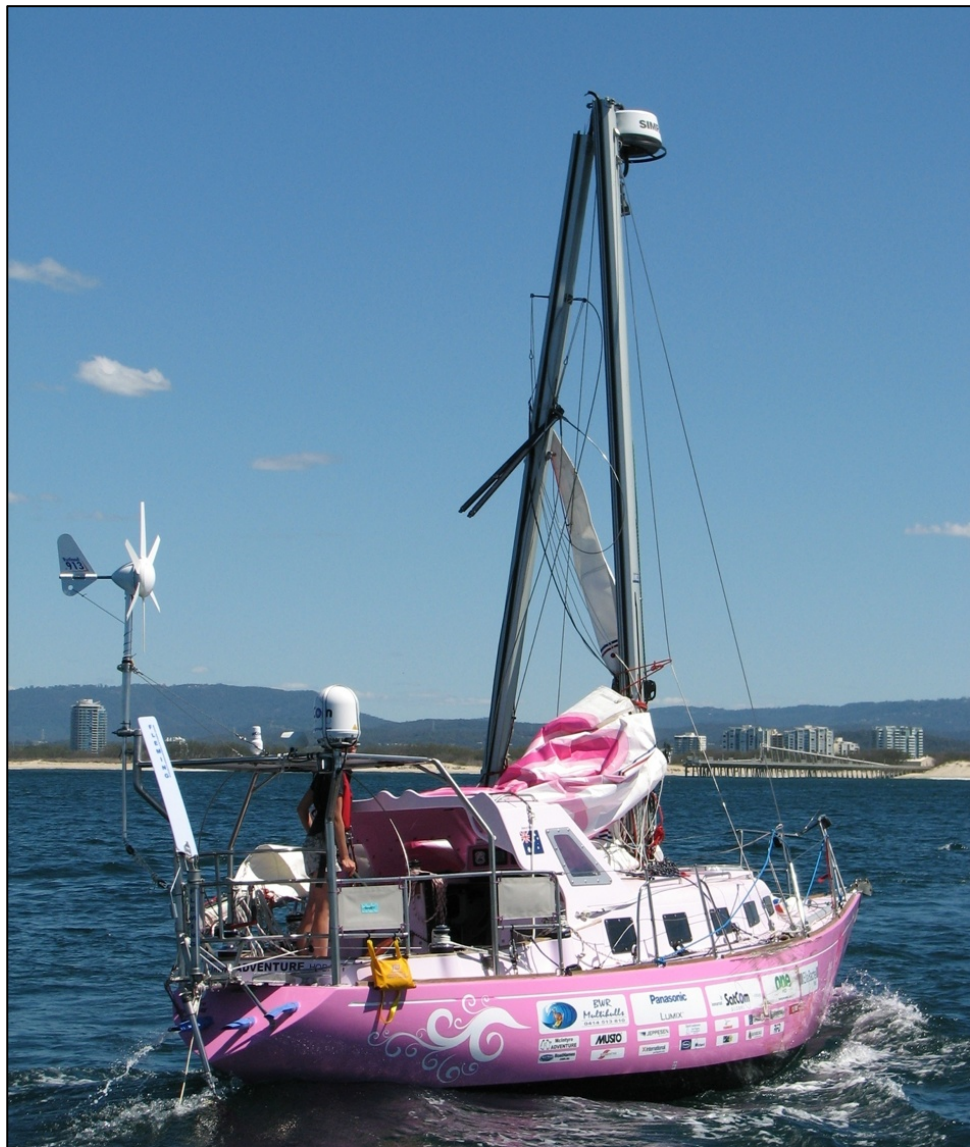
**Figure 8: Dismasted *Ella's Pink Lady* motoring towards Southport**

*Ella's Pink Lady* was dismasted as a result of the collision, but the skipper was able to cut the headsail free, retrieve the mast, the mainsail and the rigging on board and motor the damaged yacht to Southport, Queensland.

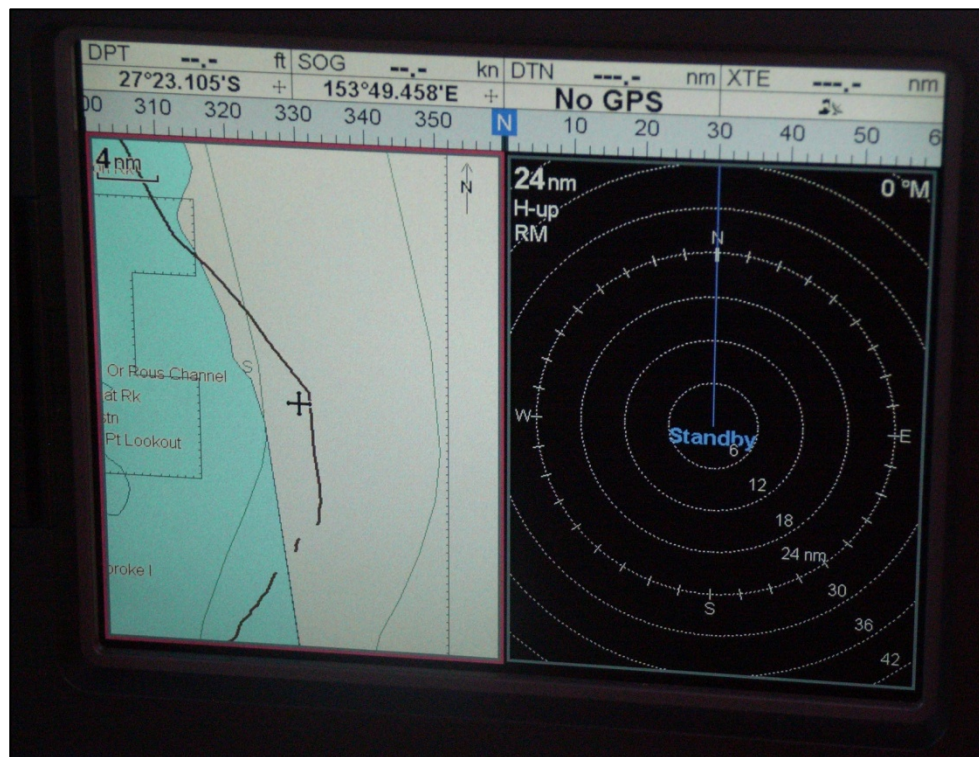
**Figure 9: *Ella's Pink Lady*'s Simrad Navstation display in split screen mode**

While it is possible that *Ella's Pink Lady*'s skipper looked at the radar and AIS displays but did not see *Silver Yang* (for the reasons previously discussed), there are further reasons as to why these devices did not alert her to the ship's presence.

The skipper had set the yacht's radar display on the 8 mile range and, since *Silver Yang* was large and constructed of steel, the ship should have appeared as a strong echo on the yacht's radar display from the time it came within its set 8 mile range. The ship entered the 8 mile range about 30 minutes before the collision but the yacht's skipper did not detect the ship during this time.
