Crew member fatality on board the bulk carrier *Nireas*

Gladstone anchorage, Qld | 20 March 2013

ATSB Transport Safety Report
Marine Occurrence Investigation
299-MO-2013-005
Final – 4 March 2014

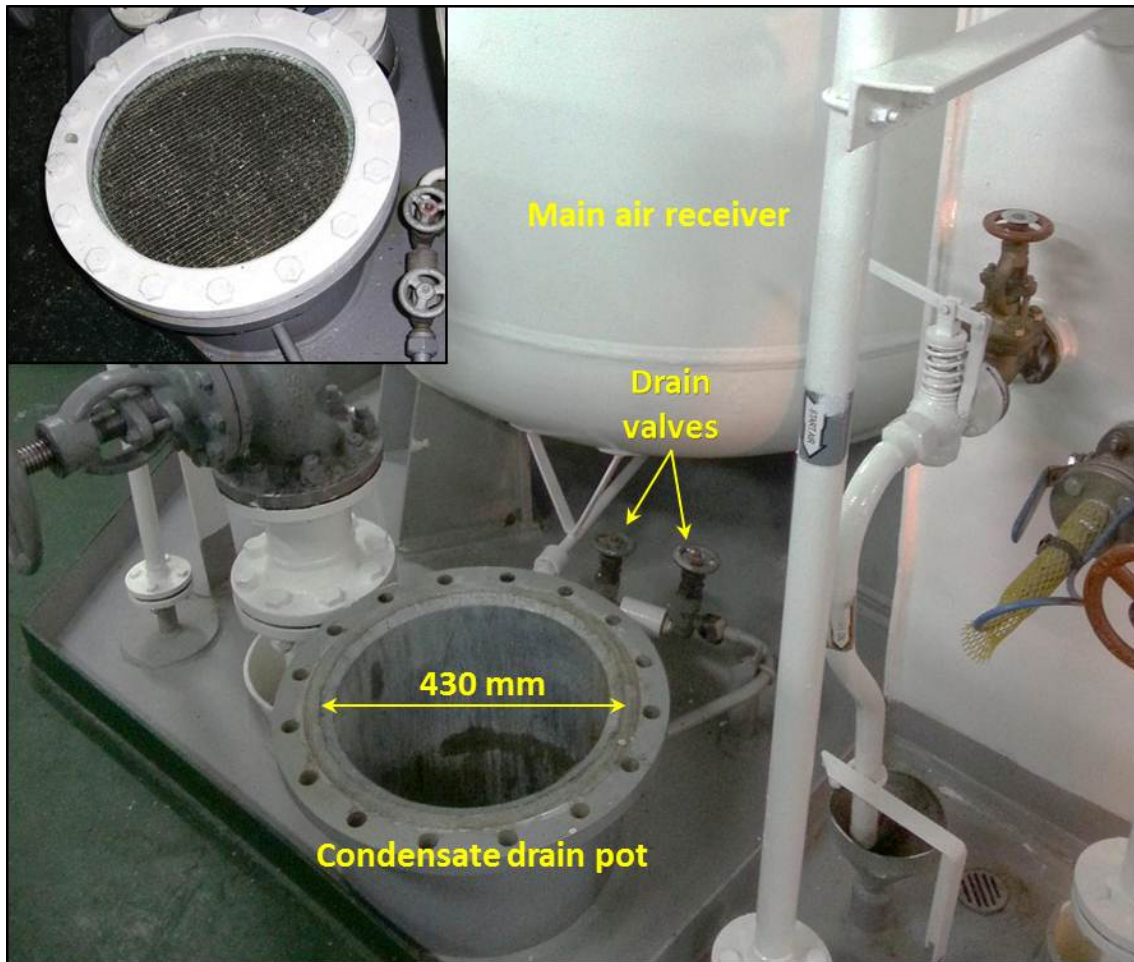
Shortly afterwards, and without warning, the observation glass exploded.

Figure 2: Forward main air receiver condensate drainage pot arrangement and inset showing a similar drainage pot with the observation glass in place

Observation glass of forward main air receiver condensate drainage pot shattered during drainage operation. The observation glasses are fitted to air receivers and air compressors throughout the engine room. The design of the drainage arrangements is to be verified. Meantime, the observation glasses have been removed from all of the pots.

Laskaridis Shipping has confirmed that the observation glasses were removed from the remaining drainage pots on board *Nireas* and its sister ship. The drainage pots were then modified under the supervision of Lloyd's Register. At that time, the glasses were replaced by steel plates which covered 2/3 of the drainage pot diameter, with the remaining area open to atmosphere.

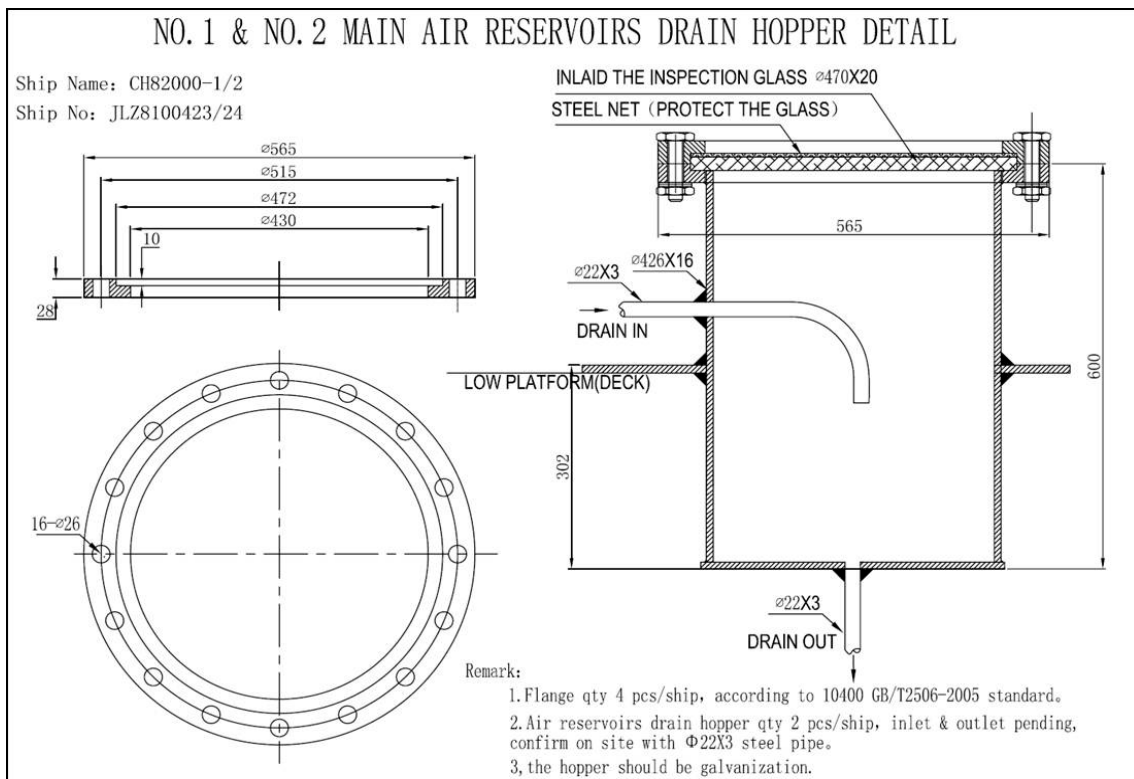
Figure 4: Main air receiver condensate drainage pot

The main air receiver condensate drainage pots were heavy steel cylinders about 600 mm high and 426 mm in diameter mounted into the deck adjacent to the air receivers (Figure 3). The top of each consisted of a toughened glass inspection cover clamped to the steel cylinder by a steel flange plate (Figure 4). The drain from the air receiver entered the cylinder from the side and was then directed toward the bottom. The outlet drain line was fitted in the centre of the bottom of the pot.

In the modified design, the hinged cover is replaced by a glass observation window and any condensate splashing is eliminated because the chamber is sealed (Figure 4). The alterations to the design included increasing the size of the chamber (by about 20 times), the use of significantly thicker materials and the use of glass rated to 16 bar.⁶

The design of the drainage pots suggests that some consideration was given to the likelihood of pressure accumulation. However, no quantitative engineering analysis of the design was

undertaken and no operational risk analysis was carried out. As a result, the possibility of an over-pressurisation of the observation glass was not identified and appropriately treated.

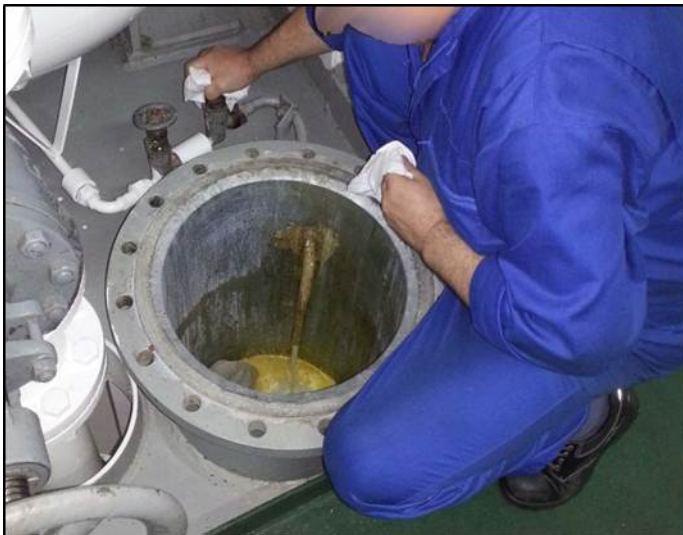
It is likely that on 20 March 2013, when the fourth engineer opened the drain valves from the main air receiver between one and two turns, the condensate which had accumulated in the air receiver overnight flowed into the drainage pot in sufficient quantity to cover the bottom of the pot and the discharge hole.

Figure 5: Draining condensate from number one main air receiver, after the accident

This flow of liquid was probably followed by a marked increase in pressure due to the inrush of pressurised air (about 30 bar) from the receiver. This pressure increase in the drainage pot was sufficient to fracture the observation glass, leading to its catastrophic failure.

The positioning of the drain valves behind the observation pot meant that the fourth engineer's upper body was positioned directly over the observation glass (Figure 5) and therefore in the path of the explosive force and debris exiting the pot.

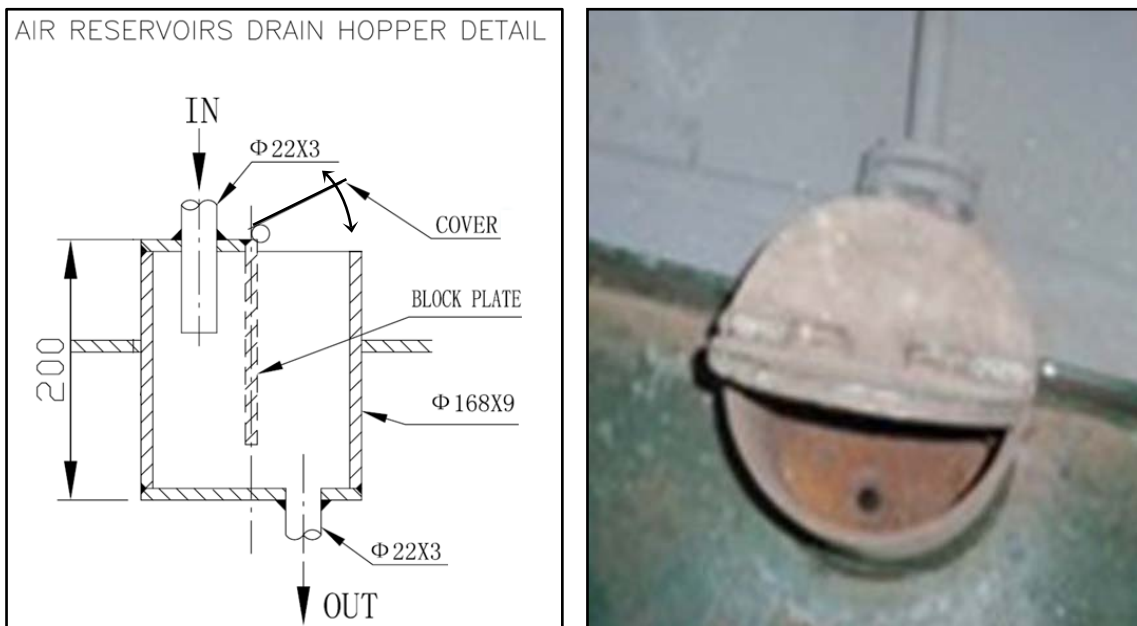
The original drainage pot (hopper) design used by Jiangsu Jinling Shipyard (Figure 6) incorporated an internal block plate to contain and limit condensate splashing and a hinged cover to allow for observation of the contents of the drainage pot and its outlet hole. This is a design commonly found on board ships and is a proven and reliable method of draining pressurised systems whilst limiting condensate splashing and allowing for visual checks during draining. However, the final positioning of the inlet pipe and the block plate combined with the quantity of condensate in the bottom of the hopper may, at times, lead to splashing of condensate out the cover.

In this arrangement, should any pressure accumulate in the drainage pot, such as due to the outlet becoming blocked, the pressure is exhausted to atmosphere via the non-sealing, hinged cover.

Figure 6: Original Jiangsu Jinling shipyard design of condensate drainage pot

The Jiangsu Jinling Shipyard contacted ships it had built with this design of condensate drain system, informed them of the accident and requested they remove the drainage pot observation glasses and replace them with hinged covers. The shipyard then reassessed the risks associated with condensate drain system designs they used, informed all employees of the accident and took measures to improve communication with shipowners and classification societies when modifications were requested.

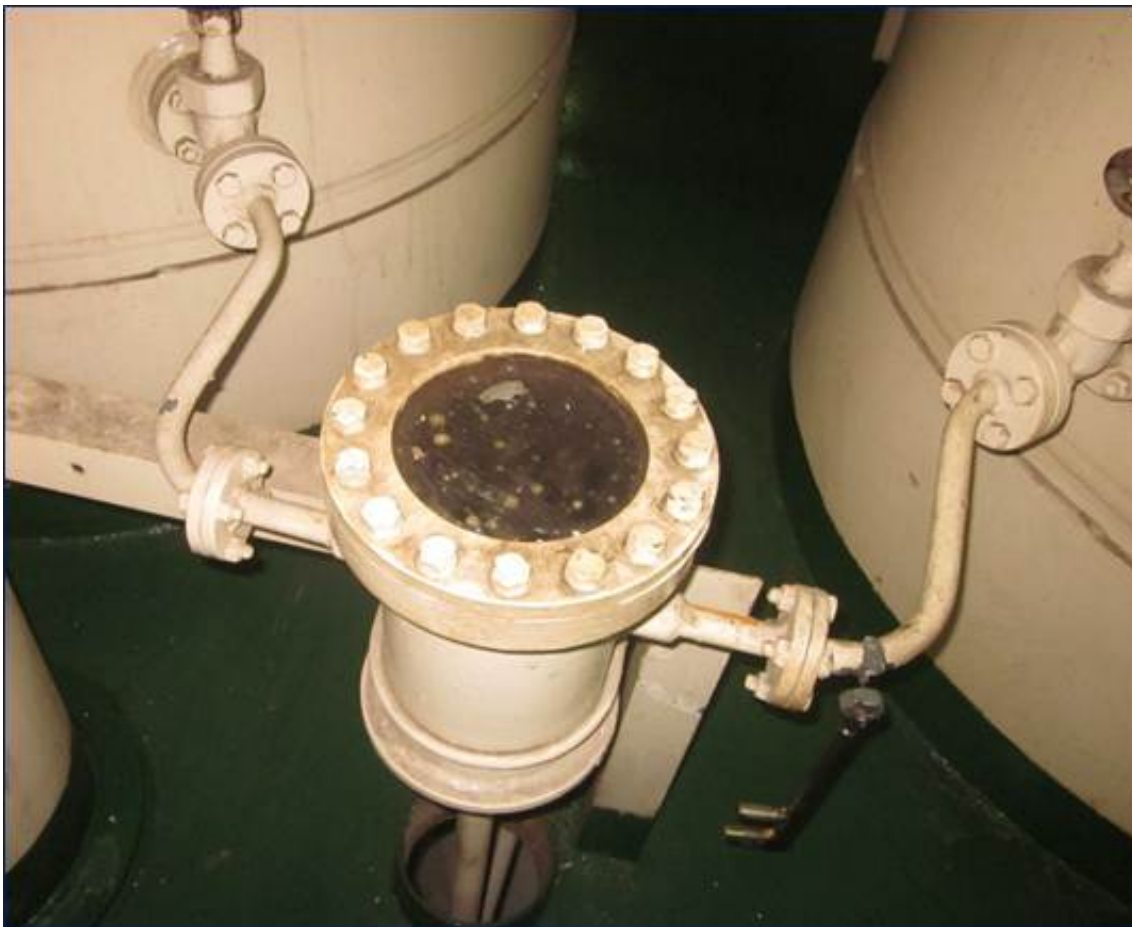
Figure 7: Similar design of condensate drain pot fitted on board another ship

These systems all include a closed observation pot with a glass viewing window similar to that fitted on board *Nireas*. Some of these drainage arrangements even have multiple system drains feeding a single pot (Figure 7).
