Crew member fatality on board the bulk carrier *Nireas*

Gladstone anchorage, Queensland | 20 March 2013

ATSB Transport Safety Report
Marine Occurrence Investigation
299-MO-2013-005
Preliminary – 31 May 2013

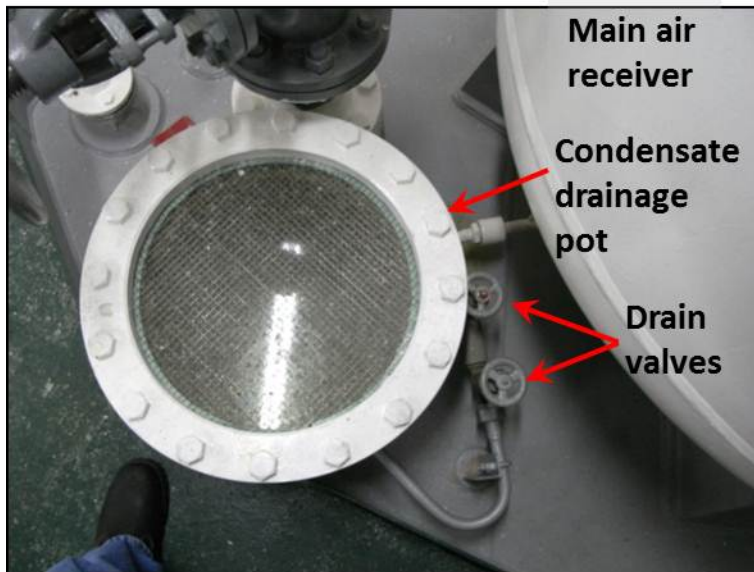
Figure 2: Main air receiver condensate drainage pot

The fourth engineer started his engine room checks and inspections, which included draining accumulated water (condensate) from the main and auxiliary air receivers.³ He opened each of the two inline drain valves of the forward main air receiver (Figure 2) about one turn and stood by while the water drained. Then, without warning, the observation window glass of the drainage pot exploded.

Initial analysis indicates that the drainage pot was exposed to full air receiver pressure (about 30 bar) and that the inspection window glass failed under the pressure.

All six similar drainage pot observation window glasses on board *Nireas* have been removed pending verification of the drainage arrangement design to the satisfaction of Lloyd's Register, the ship's classification society.

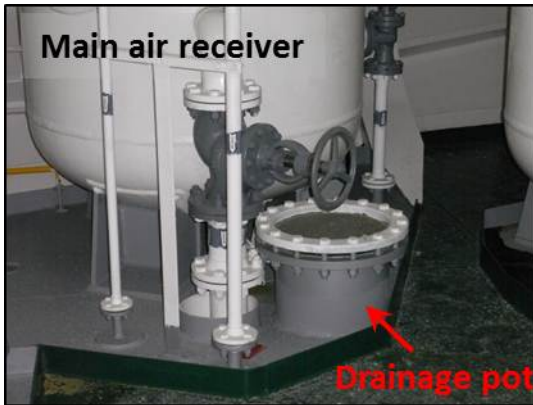
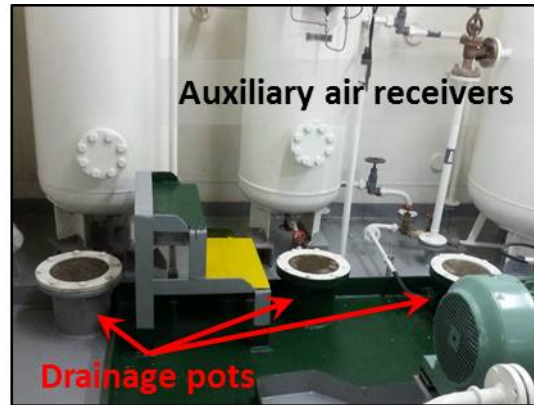
Figure 3: Air receiver condensate drainage pots

Each of the compressor and air receiver drain lines fed into a drainage pot (Figure 3) which then drained into the bilge well via the common line. The line increased in size as more drains emptied into it. Flow from the drainage pots to the bilge was clear and no valves were fitted in the lines.

The main air receiver drainage pots appeared to the naked eye to be strongly built (Figures 3 and 4) and were constructed from 18 mm thick steel cylinders. The cylinders had an outside diameter of 427 mm, were 600 mm deep and were fitted with a 32 mm thick top flange that had an outside diameter of 565 mm. The flange had 16 holes drilled through it to suit 25 mm bolts.

The observation window consisted of a 467 mm diameter piece of 18 mm thick glass which was covered with a 1 mm diameter wire mesh.

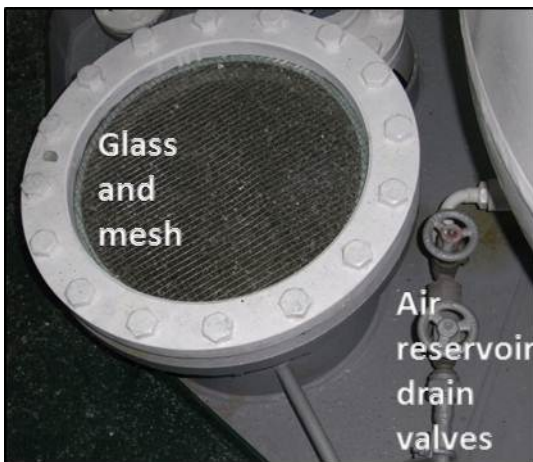
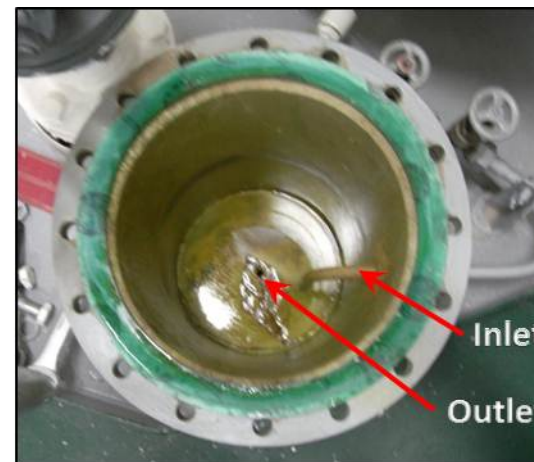
Figure 4: Main air receiver drainage pot arrangement

The 15 mm diameter⁶ drain line from the air receiver entered the side of the pot and exhausted toward the bottom. Central in the bottom of the pot was a welded-in 15 mm diameter outlet line which fed into the common drain line and finally to the aft engine room bilge.
