Engine room fire on board the bulk carrier *Marigold*

Port Hedland, Western Australia | 13 July 2014

ATSB Transport Safety Report
Marine Occurrence Investigation
312-MO-2014-008
Final – 20 April 2016

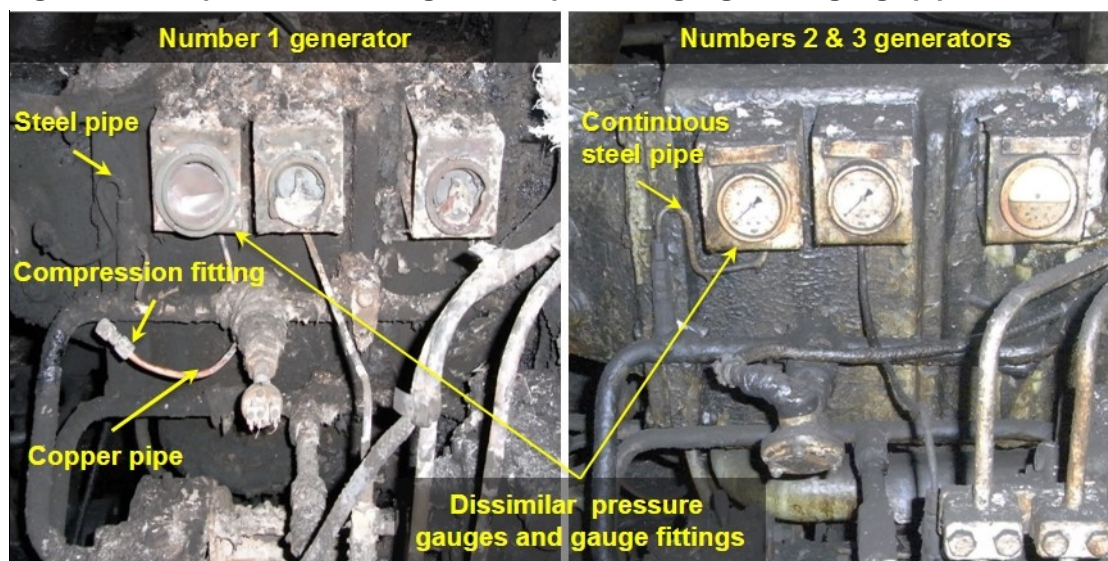
Figure 10: Comparison between generator pressure gauges and gauge pipework

The generator's fuel system pressure gauge piping originally consisted of continuous steel pipe connecting the fuel line to the pressure gauge. However, at some time in the past, a different type of pressure gauge had been fitted to the piping (fuel oil pressure before the engine). While the replacement gauge had a similar back mounting arrangement to the original, its connection fittings were incompatible with the original pipework, and it could not be directly connected to the piping. Therefore, the gauge had been connected to the original steel pipe using a section of copper pipe and a compression fitting (Figures 10 and 11).²⁰

Although the steel and copper pipes had the same nominal internal diameter, they had different outer diameters. Consequently, when the compression fitting was tightened, it is likely that the steel pipe was not adequately secured, and it separated from the fitting in the time leading up to the fire. The resulting spray of pressurised fuel oil produced a thin oil film that spread over a large area (Figure 11). It is likely that the oil film contacted a hot surface on the generator and ignited, resulting in a fire around its turbocharger.

- At about 1447 on 13 July 2014, a fire started on *Marigold's* number 1 diesel generator after a fuel oil pressure gauge compression fitting failed. Pressurised fuel oil escaping from the fitting then ignited after it came in contact with a sufficiently hot surface on the generator.

- The compression fitting that failed had been used to connect a replacement pressure gauge that had a different pipe connection fitting size to the original pressure gauge.

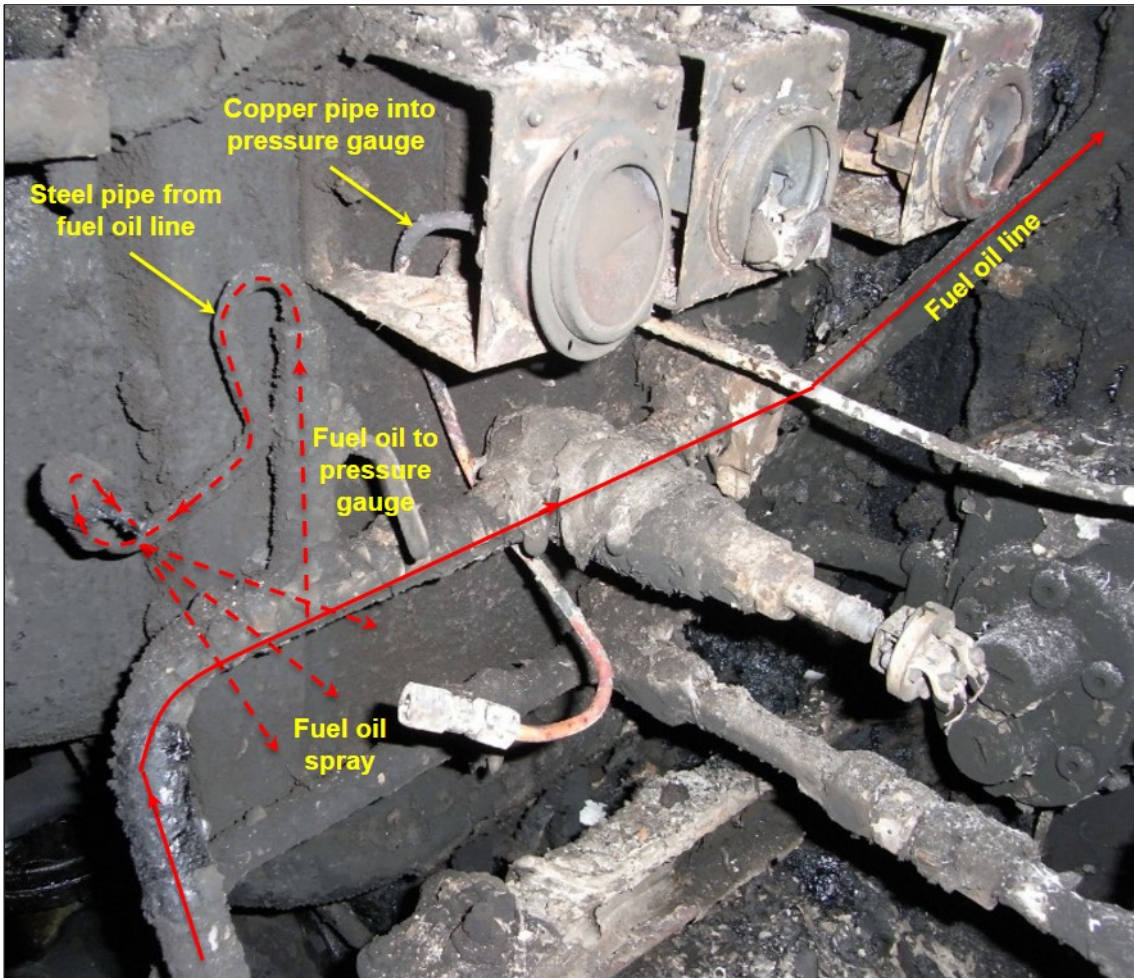
Figure 11: Fuel oil spray from compression fitting

On 13 July, while *Marigold* was loading cargo in Port Hedland, a fire started in the ship's engine room. The fire began on the ship's number one generator after a fuel oil pipe fitting on it failed. The resulting spray of fuel oil likely contacted a hot surface and ignited.

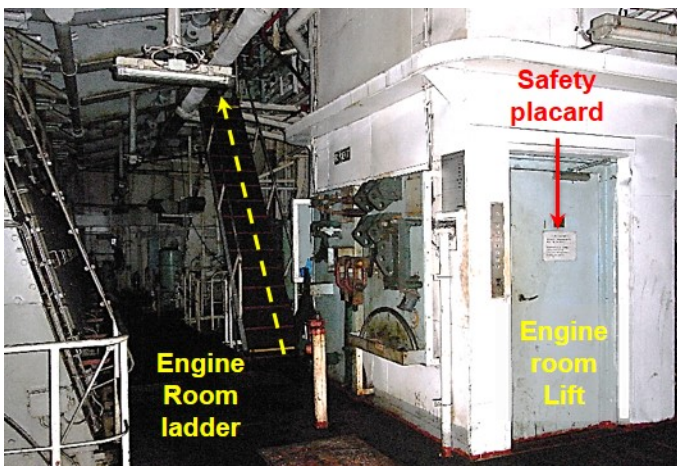
Figure 12: Engine room lift and adjacent ladder

The first engineer ordered his team to evacuate using the engine room lift. The lift accommodated only three persons, so the first engineer ascended the engine room ladder to make his exit (Figure 12).

It is universally accepted practice not to use a lift in an emergency due to the unacceptably high risk of becoming trapped in the lift if the power fails. Safety placards on the lift doors also warned 'Caution, lifts are not be used in the event of an emergency'. The crew took an unnecessary risk by using the lift.

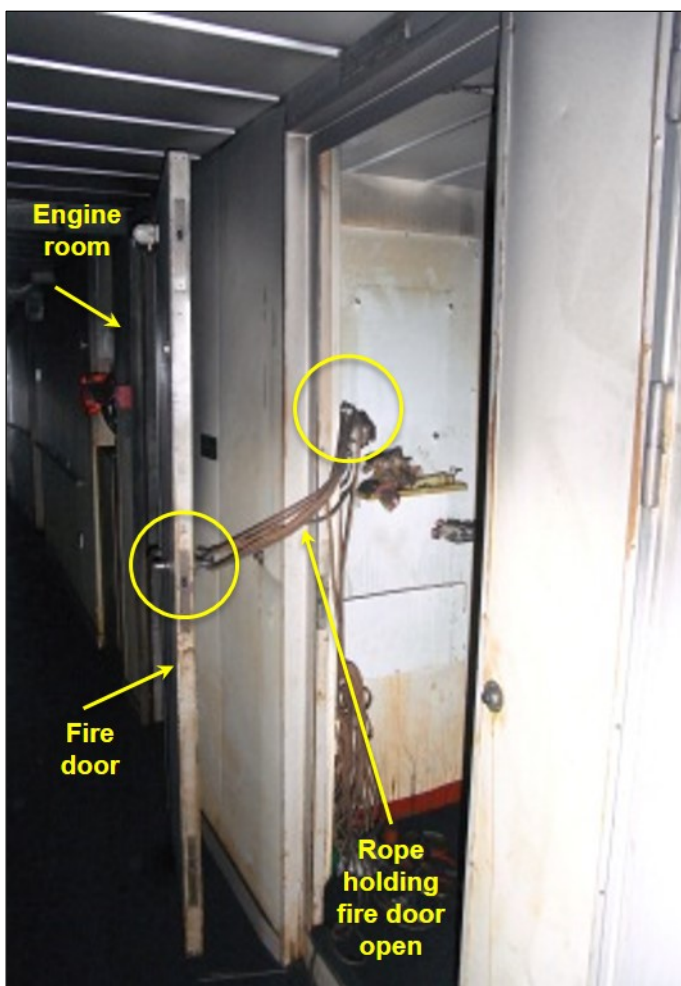
Figure 13: Fire door tied open

All fire doors on board *Marigold* should normally have been in a closed position. However, ATSB investigators found the fire door leading to the engine room from the upper deck inside the accommodation had been tied open (Figure 13).

The fire door from the accommodation remained open throughout the fire and the extended firefighting efforts. Consequently, smoke entered the accommodation and substantially affected/damaged it.

Post-fire atmospheric testing indicated that the accommodation remained uninhabitable over the following 2 days. During that time, the ship's crew would have been exposed to a hazardous and toxic atmosphere containing combustion products.

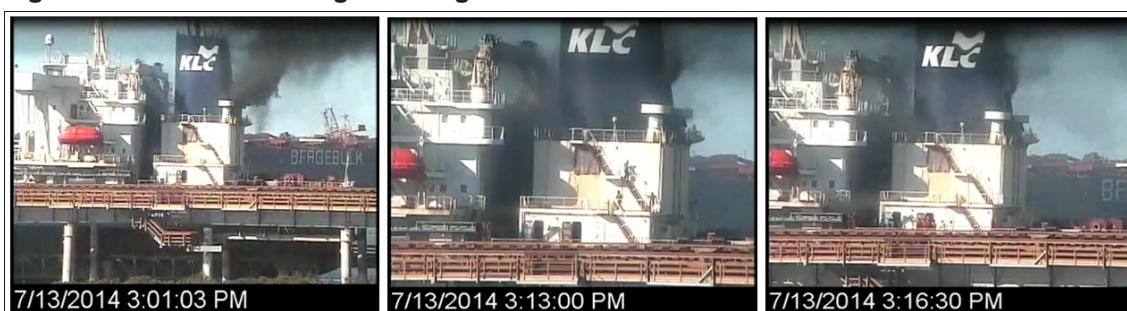
Figure 14: Smoke billowing from engine room ventilators

However, a number of mushroom ventilators and dampers could not be fully closed. The closing mechanisms of these openings were difficult or impossible to operate – indicative of inadequate maintenance of this critical equipment over an extended period. Consequently, the engine room was not effectively isolated; smoke continued to billow from the openings, and air entering the engine room sustained the fire (Figure 14).

The continuing flow of air to the fire was further exacerbated by an inability to close the engine room hatch. Heavy smoke prevented the crew from reaching the chain block used to hold the hatch open.

- **The maintenance of the opening/closing arrangements for *Marigold's* engine room fire dampers, ventilators and other openings was inadequate. A number of these could not be closed, resulting in the inability to seal the engine room to contain and suppress the fire. [Safety Issue]**

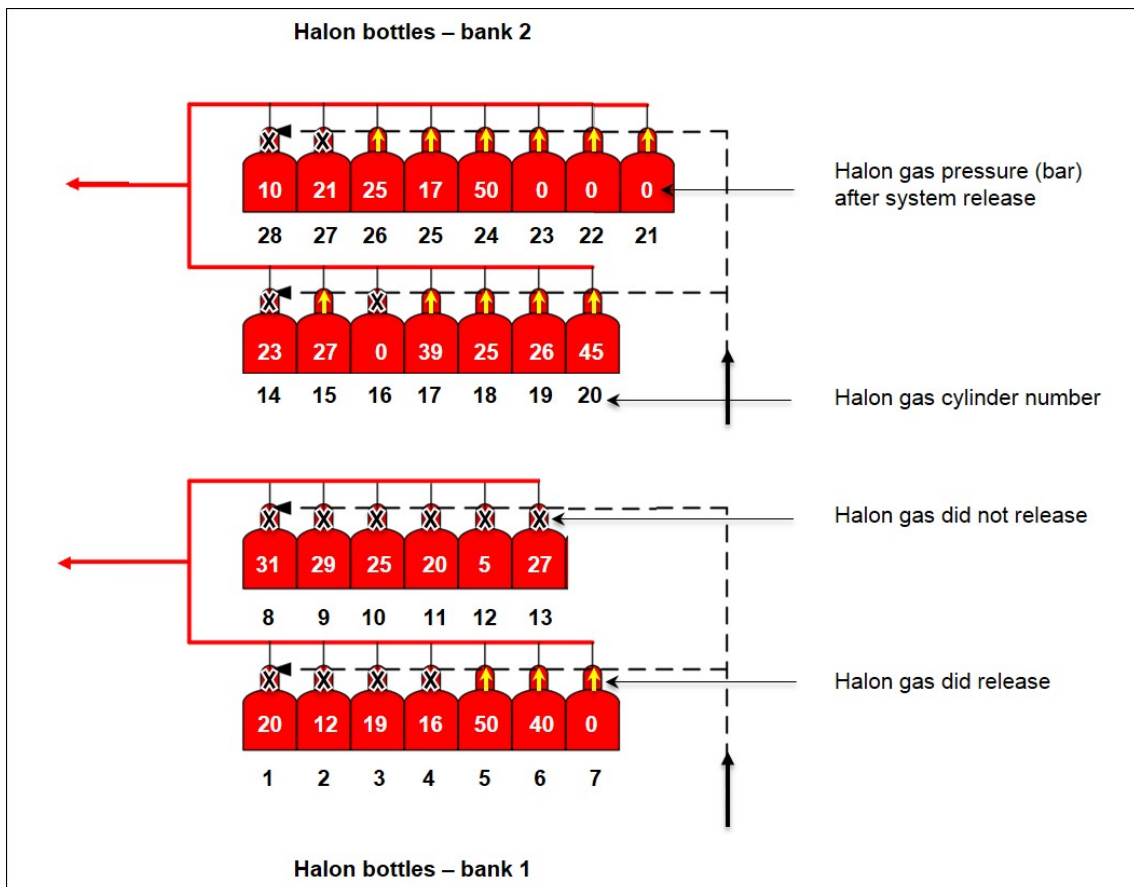
Figure 15: Halon bottle pressures after release

During their investigation on board the ship, ATSB investigators found only one of the two main distribution valves had opened. This meant that the pilot CO₂ system had only activated the Halon gas bottles of 'bank 2' (Figure 15). Therefore, there was only a partial release of Halon gas into the engine room.

The pilot CO₂ gas flowing via the open distribution valve should have activated the release valves of all the Halon bottles. However, several bottle release valves failed to activate. Further, when the chief engineer manually activated every bottle on each bank, several release valves also failed to activate (Figure 15). Investigators later found that individual bottle pressure gauge readings across the two banks varied across a wide range (0 to 50 bar).

The ATSB investigation identified a number of possible reasons for the failure of the Halon gas bottles to discharge, which include:

- inaccurate bottle pressure gauges
- insufficient bottle charge (low pressure)
- failure of bottle release valves to operate
- holed (leaking) individual pilot CO₂ flexible hoses.

- ***Marigold's* Halon gas fixed fire suppression system for the engine room was not fully operational. The multiple failures of the system at the time of the fire were not consistent with proper maintenance and testing. [Safety Issue]**

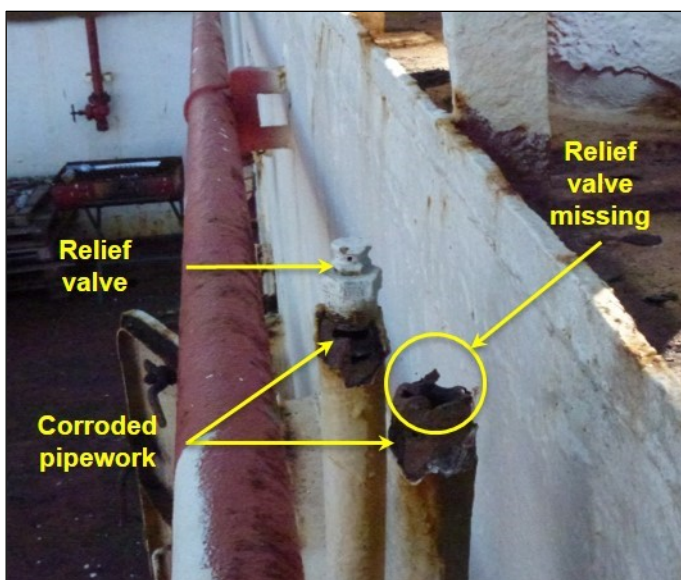
Figure 16: Halon manifold relief pipe work

In following the master's instruction, the chief engineer started removing the bottle head release pins and discharging each bottle into the main manifold. However, as the main distribution valve from bank '1' had failed to open and was still closed, the manual release of Halon gas over-pressurised the manifold and relief lines. These lines were in a heavily corroded, poor condition and the over-pressure condition caused the failure of the lines' pressure relief system, allowing Halon gas to disperse into the atmosphere (Figure 16).
