ATSB TRANSPORT SAFETY REPORT  
Marine Occurrence Investigation No. 259  
MO-2008-011  
Final

Independent investigation into the fatality on board  
the Maltese registered container ship

# Spirit of Esperance

24 November 2008

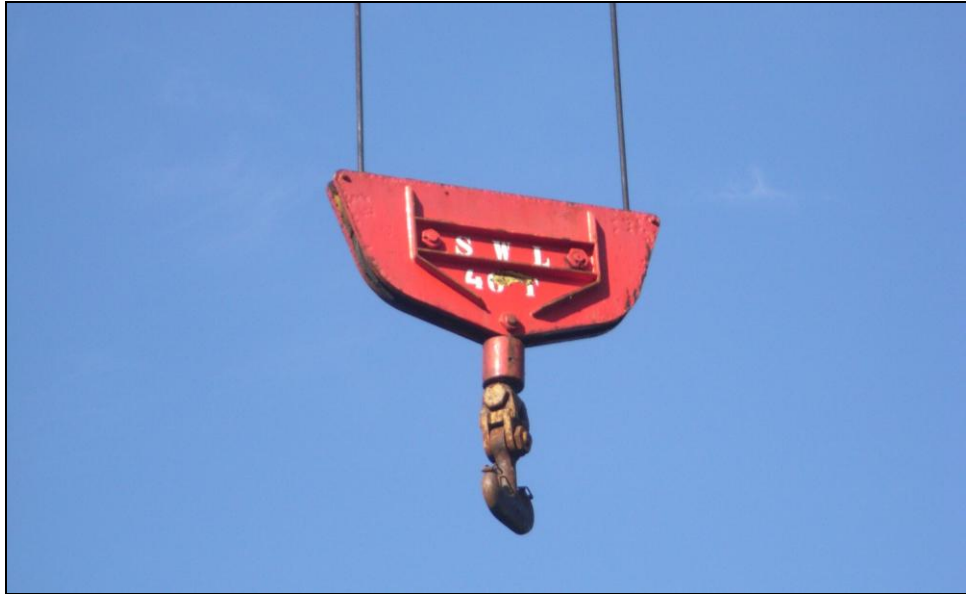
**Figure 2: The block and rams-horn hook assembly**

Each crane has a luffing wire for raising and lowering the crane jib, and a hoisting wire for raising and lowering the hook. The hoisting wire runs through a block and rams-horn hook assembly (hook) (Figure 2). The total weight of each crane's loose gear and wires is 5 t and the hooks each weigh about 2 t.

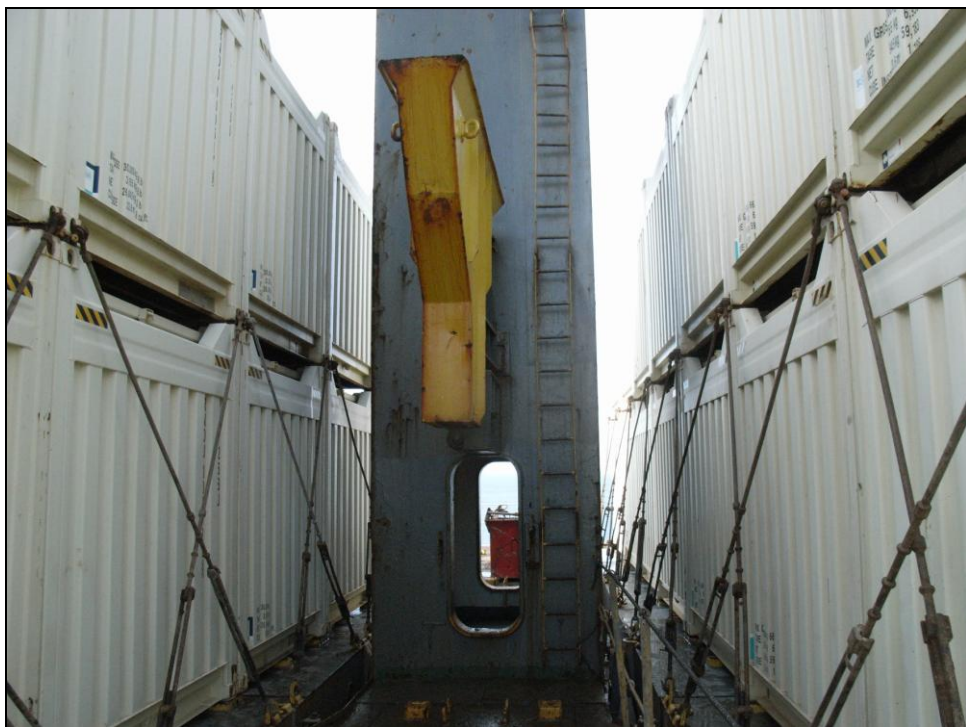
**Figure 3: The hook cradle and the emergency ladder**

The dimensions of the cradle's opening are 2550 mm x 300 mm. This allows the hook to be stowed without intervention when the ship has a stern trim of 2.1 m or less. However, with a greater trim, the hook will not stow in the cradle without manual assistance.

The cradle cannot be seen from the crane driver's cabin when containers are stowed two or more high on the hatch cover. Hence, it became usual for a crew member (known as a 'dogman') to give directions to the crane driver, via a hand-held radio, to lower the hook until it was stowed.

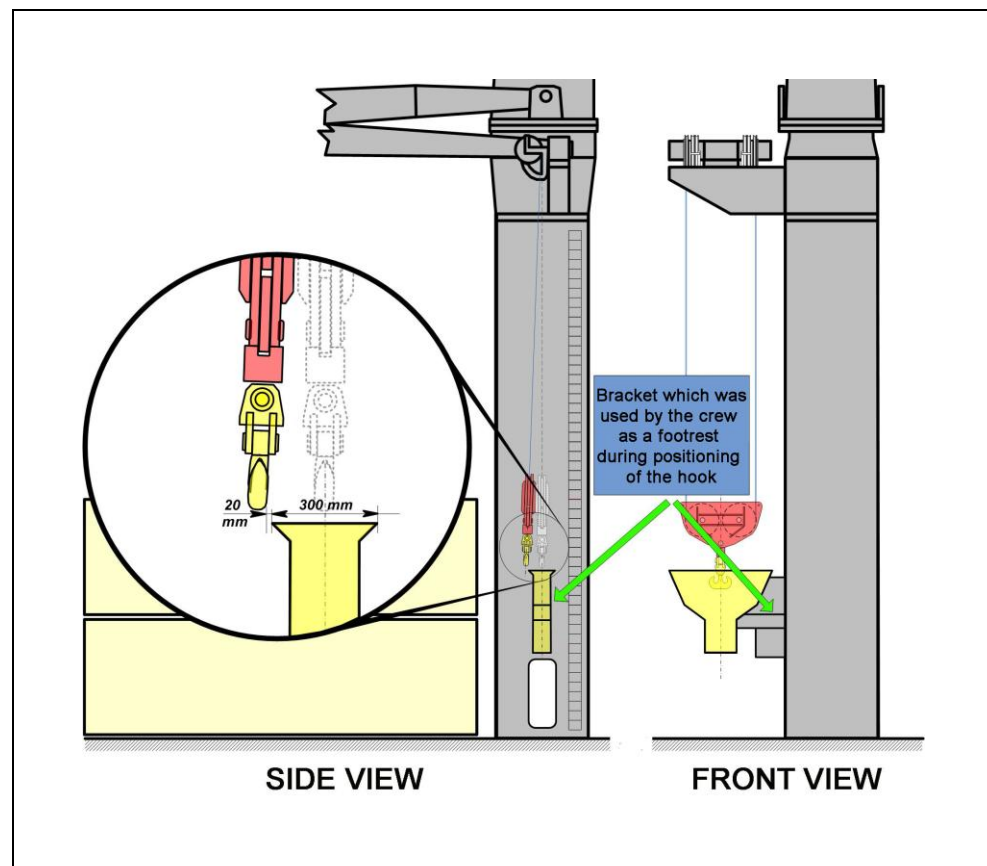
**Figure 5: The illustration of hook misaligned position**

Climbing the ladder was a relatively easy solution to the problem as the ladder was there and there was an area on the cradle bracket on which the dogman could place his foot (Figure 5). With one arm holding onto the ladder, and a foot on the bracket, the hook could be aligned manually.

This practice was not part of any procedure and the risks associated with the practice had never been identified. In addition, when the problem of hook/cradle misalignment became known, no analysis was undertaken to determine the safest and most appropriate solution to the problem, which may have been a modification of the cradle guides. Hence, the practice of manual intervention was allowed to continue because it achieved the desired outcome, that of a secured cargo hook, in a relatively short period of time.
