ATSB TRANSPORT SAFETY REPORT
Marine Occurrence Investigation No. 261
MO-2008-013
Final

Independent investigation into the fatality on board the
Australian registered floating storage and offloading tanker

Karratha Spirit

24 December 2008

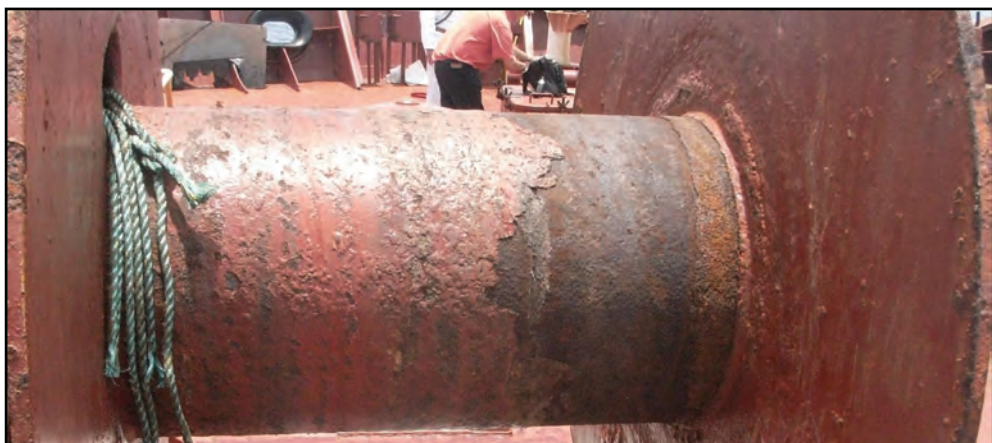
Figure 10: Port winch drum with cut lashings

At the time, he was standing between the ‘cheeks’ of the drum (Figure 10) to cut the lashing while there were still about three turns of the pickup line around the drum.

During the disconnection operation, the mooring hawser pickup line should not, and usually would not, have been under tension. The master had briefly run the main engine astern to pull the import hose out from under the mooring hawsers. Before the brake was applied on the port winch drum, the ship's movement would have assisted in pulling the pickup line from the drum. Once IR3 applied the winch brake, the ship's movement would have been arrested by the pickup line, increasing the load on it.

It is also possible that IR3 was so focussed on cutting the lashing that he did not realise how much the load was coming onto the pickup line after he had applied the winch brake. From where he was standing, he could see, at most, 20 m of the 150 m long pickup line. As the ship continued to move astern, the increasing load on the line meant that there was a significant amount of energy stored in the elastic polypropylene rope and this energy was released as soon as the sacrificial lashing was cut.

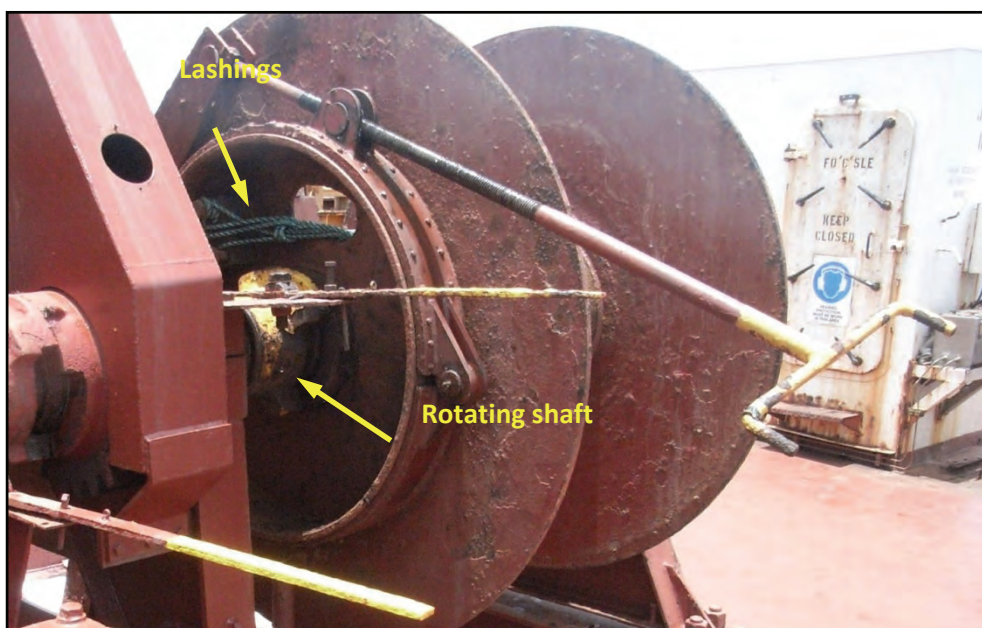
Figure 11: Sacrificial lashings outside the port winch drum

The lashing could have been cut from outside the cheeks of the drum at the point where it was attached to a strong point (Figure 11). It is not known exactly why IR3 chose to stand between the cheeks of the drum, thereby placing himself in danger. It is possible that he did not cut the lashing from outside the drum because he was concerned about having to lean over the winch drive shaft, which was turning while

the broken import hose hoist wire was being recovered or because he had just seen another IR cut the lashing on the starboard pickup line from a similar position on the starboard winch.
