**ATSB TRANSPORT SAFETY REPORT**  
**Marine Occurrence Investigation No. 265**  
**MO-2009-004**  
**Final**

# Fatality on board *Thor Gitta* at sea off Western Australia

## 21 May 2009

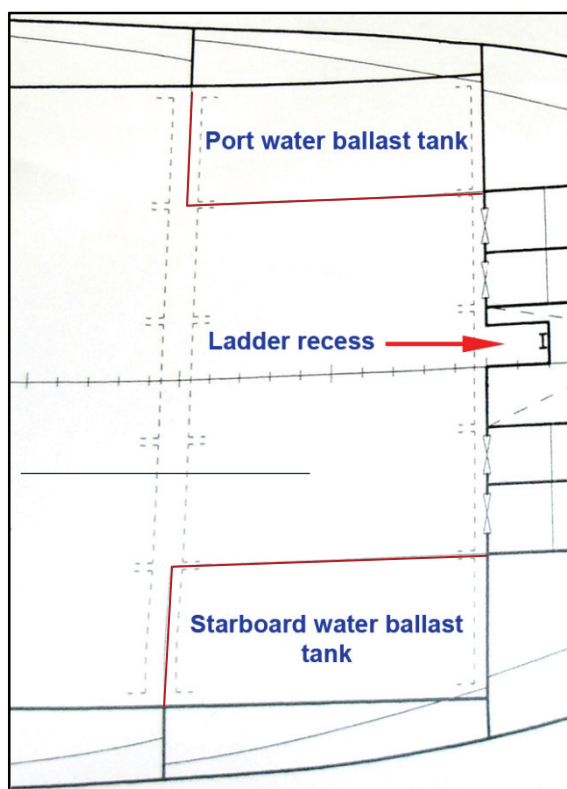
**Figure 2: Forward tween deck arrangement**

Two water ballast side tanks are located at the forward end of the hold. The tops of these tanks stand about 1.5 m above the tween deck's number one pontoon (Figure 2) and have 20 foot

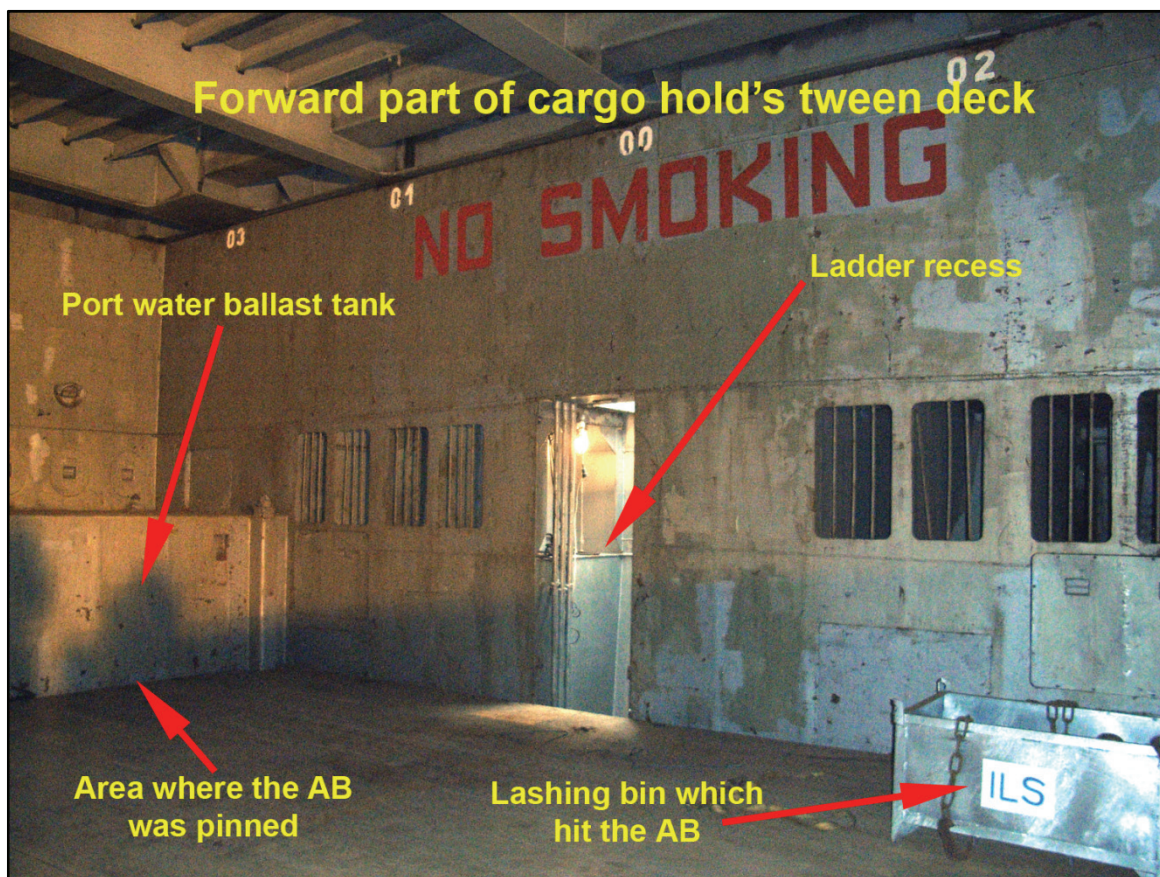
Figure 3: Accident location on the tween deck level

Shortly afterwards, the ship rolled heavily to port and the lashing bin started to slide back to port. The AB lost his balance and fell onto the pontoon, into the path of the bin. He was unable to get to his feet before the bin slid into him, hitting him

heavily in the torso and pinning him against the side of the port water ballast tank (Figure 3).

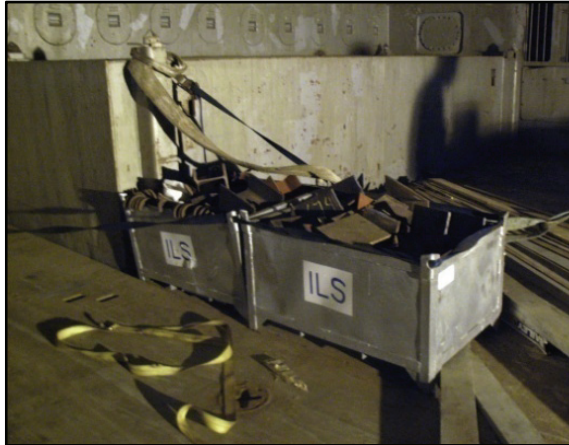
**Figure 4: Lashing bins secured after the accident**

There were lashing points/lifting points on the tops of the bins, and dedicated lashing points were available in the majority of the tween deck space, both on the hold's bulkheads and in the deck itself (flush elephant foot sockets). However, in the section of the tween deck in which the bins were secured; there were no dedicated lashing points on any vertical surface. There were several lashing points in the pontoon itself but none were

in the immediate vicinity of the bins. As a result, the straps were secured to the container footings on the top of the port water ballast tank (Figure 4).

However, the straps led upwards from the body of the bins and did not apply any downward pressure on them to 'hold' them onto the pontoon, thereby increasing the risk of the bins sliding about on the relatively smooth tween deck surface.

There were no shipboard procedures to provide the crew with guidance as to where and how to secure the movable lashing bins. As a result, the bins were secured in an area of the tween deck which did not have suitable lashing points.

- Fall arrest systems have been mounted in the access shafts to the holds both fore and aft.
- The safety instructions and workplace risk assessments for entering the holds have been revised.
- To enhance safety, extraordinary safety meetings will be held and work instructions given.
- These preventive measures are also being implemented on *Thor Gitta's* sister ship, *Thor Ingeborg*.
- The other ships in the fleet have received information (lesson to be learned) about the fatality and injury. Where steel drums are used for storage of lashing gear, they are to be replaced by metal bins.
