# Serious injury on board *United Treasure* off Port Kembla, New South Wales

7 July 2009

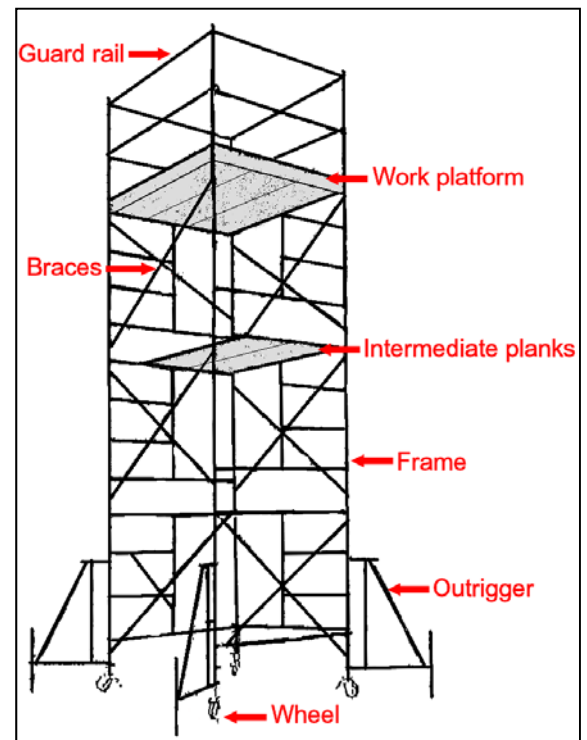
Figure 2: Mobile scaffold tower as designed

During the voyage, the crew assembled the new scaffolding and the master and chief mate inspected it. Made from aluminium, the scaffolding was similar to other common types of mobile towers designed for use on a stable, level surface. It could provide a 1.6 m x 1.5 m work platform up to a height of 8.5 m. The platform was positioned on top of the tower which is assembled in 1.55 m high tiers (lifts) and had height adjustable, lockable wheels at its base (Figure 2).

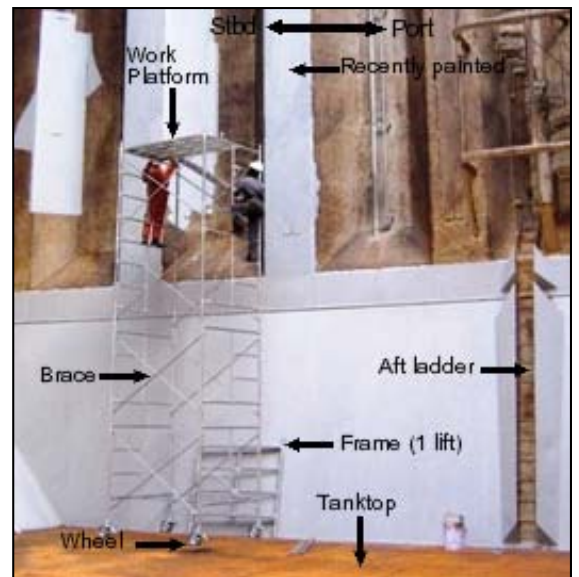
**Figure 3: Scaffolding in number one cargo hold**

At about 1115, the crew removed the guy rope, moved the tower further to starboard and began increasing its height (Figure 3). One lift was added and the work platform positioned on the tower. The AB and the OS then climbed on to the platform, now 8 m high, to add another lift. They hooked their safety belt lanyards to the tower, which had its wheels locked but was otherwise unsecured. They then lowered a heaving line to pick up frames and braces for the next lift.

At about 1130, both the AB and the OS moved to the platform's inboard (port) side to heave up the equipment that the bosun had tied to the heaving line. As they lifted the equipment off the tanktop, *United Treasure* rolled and the tower swayed. The AB and the OS shouted for help and the bosun and chief mate quickly grabbed the base of the tower to steady it. However, the tower toppled to port and the AB and OS fell with it to the tanktop.

The mobile tower was not secured to any part of the ship's structure and the seamen had not secured themselves to a strong point on the ship. Furthermore, the tower was not assembled as designed and except for locking its wheels, no

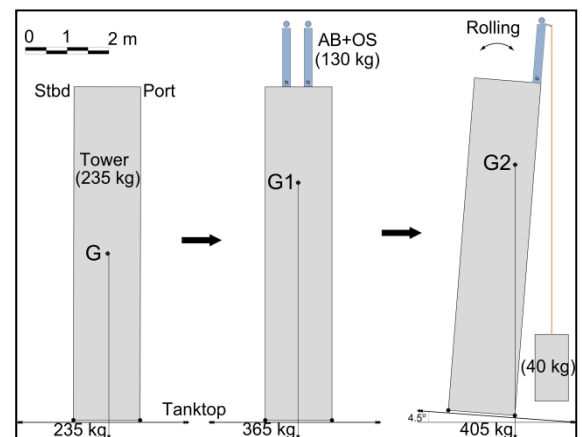
Figure 4: Progression to the tower toppling

On 7 July, after its height was increased to 8 m, the tower weighed about 235 kg. This weight acted through its centre of gravity located at its geometrical centre, 4 m above the base (point G in Figure 4). There were no outriggers to improve the tower's stability by increasing its wheel base of 1.7 m x 1.6 m. Hence, if the tower was tilted more than about 11.5°, its weight would act outside the base and the tower would topple.

When the AB and the OS climbed onto the tower's work platform, its centre of gravity shifted<sup>7</sup>. Together, the two men weighed approximately 130 kg and the tower's centre of gravity moved 1.7 m upwards (G1). The tower could now topple if tilted more than about 8°.

When both seamen moved to the port side of the platform, the tower's centre of gravity also moved to port. Then, when they lifted the approximately 40 kg of equipment, the centre of gravity again moved. The combined effect of their movement and the additional weight suspended from their hands shifted the centre of gravity about 0.35 m laterally and 0.3 m upwards (G2). The tower could now topple if tilted more than about 4.5° to port.

At about 1130, *United Treasure* rolled to port sufficiently for the tower to topple over.

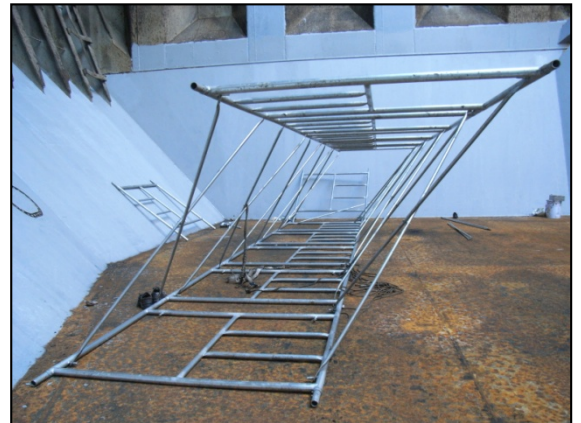
**Figure 5: Twisted tower after the incident**

With only three planks available, the tower was assembled without the two intermediate planks required at every alternate lift. Intermediate planks were necessary to prevent the tower from twisting during use (Figure 5).

The outriggers were another important component of the scaffolding that had not been received. Without these, the tower was less stable than it should have been. Furthermore, when it toppled on 7 July 2009, the height was being increased to more than its maximum design height with outriggers fitted.
