ATSB TRANSPORT SAFETY REPORT
 Marine Occurrence Investigation No.268
 MO-2009-008
 Preliminary

Collision between *Silver Yang* and *Ella's Pink Lady* off Point Lookout, Queensland 9 September 2009

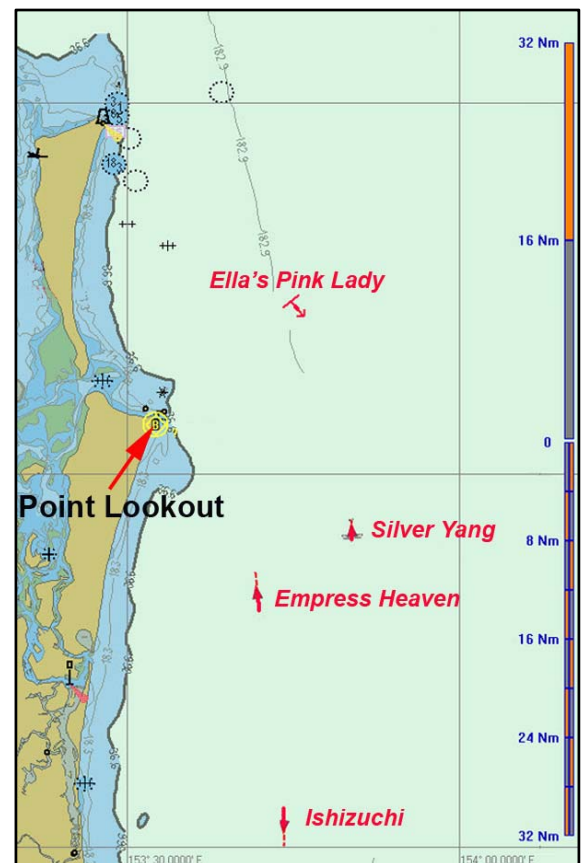
Figure 3: AIS recorded image showing the relative positions of both vessels at 0030

By 0030 on 9 September, *Ella's Pink Lady* was about 15 miles northeast of Point Lookout and making good a course of about 140°(T) at a speed of 4 knots (Figure 3).

Silver Yang was now about 17 miles east-southeast of Point Lookout, on a northerly heading and travelling at a speed of 8.7 knots.
