ATSB TRANSPORT SAFETY REPORT
Marine Occurrence Investigation No. 278
MO-2010-007
Final

Independent investigation into the loss of deck cargo from the
Panama registered multipurpose cargo ship

Mimasaka

4 October 2010

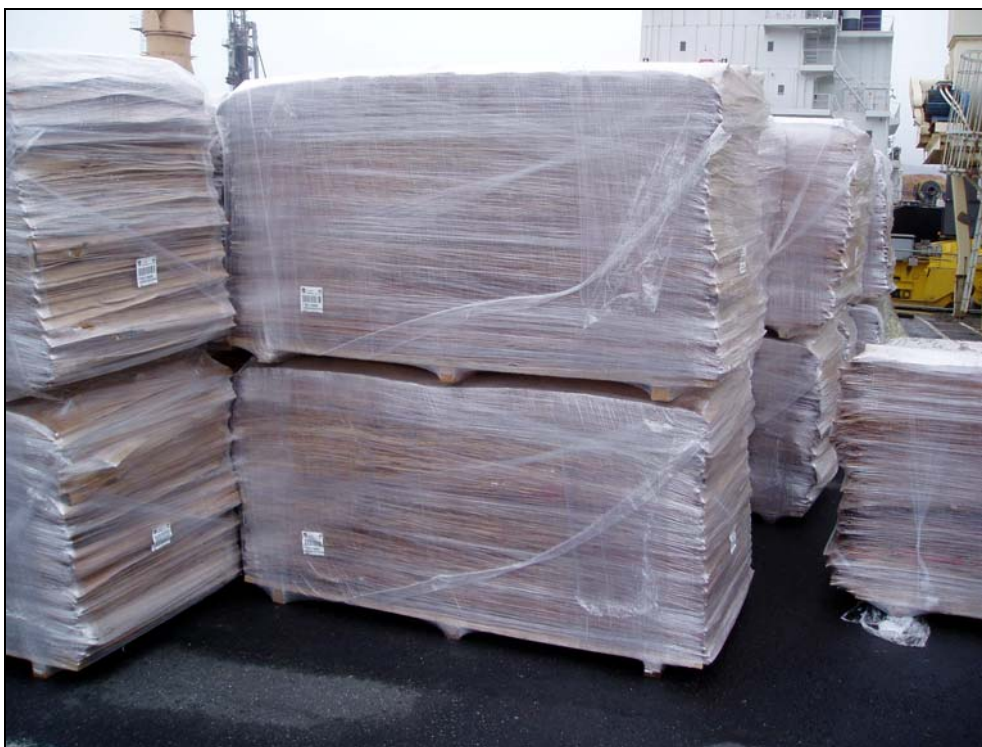
The packs of veneer had been delivered to the wharf by the shipper, wrapped in two types of plastic: 25 micron 'remill' (with some recycled content) and 20 micron 'full virgin' (with no recycled content) (Figure 2). The packs varied in length between 1,900 mm and 2,350 mm and between 990 mm and 1,080 mm in width. They ranged in height from 890 mm to 1,220 mm.

Figure 2: Timber veneer packs awaiting loading at Burnie

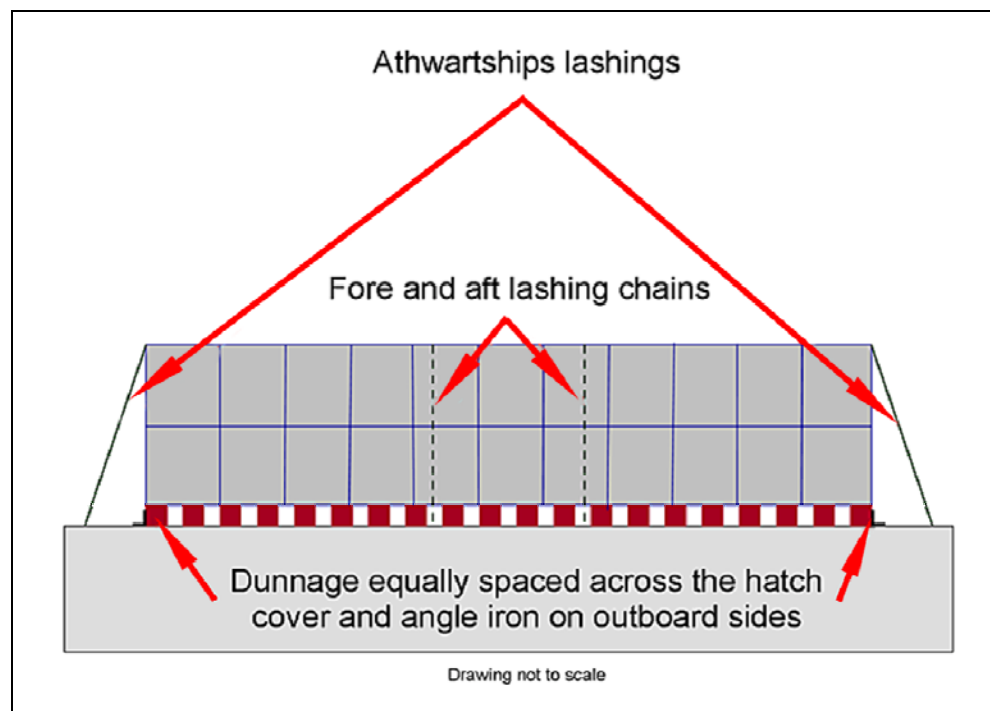
The veneer packs had been loaded fore and aft, two high on the hatch covers, with the bottom level (tier) sitting on the dunnage (Figure 3). The lengths of angle iron were welded on the outboard side of the hatch covers to prevent the outermost piece of dunnage from sliding further outboard.

Figure 3: *Mimasaka's* deck stowage and securing arrangement on departure Burnie

However, the angle iron had little or no effect in stopping all the dunnage from moving. All it did was prevent the outboard pieces of dunnage from moving further outboard. The remainder of the dunnage was only held in place by the weight of the cargo, which would have varied considerably when the load was subjected to vertical accelerations of increasing magnitude in the deteriorating weather. As the tension was progressively lost in the lashing arrangement, there would have been increasing movement between the relatively smooth dunnage and the newly painted hatch covers. This would have, in turn, resulted in the entire cargo stow becoming less stable and subject to movement.

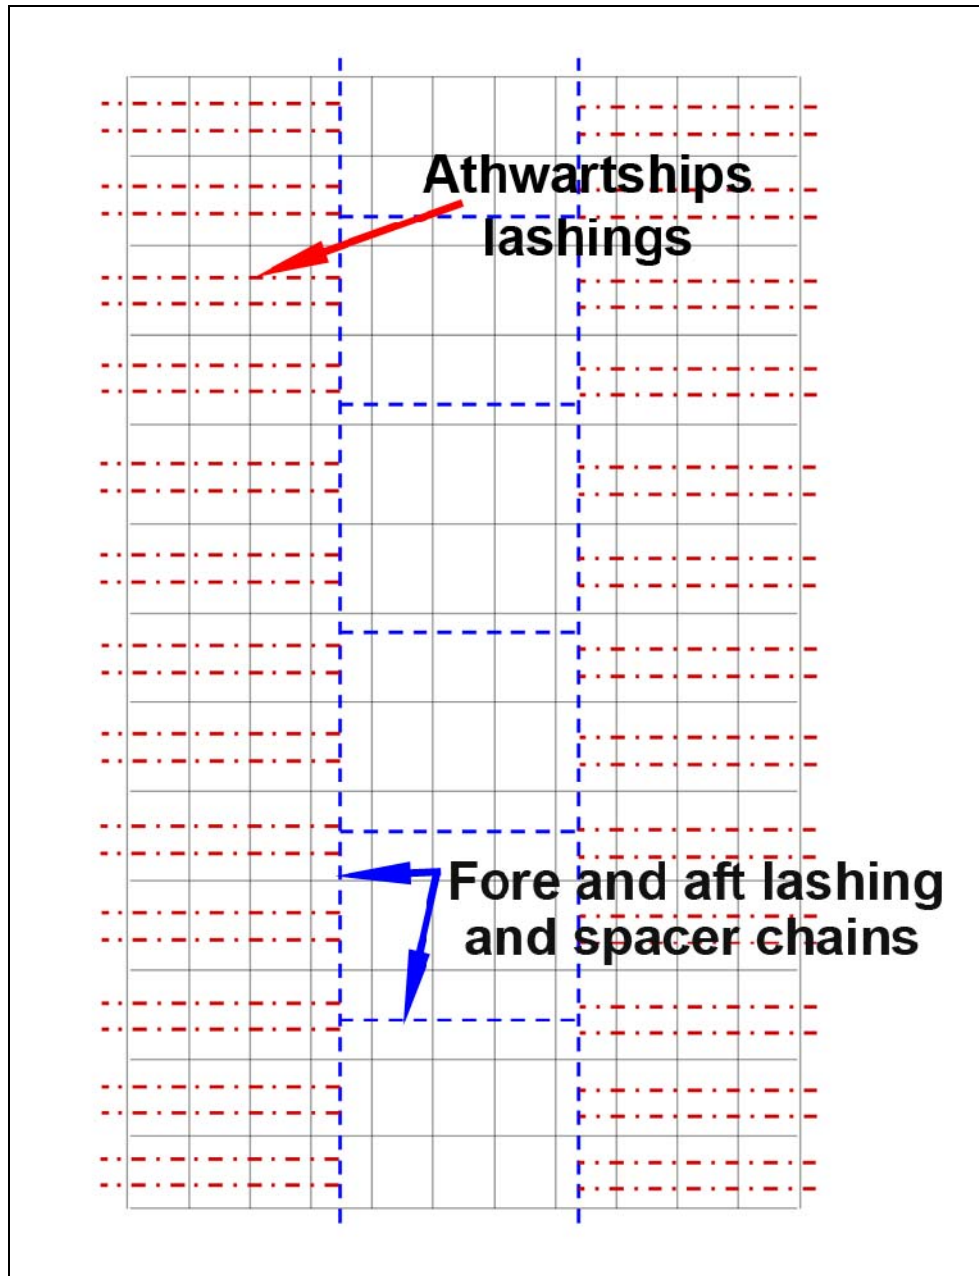
Two lengths of lashing chain, made up of a number of smaller lengths, ran fore and aft over the veneer (coloured blue in Figure 4). These lengths of chain were secured to 'D' rings located at the forward and after end of each hatch cover.

After making up the fore and aft chains lengths, there were not enough chains left to enable athwartships lashings. To overcome this, the crew used a combination of the remaining chains and webbing straps with ratchets (which were already on board). Two lashings ran over each set of veneer packs and these were secured to the fore and aft chain lengths (coloured red in Figure 4). These lashings were secured to 'D'

Figure 4: Plan view of *Mimasaka's* securing arrangement

After the packs of veneer had been loaded onto the dunnage on the hatch covers, the crew put the lashing chains and webbing straps over the stows of veneer on each of *Mimasaka's* hatch covers (Figure 4).

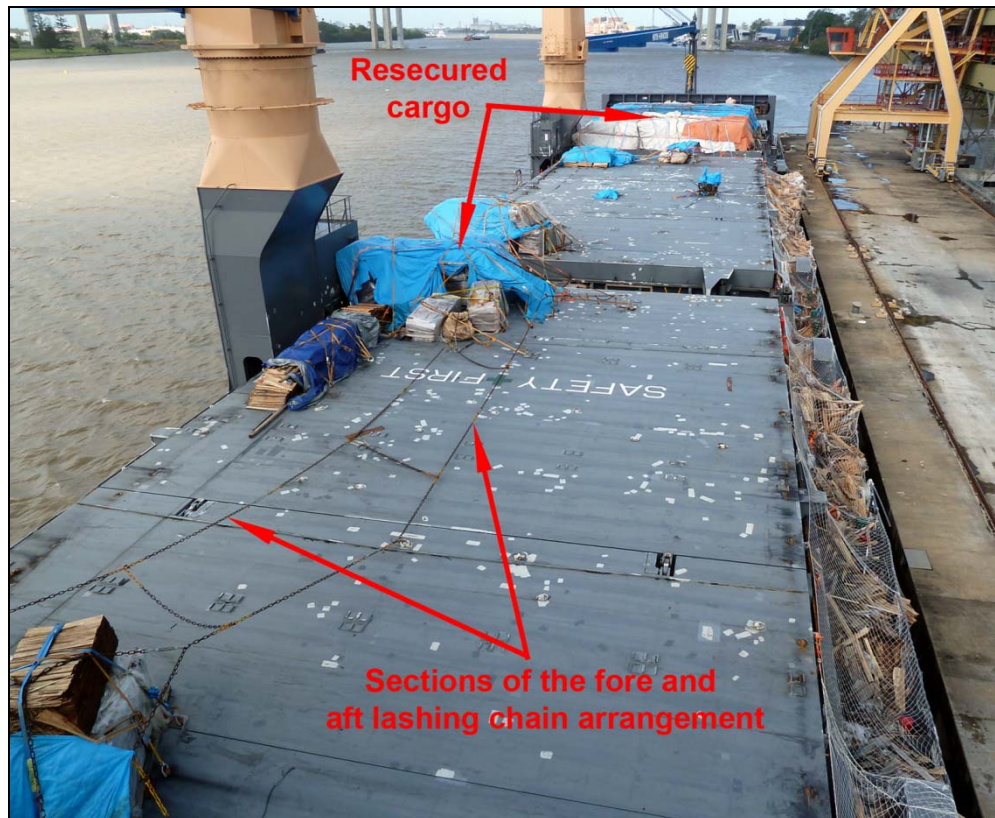
Figure 6: *Mimasaka's* foredeck showing the lashings applied in Yamba

At 0630 on 7 October, stevedores boarded the ship and began to resecure the deck cargo (Figure 6). By 1400 on 8 October, this work was completed and by 1530, *Mimasaka* was underway for Brisbane.

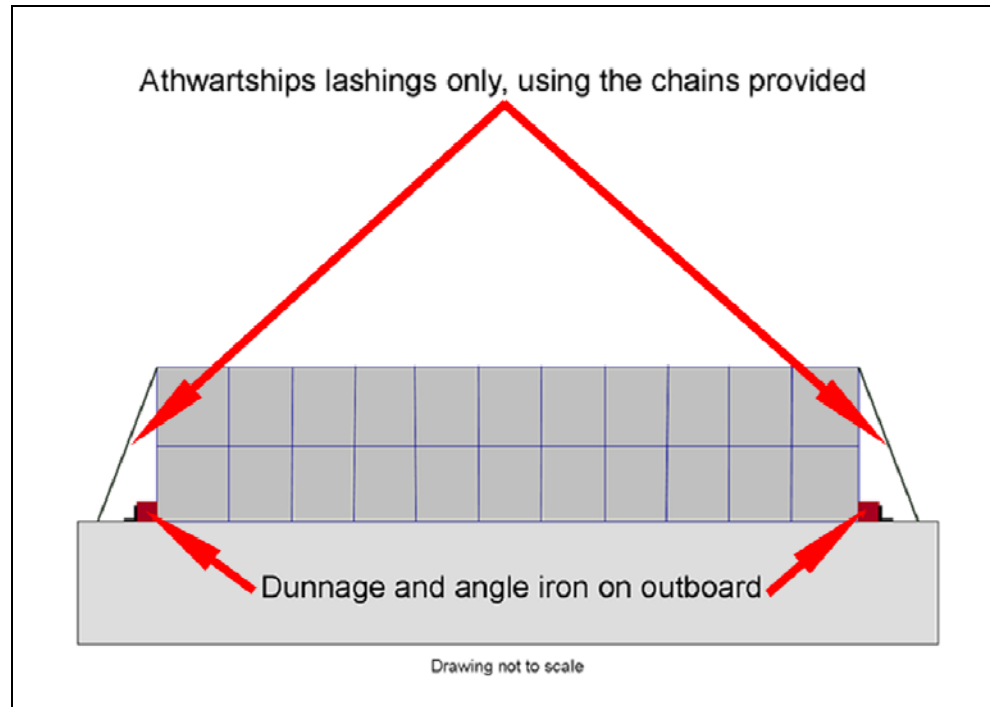
If the packs of veneer had been stowed as the charterer intended (section 2.3 of this report), they would have sat directly on the hatch covers, with the dunnage only on the outboard side of the packs to stop them from moving athwartships (Figure 7).

Figure 7: Intended use of the dunnage and angle iron

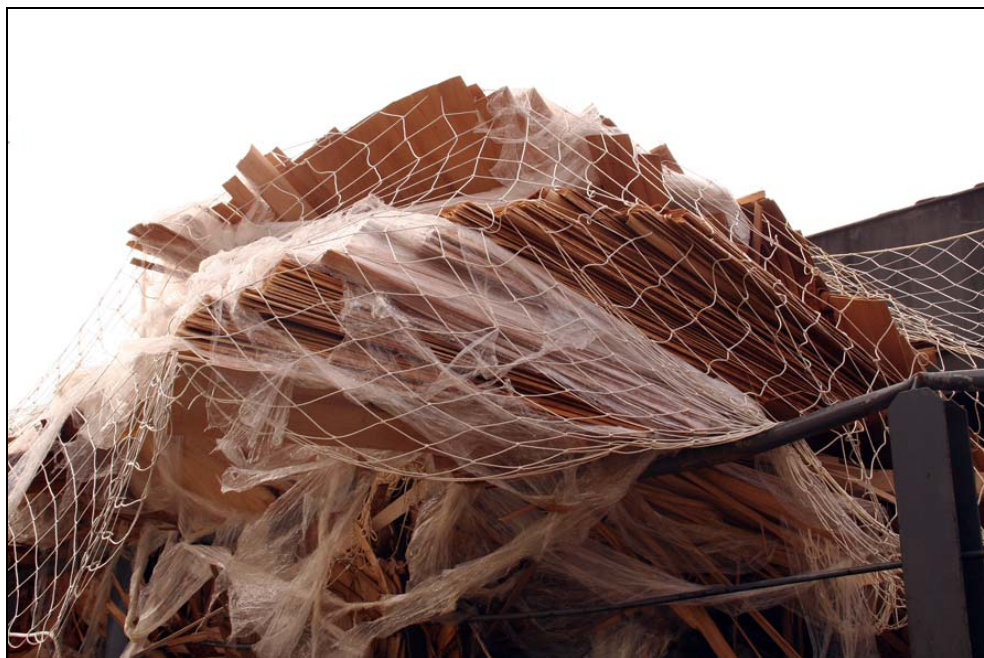
If the individual packs of veneer had strapping or banding around them, they would have been far more rigid and possibly able to better withstand movement within the cargo stow.

Figure 8: Some of the remaining deck cargo, note the plastic wrapping

Ta Ann Tasmania's packs of timber veneer did not conform to the recommendation in section 2.3. Consequently, the lack of banding on the outside of each pack possibly resulted in the veneer stows on deck not being as secure as they could have been and this, when combined with the lashing arrangement applied in Burnie, possibly contributed to the loss of the deck cargo on 4 October 2010.

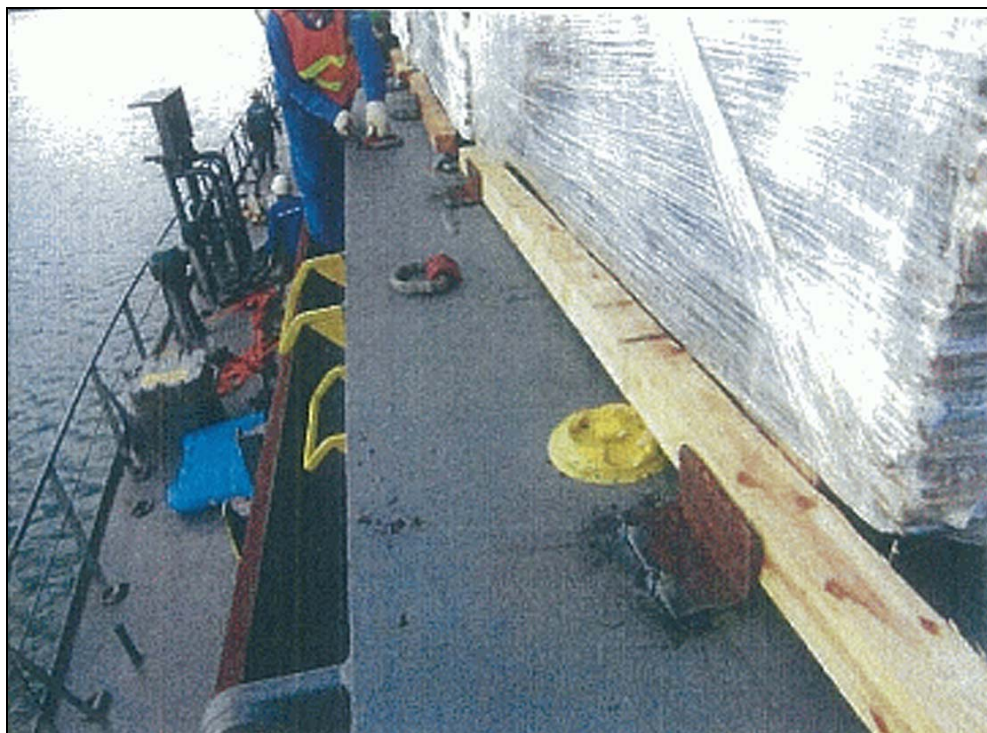
The photograph clearly showed the dunnage and angle iron arrangement and the veneer pack sitting directly on the hatch cover and not on the dunnage (Figure 9).

Figure 9: Photograph in the lashing instructions provided to the ship in Yamba

Had the initial instructions for stowing and securing the veneer deck cargo been the same as those provided to the ship at Yamba, the deck cargo would probably have been appropriately stowed and secured.
