ATSB TRANSPORT SAFETY REPORT
Marine Occurrence Investigation No. 288
MO-2011-007
Final

Breathing apparatus air compressor explosion on board the woodchip carrier *Universal Gloria* off Eden, New South Wales

11 October 2011

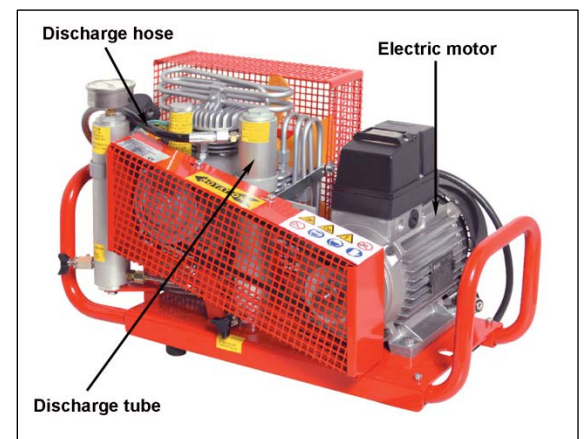
Figure 4: Similar portable air compressor

The third mate checked all the connections and opened the OBA cylinder valve. Then, as he reached over the compressor to switch it on, the compressor discharge tube (Figure 4) exploded.

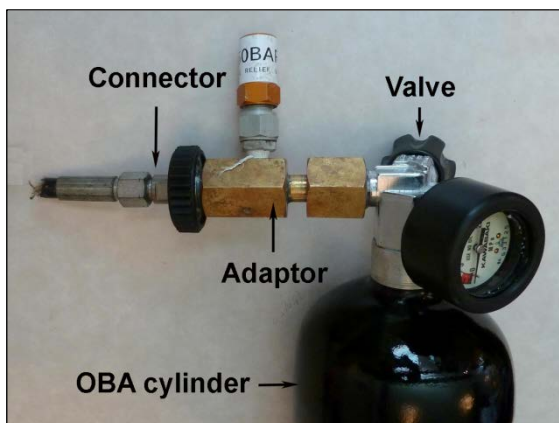
Figure 5: Cylinder, hose connector and adaptor

the compressor discharge hose connector. He fitted the adaptor to the hose connector and then fitted it to the OBA cylinder (Figure 5).

The compressor discharge hose adaptor that allowed the connection of Kawasaki BA cylinders to the air compressor (Figure 5) was not required on board *Universal Gloria* because the ship only had Sabre BA sets. However, the adaptor had been supplied in case the ship ever carried Kawasaki BA sets.

At the time that the adaptor was supplied, there was probably no consideration of the fact that the oxygen cylinders in the Kawasaki OBA sets had the same thread as Kawasaki BA cylinders and that the adaptor would allow the inadvertent connection of an oxygen cylinder to the air compressor. As a result, the adaptor was placed in the box next to the compressor in case Kawasaki BA sets were ever carried on board the ship in the future.

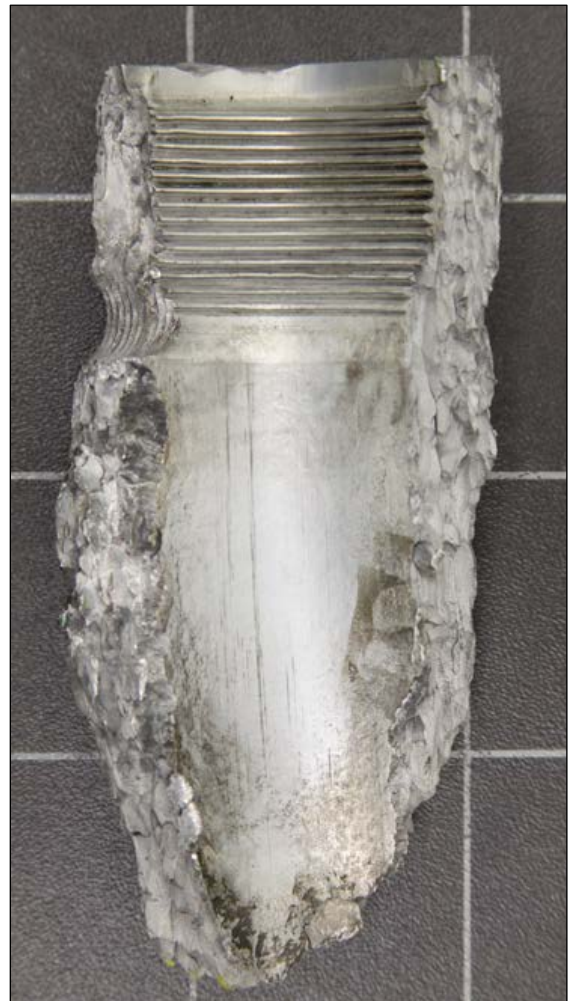
Figure 6: Section of fractured discharge tube

Within seconds, the temperature of the oxygen-rich environment would have exceeded the auto ignition⁷ temperature of any oil that had been trapped in the discharge tube filter, or any other part of the discharge circuit. Once the oil ignited, a near instantaneous over-pressurisation within the compressor caused the rupture of the discharge tube (Figure 6) and hose. A flame front was then blown out of the compressor, engulfing the third mate.

- The compressor discharge tube and hose ruptured due to an over-pressurisation that occurred when oil ignited in the hot oxygen-rich environment within the discharge circuit of the compressor.
- The third mate did not possess sufficient knowledge to enable him to safely and effectively operate and maintain the ship's oxygen breathing apparatus.
- The ship's safety management system documentation did not provide the crew with appropriate guidance in relation to the operation and maintenance of the oxygen breathing apparatus. [*Minor safety issue*]
- The ship's crew were not appropriately trained or drilled in the operation and maintenance of the oxygen breathing apparatus. [*Minor safety issue*]
