Australian Government
Australian Transport Safety Bureau

Collision between the bulk carrier *Furness Melbourne* and the yacht *Riga II*

North of Bowen, Queensland | 26 May 2012

ATSB Transport Safety Report
Marine Occurrence Investigation
295-MO-2012-006
Final – 12 December 2013

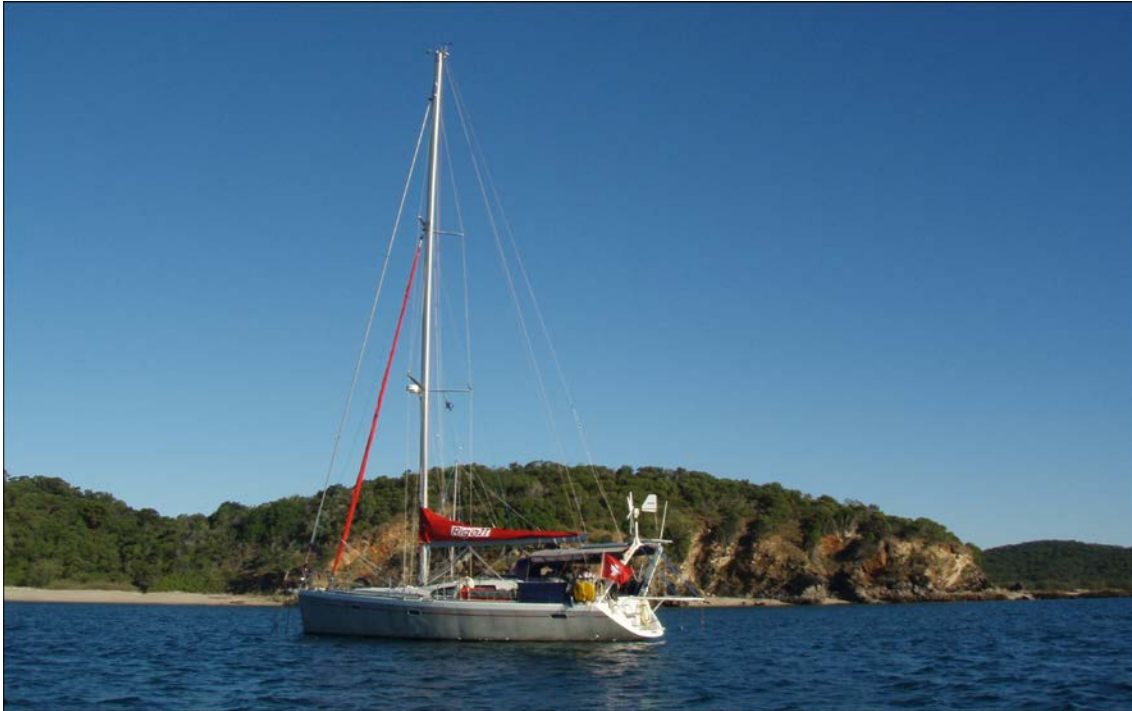
Figure 3: *Riga II*

By 0647, *Riga II* had been safely towed into Bowen and secured in the marina. In addition to losing its mast, sails and rigging, the yacht's hull, handrails and paintwork on the starboard side, were damaged. The internal support of the mast had moved, as had some cabinetwork and internal lighting.

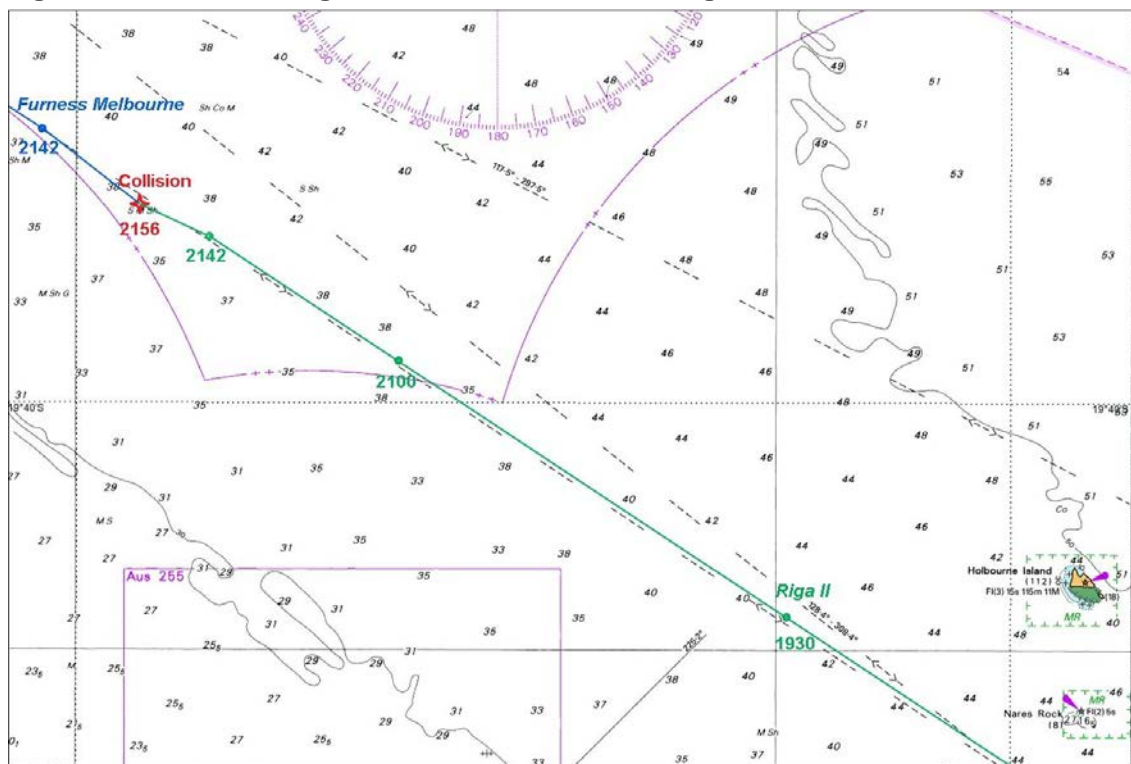
Figure 4: Section of navigational chart Aus 826 showing area west of Holbourne Island

Shortly after 2100, the seaman reported a white light fine on *Furness Melbourne's* port bow. The third mate told the seaman that the light was a distant lighthouse. At this time, Holbourne Island and Nares Rock, both of which were fitted with lights, were a little over 30 miles away (Figure 4).⁶

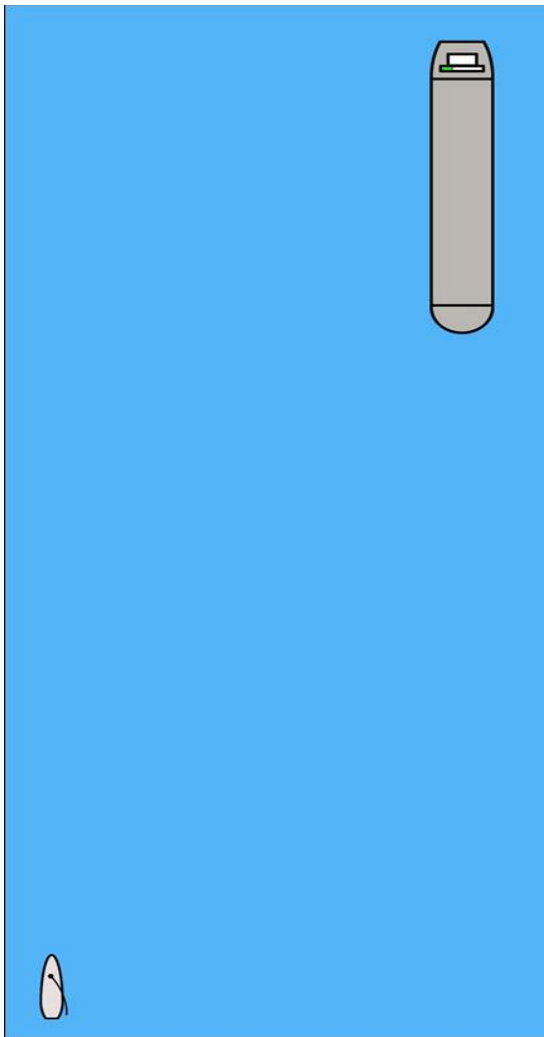
Figure 5: The skipper’s mental image

When the skipper identified the ship’s starboard (green) sidelight, he concluded that *Furness Melbourne* was to starboard of the yacht and the two vessels were on reciprocal courses (Figure 5). He thought that by altering course to port he was opening up the passing distance between the two vessels. However, the two vessels were not on reciprocal courses, the yacht was crossing the ship’s bow (Figure 6). Furthermore, the ship was probably at a range of less than 2 miles, not 4 miles as concluded by the yacht’s skipper.

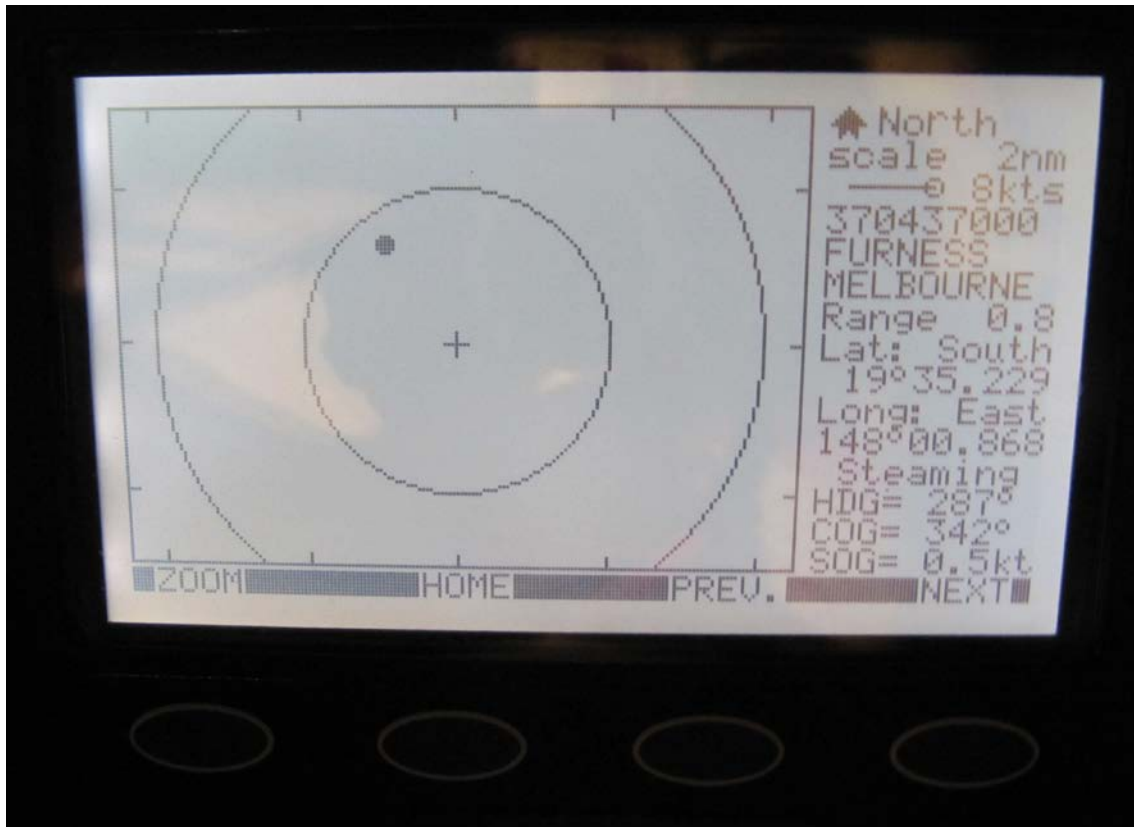
Figure 7: Photograph of *Riga II*'s AIS unit display taken after the collision when the scale had been set to 2 miles

As previously discussed, it is likely that the yacht’s AIS alarmed when *Furness Melbourne* was identified at a range of about 2 miles. Since the range of the alarm (inner ring on the display in Figure 7) is automatically set at half of the selected range scale (the outer ring on the display), the AIS unit was probably set on the 4 mile range scale. This may be contrary to the information provided by the yacht’s skipper and his wife, who stated that it was set on ‘8 miles, 4 miles all around’. However, their statement does not clearly identify the selected range scale and, when they were asked to clarify what they meant by this statement, they demonstrated that they did not have a clear understanding of the operation of the AIS unit and its controls.

What is certain is that the AIS unit did not provide the skipper with sufficient warning of the presence of other vessels. Had the AIS unit been set on a larger and more appropriate range scale, it would have provided the skipper with more time in which to properly appraise the situation and the risk of collision.
