ATSB TRANSPORT SAFETY INVESTIGATION REPORT
Rail Occurrence Investigation 2004/008
Final

Derailment of Pacific National Train 7MP5 Glenalta, South Australia

21 November 2004

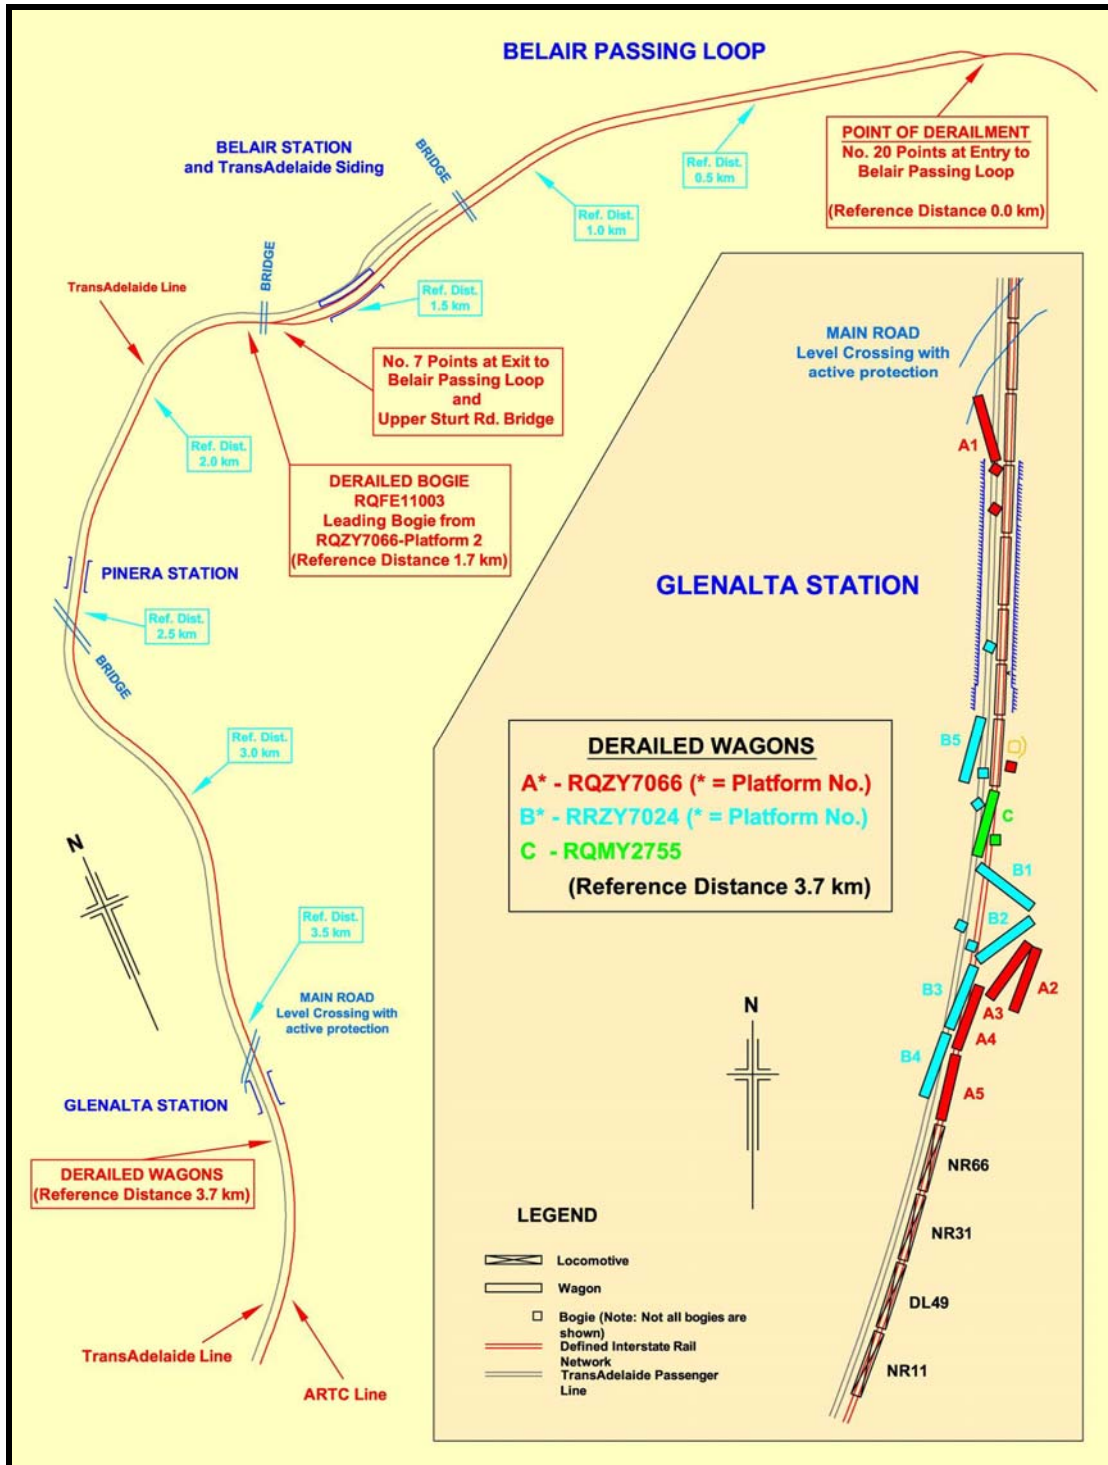
Figure 4: The derailment site

The point of derailment (0.0km)³ occurred at the ‘Vee’ of the facing points, where markings indicated that a wheel had ridden over the check-rail allowing the opposite wheel to travel up the wrong side of the Vee.

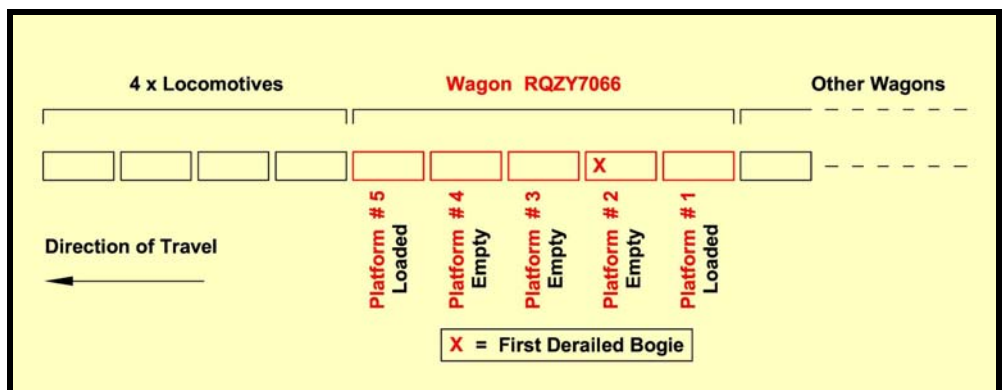
Figure 6: Train 7MP5, showing wagon RQZY7066 and the first bogie to derail

Wheel flange markings at point of derailment, damage to civil infrastructure and the post derailment location of wagon components suggest that initially only the lead bogie of the fourth platform (Platform #2 of 5-unit well wagon RQZY7066, coupled immediately behind the locomotives) derailed. The wheels from both axles continuing to strike the concrete sleepers on the right-hand side of each rail as the train progressed towards Glenalta. At the exit of the Belair crossing loop (1.7km) the leading derailed wheels struck the check-rail and Vee of the turn-out, resulting in the bogie lifting over to the left-hand side of the track and subsequently striking the point machine (number 7 points).

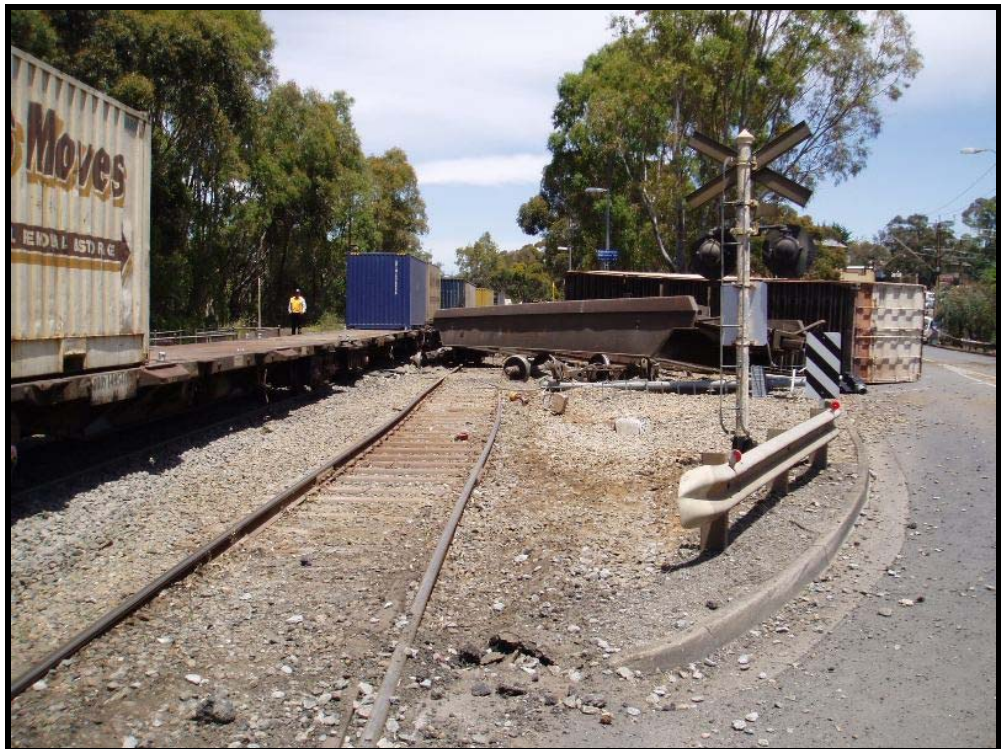
Figure 7: View of RQZY7066 - Platform #1

Platform #1 of the first 5-unit wagon pivoted almost 180 degrees, demolished a pedestrian crossing, came to a rest against the Glenalta railway station platform and spilled its freight container onto the road. Platform #5 of the second 5-unit wagon, complete with its freight container, struck and slid the length of the station

platform, demolished a second pedestrian crossing and came to rest on its side immediately after the station platform.

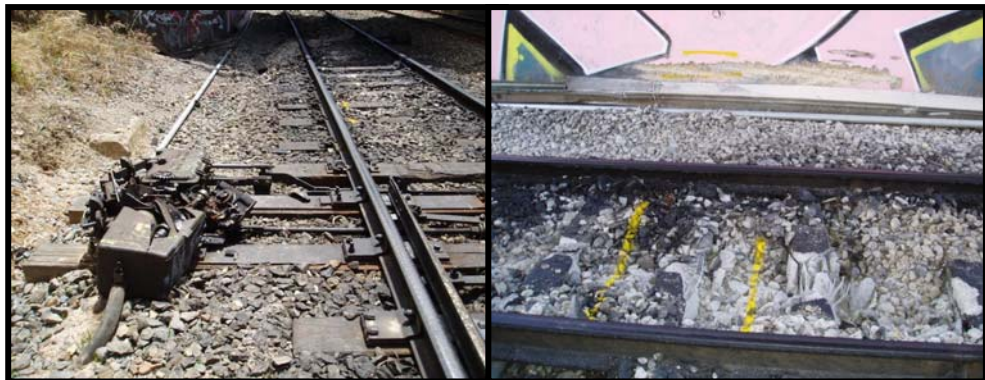
Figure 8: Damaged point machine (left), concrete sleepers, bridge abutment and cable ducting (right)

Approximately 4km of standard gauge track was damaged, with concrete sleepers requiring the bulk of the repair and/or replacement. The point machine and control rods located at the Adelaide end of the crossing loop were extensively damaged and required replacing, as did the associated Vee crossing. Minor damage was caused to a road bridge abutment and signalling cable ducting. Pedestrian crossings were damaged at three metropolitan passenger stations.

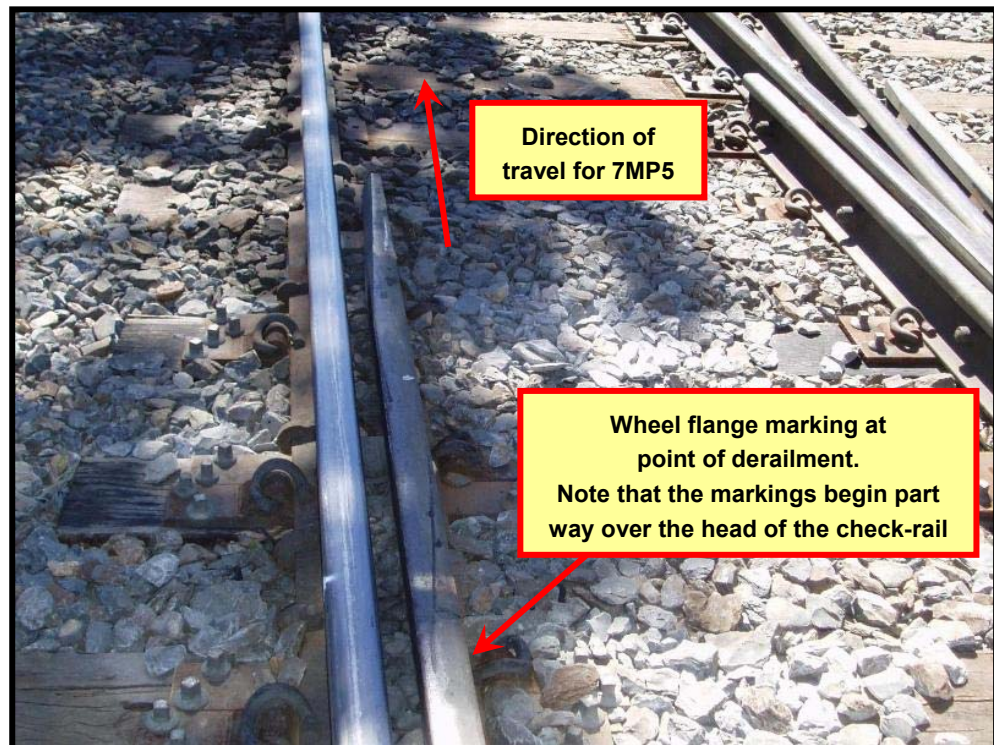
Figure 9: Markings over check-rail at the point of derailment

Markings at the point of derailment indicated that a wheel had ridden over the check-rail allowing the opposite wheel to travel up the wrong side of the 'Vee'. The investigation noted the lack of a continuous mark over the entire width of the check-rail head. This indicates that the wheel was airborne prior to contact with the head of the check-rail.

Under normal operation, when a wheel set is traversing a set of facing points, the check-rail is positioned to guide the back of the flange of one wheel such that the opposite wheel flange face is clear of the crossing Vee. If the wheel is given the opportunity to travel the wrong side of the Vee, the wheel set is likely to derail.

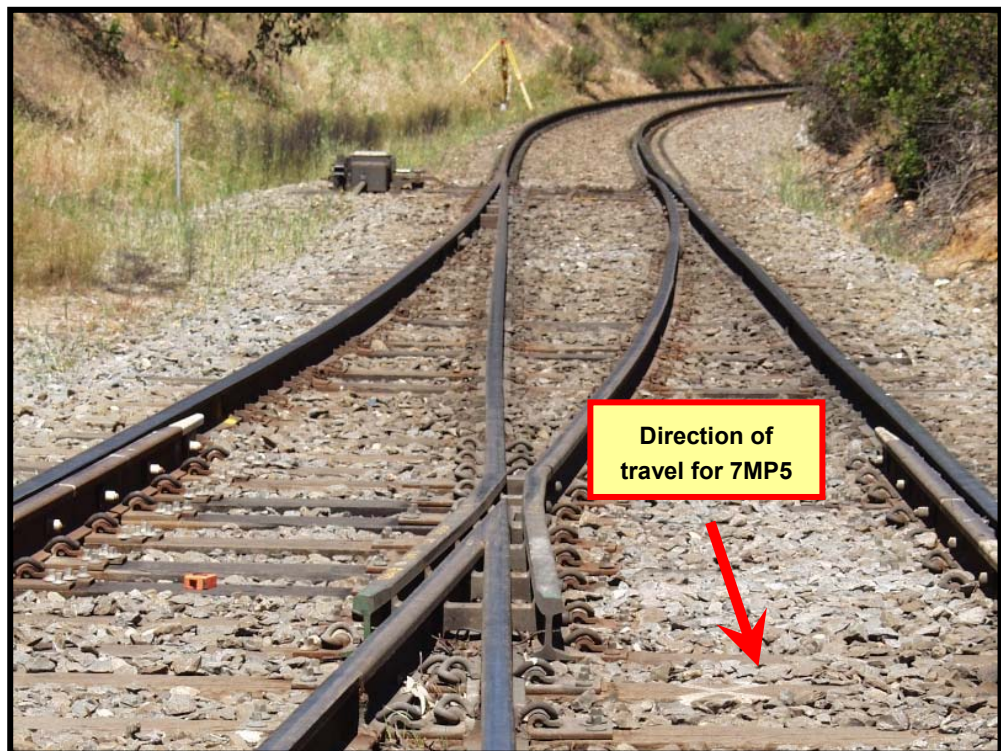
Figure 11: View of the curve leading immediately into the Belair turn-out

However, this is not the case where the curve radius is reduced to 190m. On this part of the curve, the actual cant varies between 25mm and 48mm (Refer to Appendix 7.1) resulting in a cant deficiency as high as 131mm (based on an equilibrium cant of 156mm). This exceeds the limits specified in both standards. There are two reasons why cant and cant deficiency may not conform to the requirements of the ARTC standard and the ACOP. Either the required cant has not been maintained, or the design parameters are not entirely appropriate.

Looking purely from the perspective of maintaining a 190m radius curve with a design cant of 80mm, a cant of 25mm equates to a cant variation of 55mm. Consequently, this defect requires a P2 response (inspect within 7 days and repaired within 28 days) in accordance with the ARTC standard⁸. This standard also requires that a speed restriction (calculated at 40 km/hr) be applied until the defect is repaired.

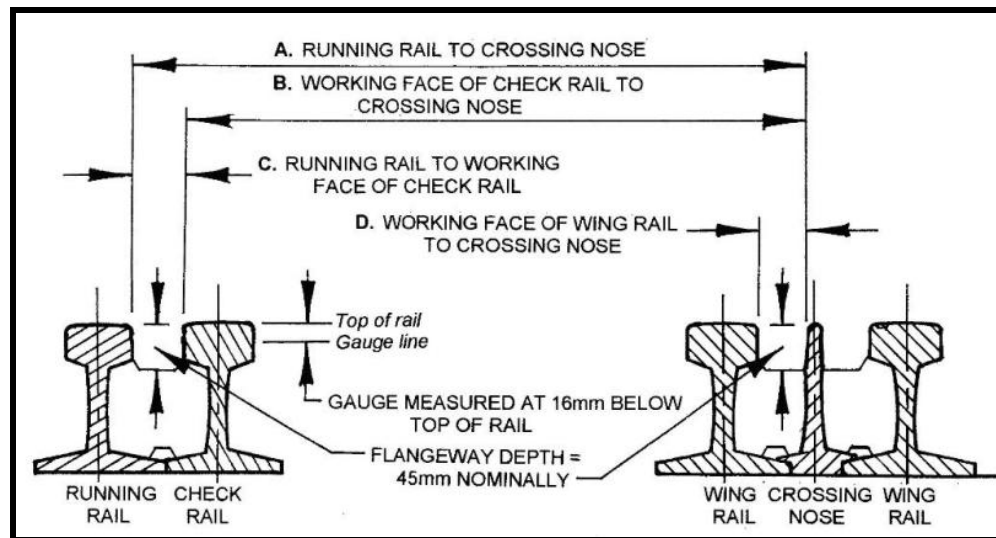
Figure 12: Turn-out cross-section at V-crossing (Refer to Table 3)

While assessment against the ARTC standards shows each measurement as compliant, assessment against the ACOP shows non-compliance for dimension C (Refer to Table 3 and Figure 12). This dimension is not considered critical since the flared check-rail entrance will guide the wheel into the flange-way and the tight flange-way will eventually wear to the design dimension. However, a tight flange-way can serve to increase the contact forces between the wheel flange and the check-rail. The critical measurement is B – D (1347mm), which must be less than the back-to-back dimension of the rollingstock wheels (1357mm to 1360mm) and is compliant.

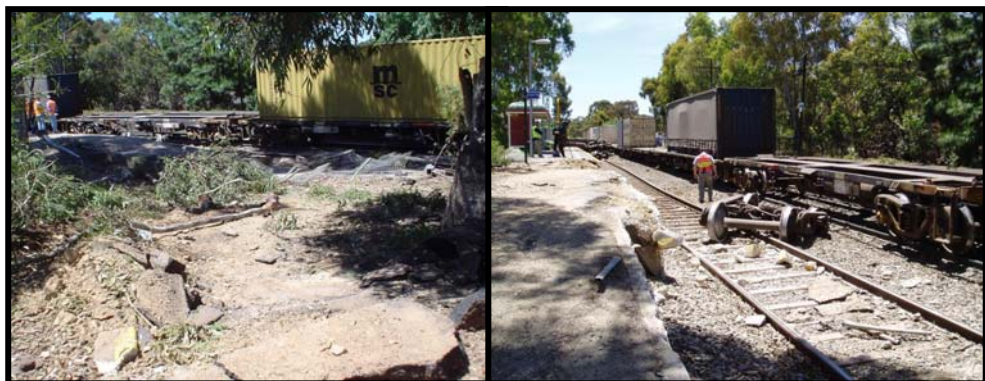
Figure 18: Damaged pedestrian crossing and passenger platform at Glenalta Railway Station

Approximately 60 metres of TransAdelaide's broad gauge passenger track was extensively damaged in the vicinity of the Glenalta railway station. Similarly, the passenger platform and lighting were damaged with two pedestrian crossings completely demolished. Derailed wagons also caused damage to line-side signalling, cabling and a standby power generation room. The damage sustained to a standby power generation room resulted in a minor diesel fuel spill which required clean-up using the appropriate control procedures.

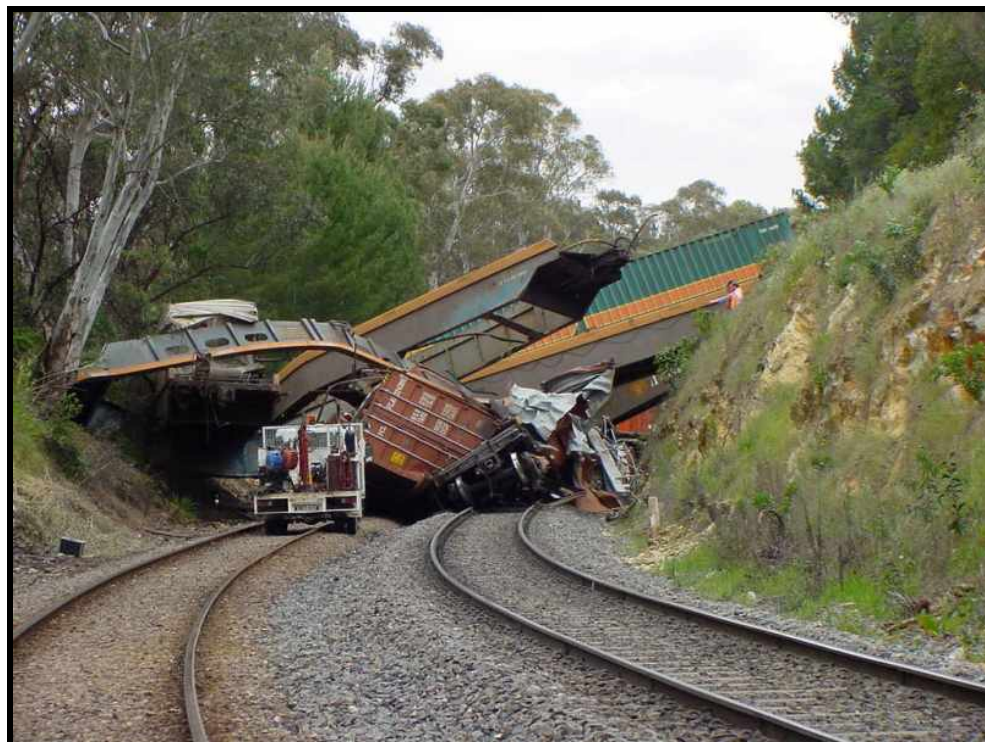
Figure 21: Derailment of 2MP5, Glenalta SA, 22 October 2002

The investigation determined that the cause of the derailment was the trailing end of the empty second platform of a 5-unit wagon lifting sufficiently to allow the leading end of the third platform to be forced underneath it. High dynamic braking forces accompanied by large trailing loads behind an empty platform were identified, among others, as contributing factors.
