ATSB TRANSPORT SAFETY INVESTIGATION REPORT
Rail Occurrence Investigation Report - 2005/004
Final

Level Crossing Collision

Edith Street, Horsham, Victoria
11 August 2005

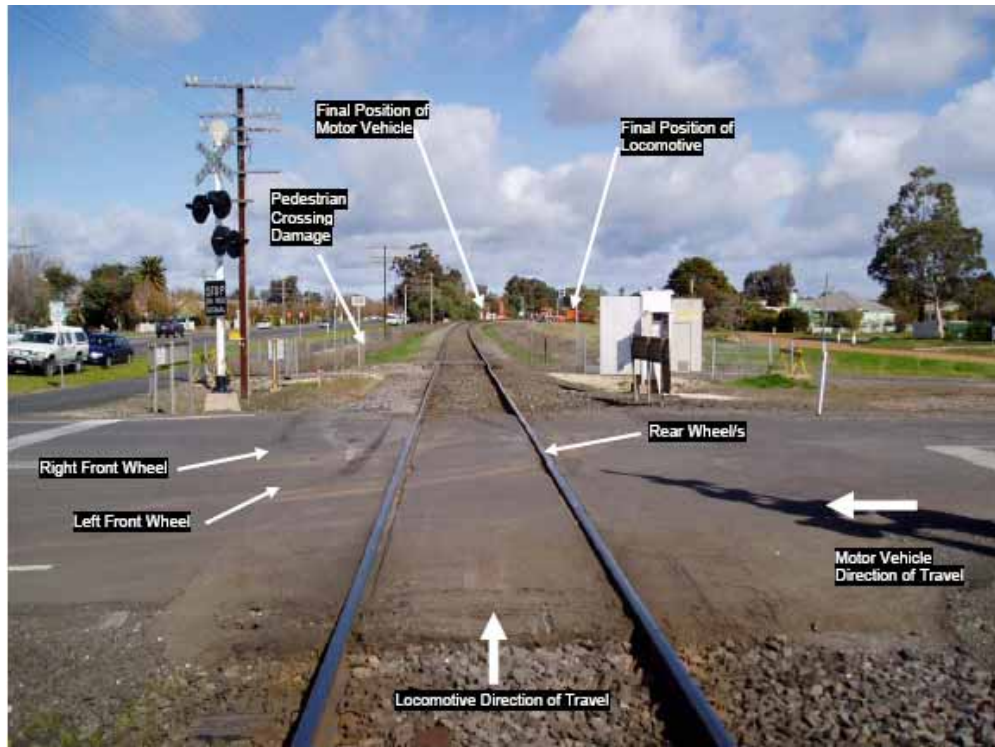
Figure 3: Tyre marks indicate the position of the motor vehicle at the moment of impact. There was no evidence of vehicle braking or skidding in the approach to the crossing.

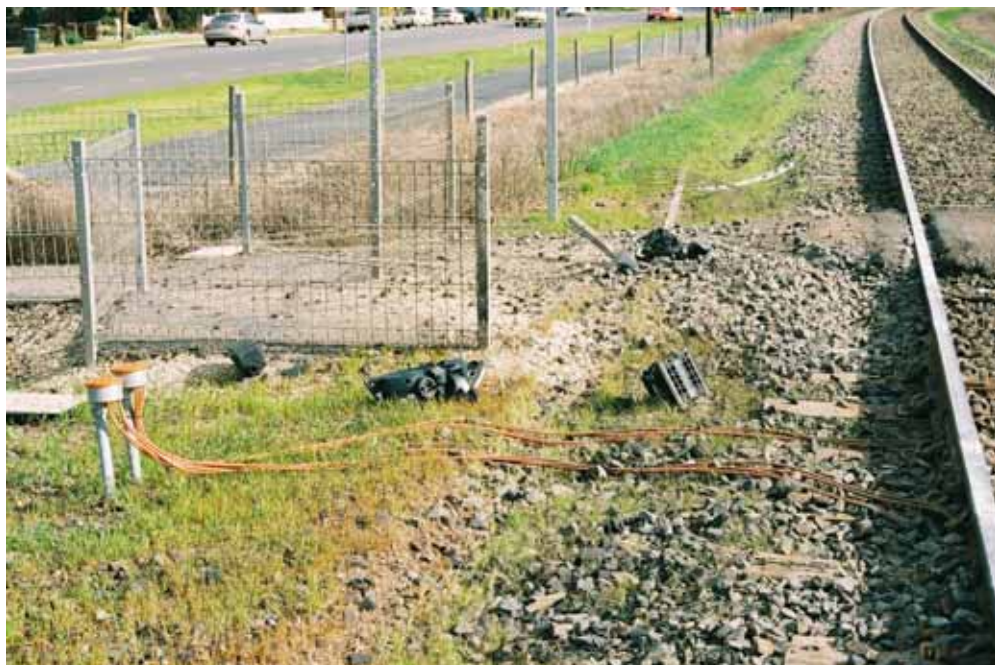
Figure 4: Damage caused by the motor vehicle colliding with the near-by pedestrian crossing. (Photograph, courtesy of Victoria Police).

There was no damage to the Edith Street level crossing; however the nearby pedestrian crossing was damaged.

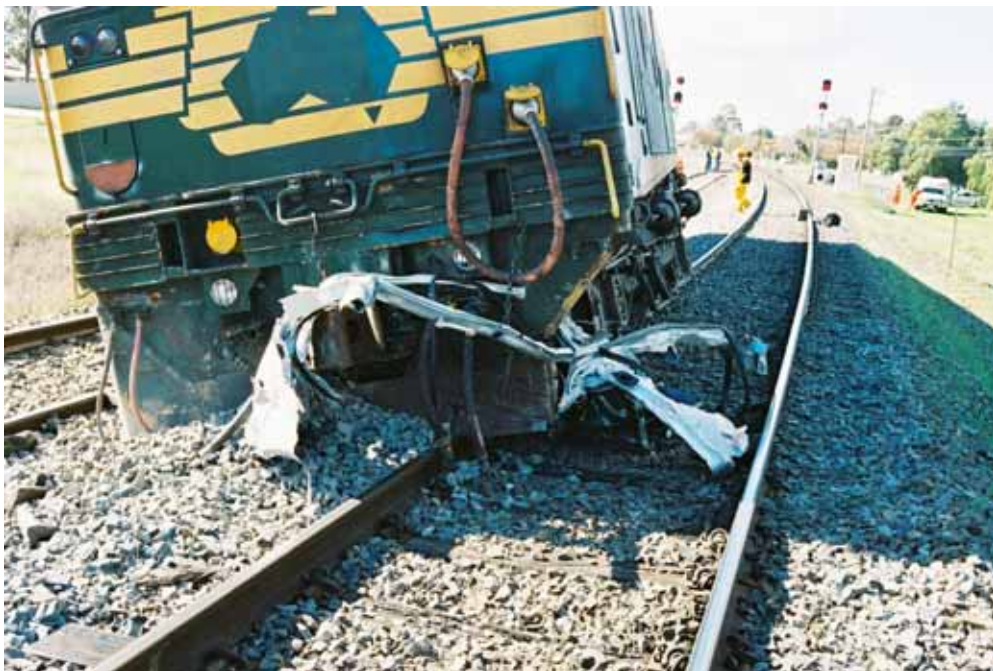
When the motor vehicle collided with the points-machine it was dislodged from the front of the locomotive before being rolled onto its side and thrown down a small embankment before coming to rest against the right-of-way fence. The points-machine was destroyed in the collision and thus the turnout blades for the points were no longer locked in position. This in turn allowed the blades to move under the locomotive with the lead bogie travelling along the main line and the trailing bogie being diverted onto the crossing loop. The locomotive rapidly decelerated as it derailed and came to a rest leaning to the right, a distance of approximately 330 m past the level crossing.

Figure 5: Damage to the points-machine, caused the locomotive to derail. Part of the motor vehicle remained wedged in the locomotive coupler. (Photograph, courtesy of Victoria Police).

The locomotive was derailed as an indirect result of the collision, when the points-machine was destroyed and consequently failed to provide any holding of the points turnout blades. The train sustained minor damage, mainly the loss of the left-hand side leading sand box and a bent left hand side step. A small leak also developed on the right hand side fuel sight glass.

The points-machine was destroyed and about 50 m of track were damaged just past the turnout where the train derailed.

The locomotive was re-railed and moved to Horsham Station yard where the bogies were replaced and other repairs effected.

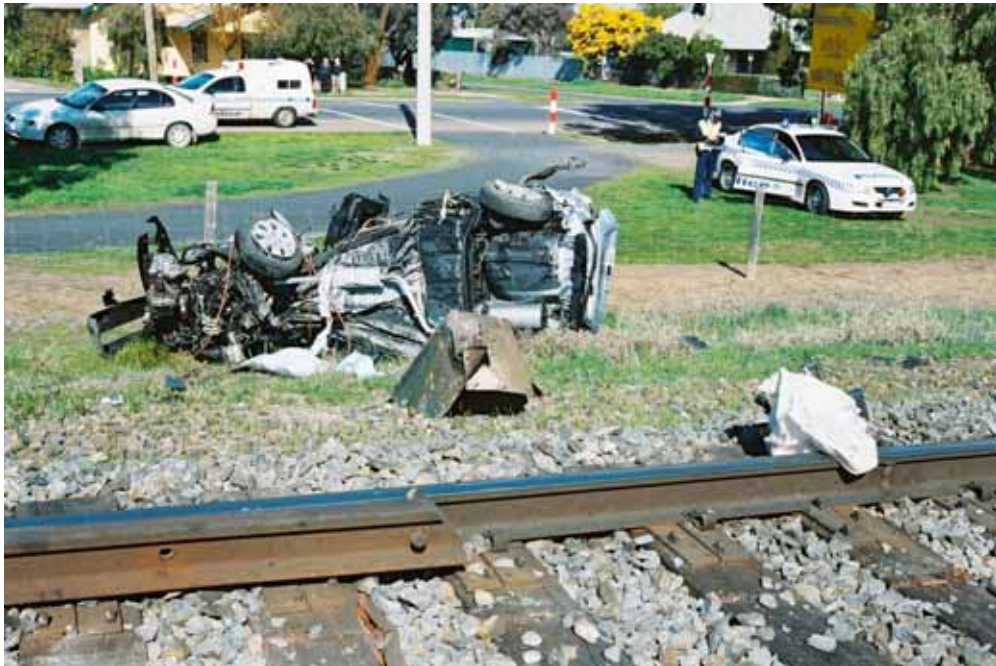
Figure 6: The motor vehicle was pushed 220 m along the track before colliding with the points-machine. (Photograph, courtesy of Victoria Police).

The motor vehicle was struck on the rear left hand side before being pushed along the track for approximately 220 m. Pieces of the vehicle were broken off and scattered along the length of the track. The motor vehicle was destroyed as a result of the collision.

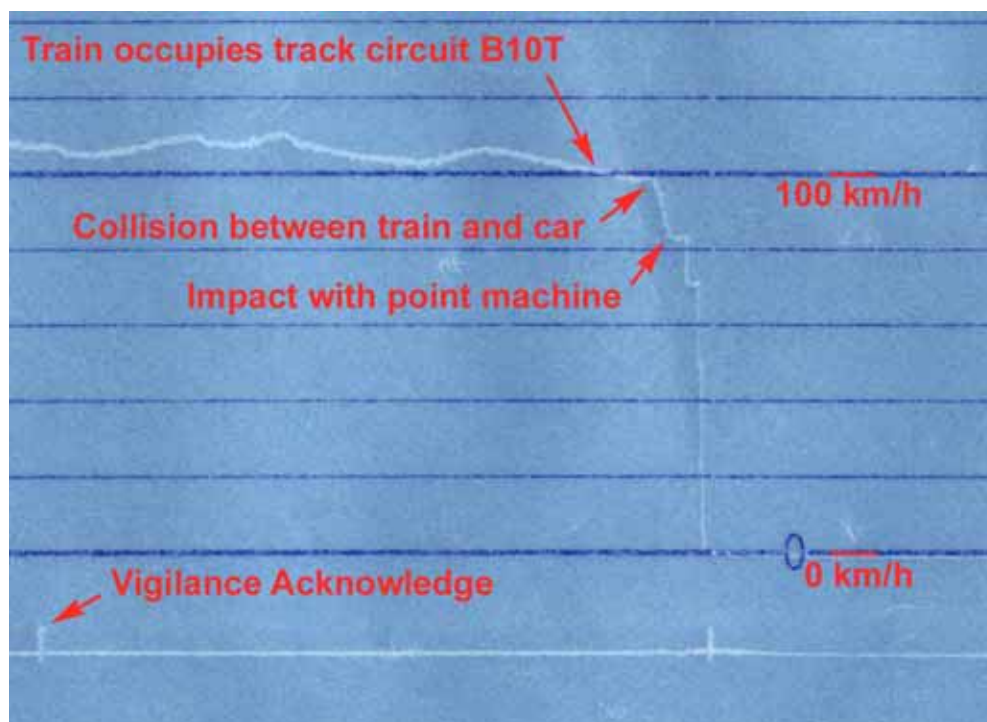
Figure 9: Locomotive G535 Hasler data logger tape

Locomotive G535 is fitted with a Hasler data logger. This is an electro-mechanical strip chart recorder used for recording train speed and vigilance activation information on locomotive G535. An examination of the data log was used in reconstructing the sequence of events leading up to this accident. A review of the data log (Fig. 9) shows that G535 had been driven at speeds consistent with the posted limits and started emergency braking shortly before passing over the Edith Street level crossing.

From the data extracted from the Hasler log and knowing the length of the Edith Street level crossing activation point, it is possible to calculate the warning time provided by the crossing equipment. This was calculated as 23 seconds, which is consistent with data downloaded from the Centralised Train Control (CTC) data logger and the level crossing Remote Terminal Unit (RTU) data logger.

Based on the data extracted from the locomotive, the train's braking performance is not considered to be a factor which contributed to the accident.

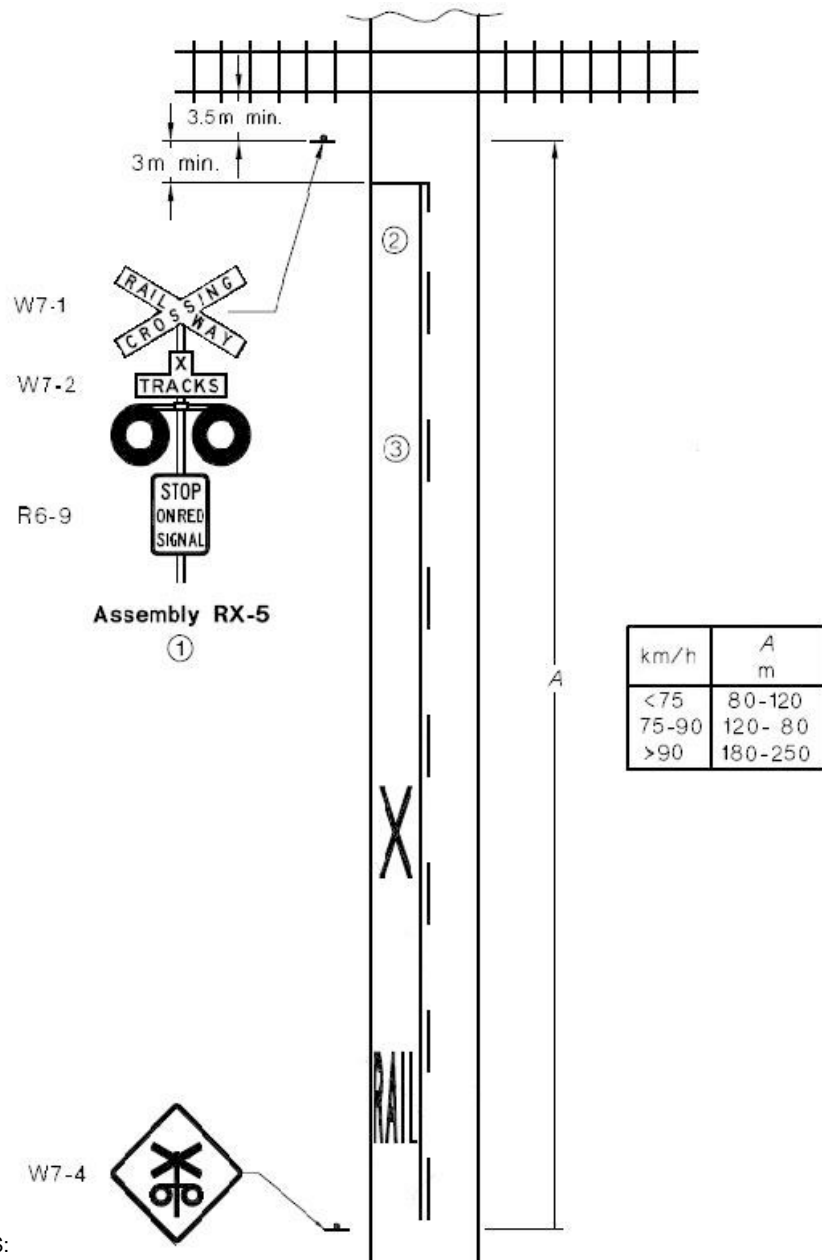
Figure 12: AS 1742.7 – 1993, Standard signage and road marking layout for 'crossing controlled by flashing lights'

All of the road markings and signage at the Edith Street level crossing were found to be in compliance with AS 1742.7 – 1993, 'crossing controlled by flashing lights' (Fig. 12) except for the 'Stop on Red Signal' sign (R6-9) which did not comply with the current standard. However, the sign did conform to an earlier standard – 'black background with white' lettering as compared with the newer standard 'white background with black' lettering. This issue is not considered important and

- The ATSB recommends that the Horsham Rural City Council develop a program for the regular inspection of all level crossings in the shire to ensure that road markings and signage conform with Australian Standard AS1742.7:1993, Manual of Uniform Traffic Control Devices, Part 7: Railway Crossings.

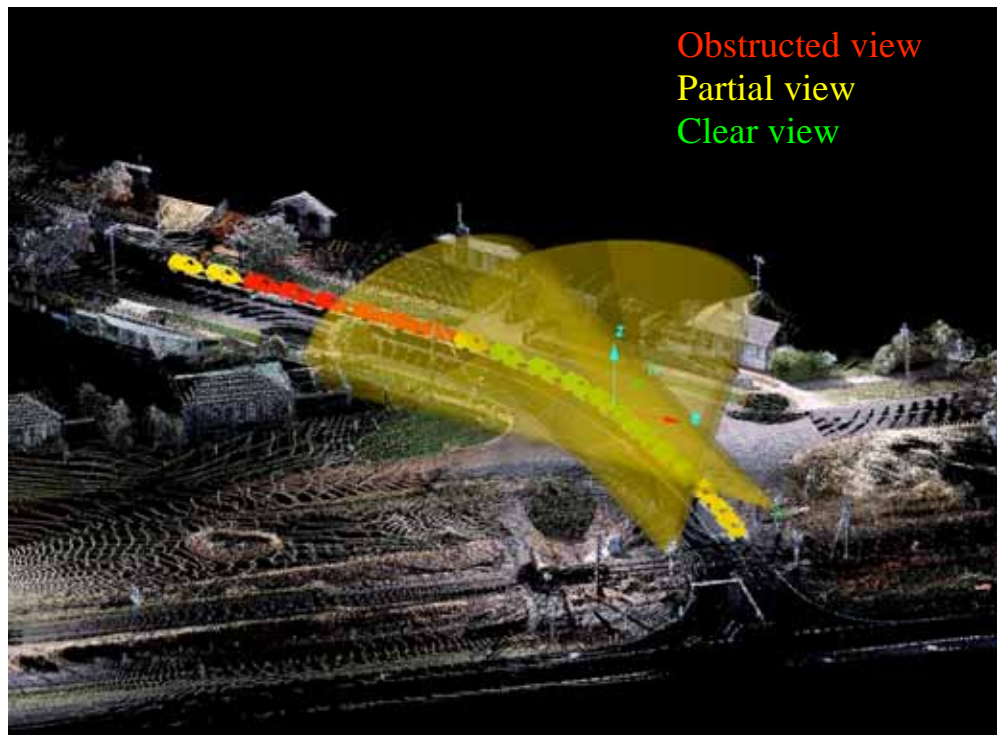
A site inspection of the crossing established that the flashing lights generally provide good coverage of the approaches, which includes road traffic coming from the west along Edith Street. However, the curvature of Edith Street limits the sighting distances from the western approach to approximately 80 m (Fig. 16).

Figure 16: 'Visibility Diagram'. Unobstructed sighting available at a distance of approximately 80 metres from level crossing

Given the relatively low road speeds, 50 km/h, the 80 m sighting distance provides adequate braking distance for road traffic. At the time of day when the accident occurred, 1213, the sun was approximately 7 to 8 degrees east of true north and at an altitude of approximately 38 degrees. Reflection and ghosting off the flashing light lens surfaces was unlikely to have affected their visibility for an approaching motorist.
