ATSB TRANSPORT SAFETY INVESTIGATION REPORT
Rail Occurrence Investigation 2006/015
Final

Level crossing collision between
The Ghan Passenger Train (1AD8)
and a
Road-Train Truck
Ban Ban Springs, NT

12 December 2006

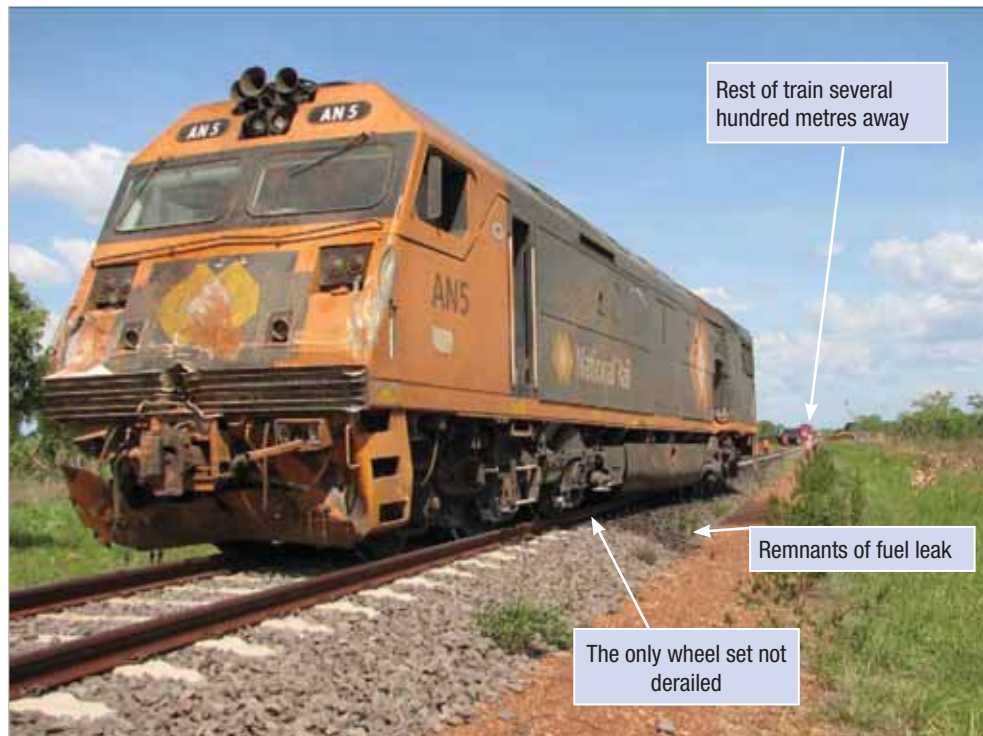
Figure 5: Lead locomotive separated from rest of train

After the initial impacts, *The Ghan* continued past the collision point, progressively derailed as the train decelerated. During this time, the lead locomotive broke away from the second locomotive and the motorail wagon (that was coupled to the second locomotive) broke away from the passenger carriages. By the time *The Ghan* had stopped, both locomotives, the motorail wagon and nine passenger carriages had derailed and the lead locomotive was several hundred metres ahead of the second locomotive, motorail wagon and the rest of the train.

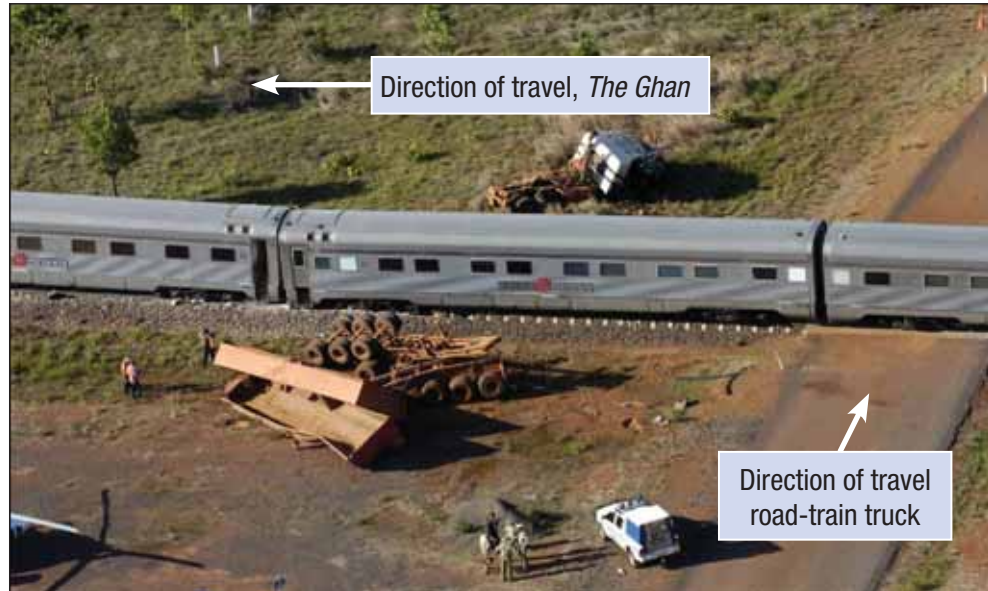
Figure 8: Separation of prime-mover and trailers

The impact of the collision caused the prime-mover and two trailers of the road-train to separate and come to rest either side of the rail line immediately to the west of the Fountain Head Road level crossing.

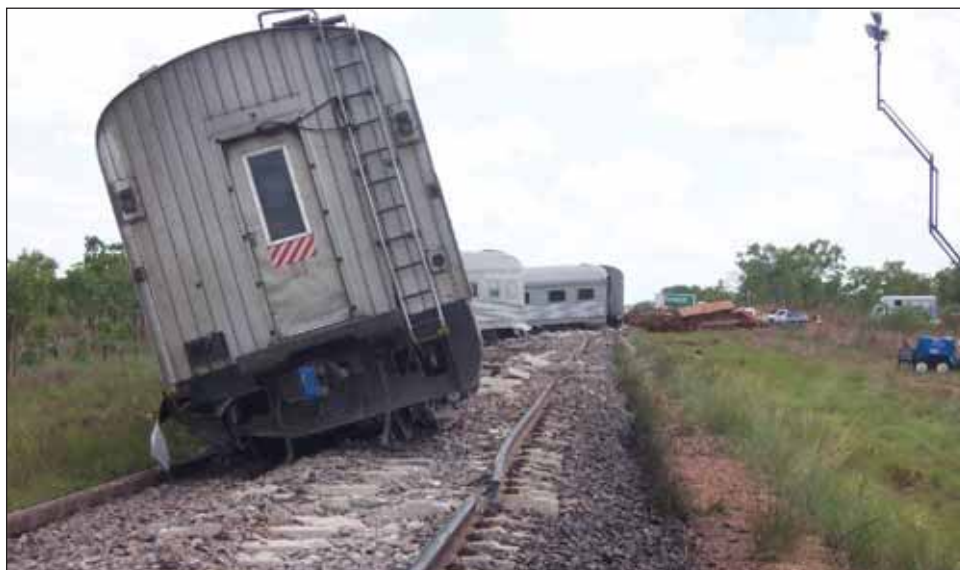
Figure 11: Damage to rail infrastructure in the vicinity of derailed carriages

In all, 392 concrete sleepers and 300 m of rail between the level crossing and the vicinity of the second locomotive required replacement before the track could be re-opened. A further 317 concrete sleepers and 165 m of rail beyond this point were replaced in due course. The estimated cost of the repairs to the rail infrastructure was \$536,000.

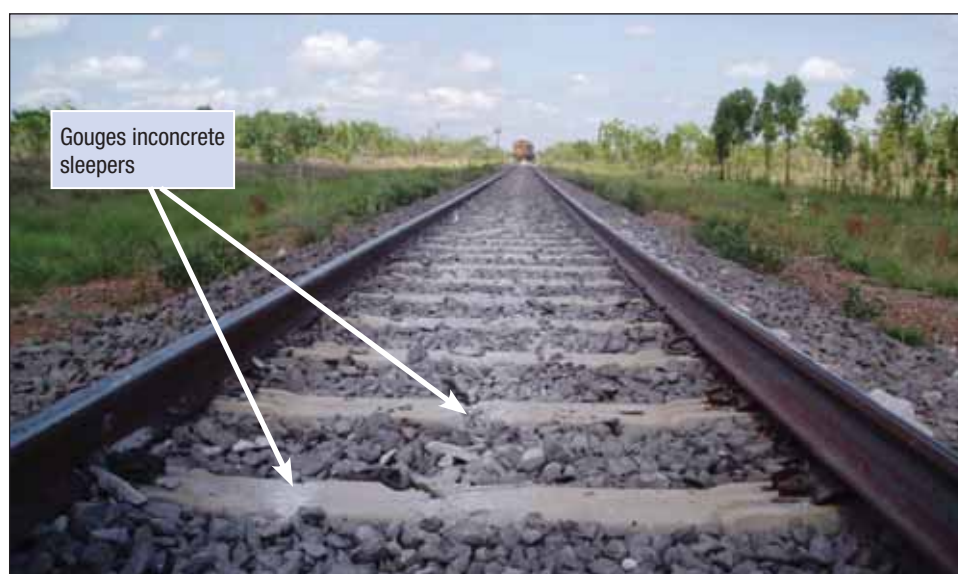
Figure 12: Damage between second and lead locomotives, taken from immediately in front of NR 109

Damage to the rail infrastructure between the second locomotive and the lead locomotive, a distance of 160 m, was mainly confined to gouges on the cement sleepers, rail damage and some ballast displacement.

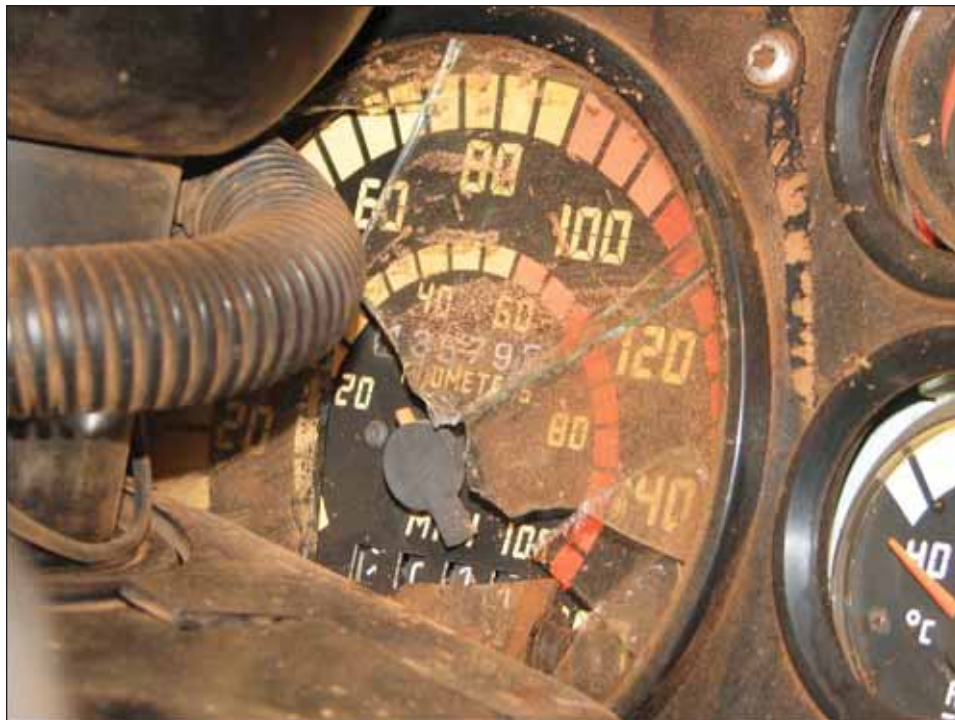
Figure 17: Truck speedometer jammed at about 50 km/h

If the truck was travelling at an average speed of 50 km/h on the approach to the level crossing then, 5.5 seconds before the collision, it would have been about 76 m from the level crossing when the train driver first sighted it. This scenario seems to be the most likely.

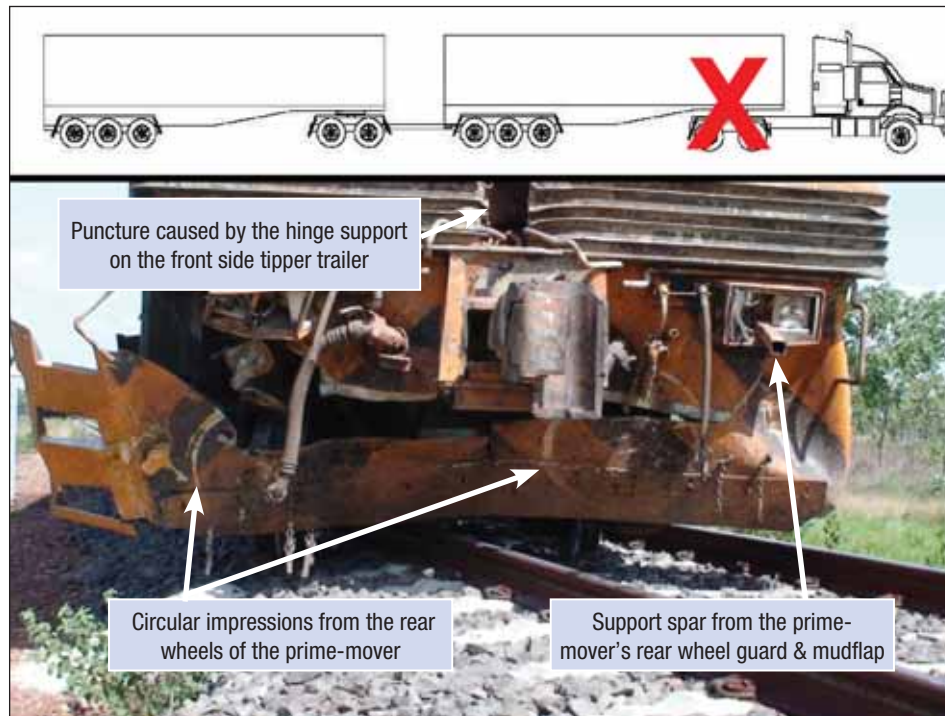
Figure 19: Point of impact

The initial impact was distributed across the front lower half of the lead locomotive (AN 5) and appeared to have been primarily absorbed by the bottom edge of the skirt and/or cowcatcher up to the bottom edge of the windcreens. Markings on the cowcatcher indicated that the point of impact was between the two axles of the prime-mover (the pivot point between the prime-mover and first trailer). In addition, a hole had been punched in the front of the locomotive immediately above the cowcatcher; this was consistent with an impact with the truck's first side-tip trailer hinge support that was located immediately above the pivot point of the trailer. Also, a steel bar was found imbedded in the locomotive's left-hand ditch light. This steel bar was the wheel guard and mudflap support spar that was later found to be missing from the rear of the road-train's prime-mover.

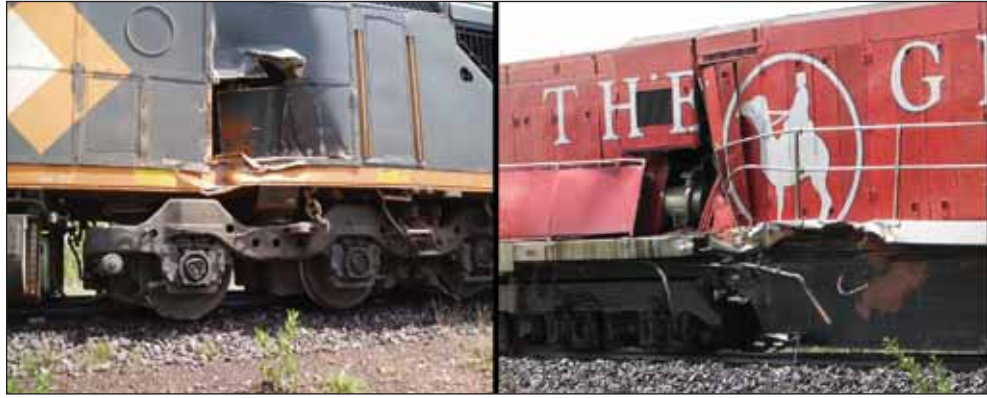
Figure 20: Left-hand side of locomotives AN 5 (left) and NR 109 (right)

The first trailer struck the side of the lead locomotive (AN 5) while the second trailer struck the side of the second locomotive (NR 109). The impact was sufficient to punch large holes in the sides of both locomotives.

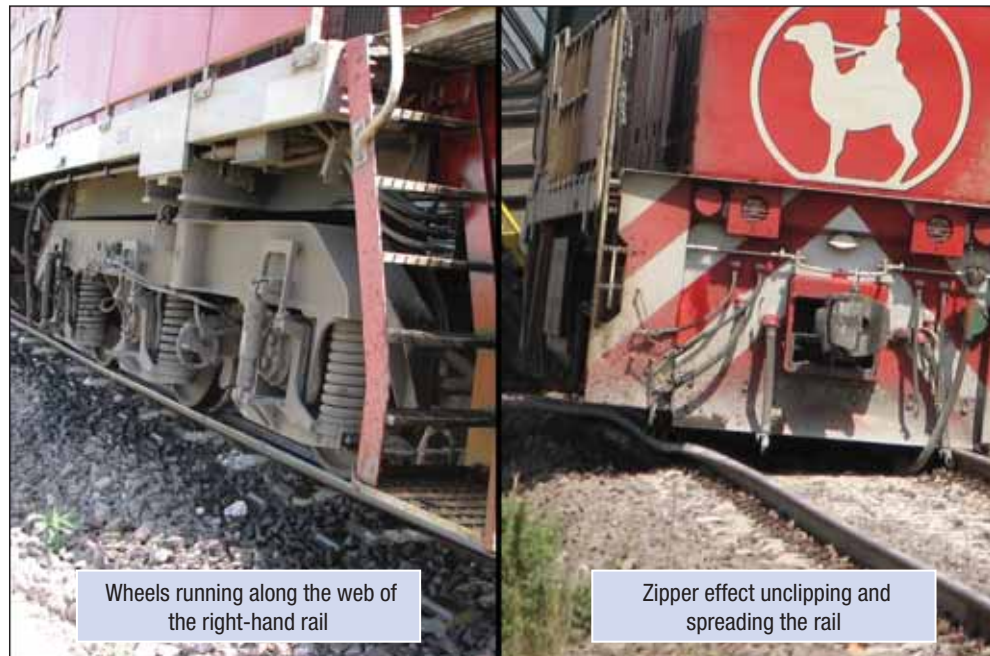
Figure 21: Leading end of locomotive NR 109

During the collision sequence it appears that the lead bogie of the second locomotive (NR 109) fell between the rails with its right-hand wheels running along the web of the rolled right-hand rail. The second locomotive then continued travelling in this state with the second bogie acting like a zipper that spread and unclipped the rail from its fastenings as it went. The wheels on the rear bogie of NR 109 and bogies of the following wagons fell completely between the two rails and travelled along the four-foot making hard contact with the concrete sleepers.

The repeated impact of the wheels resulted in the failure of the majority of the concrete sleepers. This meant that the rail gauge could not be maintained and so the controlled passage of the following rail vehicles was lost. The second locomotive

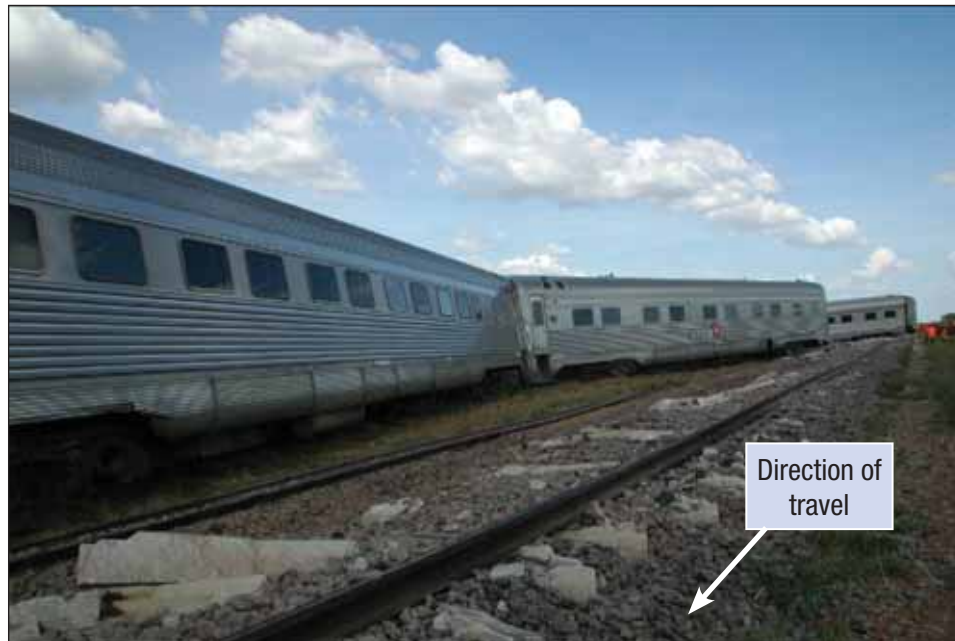
Figure 22: *The Ghan* carriages jack-knifed, northern side of the track

broke away from the lead locomotive and, in a derailed state, slowed dramatically. Momentum and the lack of lateral constraint caused the following wagons to bunch and jack-knife (predominantly) to the northern (right-hand) side of the track.

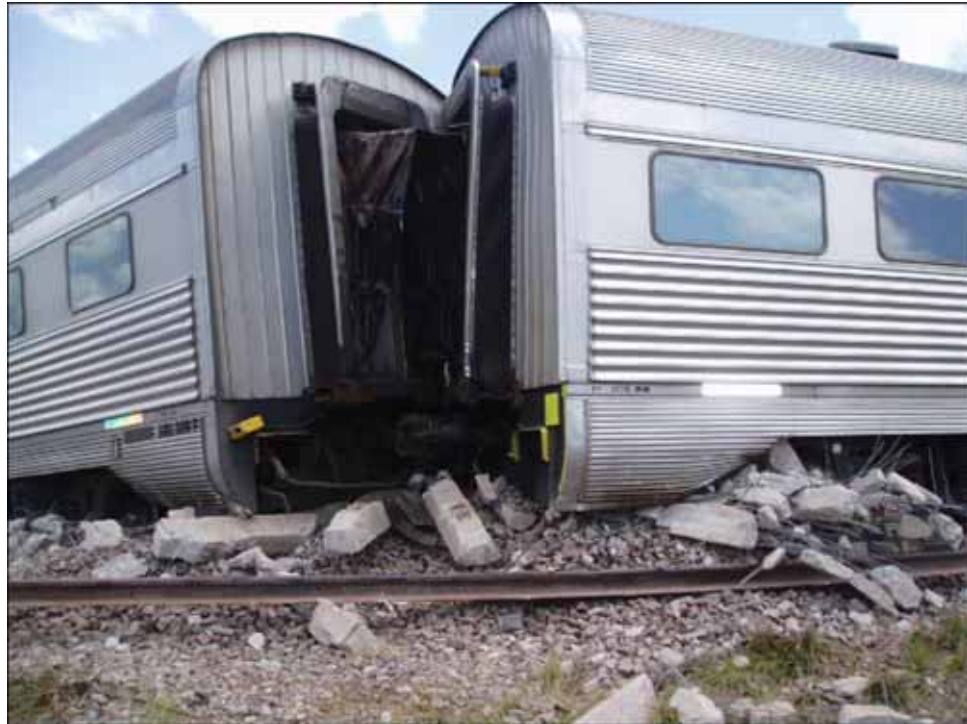
Figure 28: Vestibule area between connected carriages

With the exception of one end-carriage door between the Gold Kangaroo lounge carriage and the adjacent sleeper carriage (ARL 920Y), no interconnecting end doors or side door exits jammed. However, during the derailment sequence, some of the carriages concertinaed, thereby causing flexing that opened up the walkway/ vestibule areas between these carriages. Had someone been in these areas when the accident occurred, their safety could have been jeopardised.

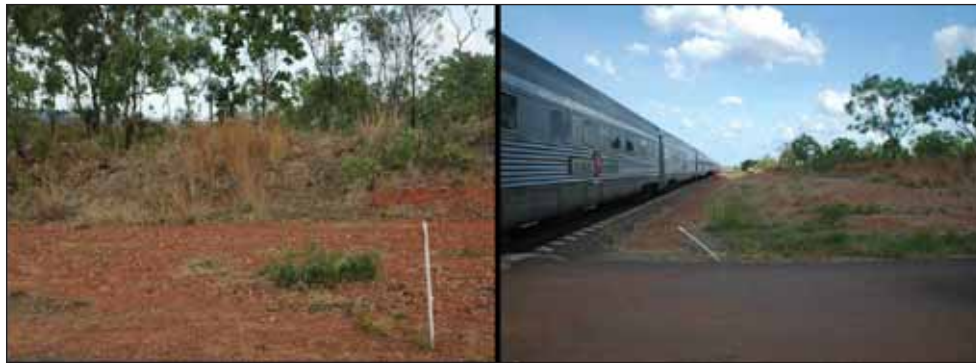
Figure 31: Left photo is the view towards the east 40 m from level crossing, right photo is the view along the track to the east from the stop sign

The actual sighting distances for road vehicles stopped at the stop sign at the Fountain Head Road level crossing are, in clear weather, about 1200 m to the east and about 1000 m to the west. This is well in excess of the 727 m that was calculated using the Queensland model. Therefore, the Fountain Head Road level crossing is in compliance with the sighting distance requirements for 'Stop' sign control as assessed using a model applicable at the time and the arbitrarily agreed distance of 1000 m.

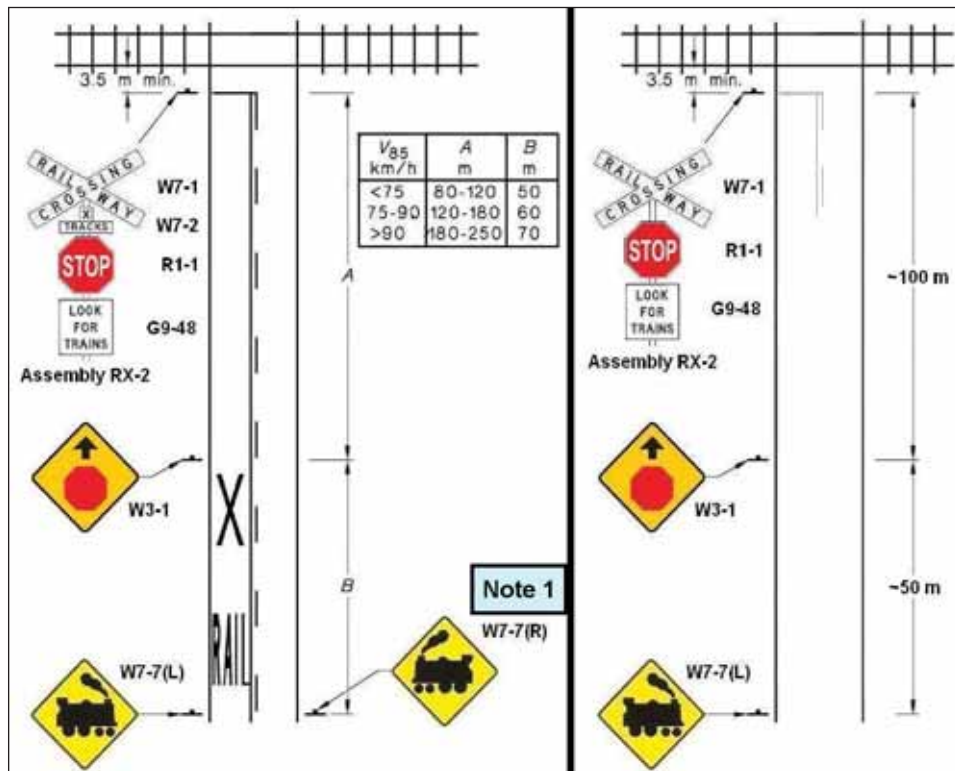
Figure 32: Left, signage and road markings as required by Australian Standard 1742.7-1993, right, signage and road markings as installed at Fountain Head Road level crossing on 12 Dec 2006

Note 1: AS 1742.7-1993 states that the right-hand 'Railway Crossing Ahead' sign, W7-7(R), is optional and only intended for use on busy roads. Consequently, this sign was not installed at the Fountain Head Road level crossing.

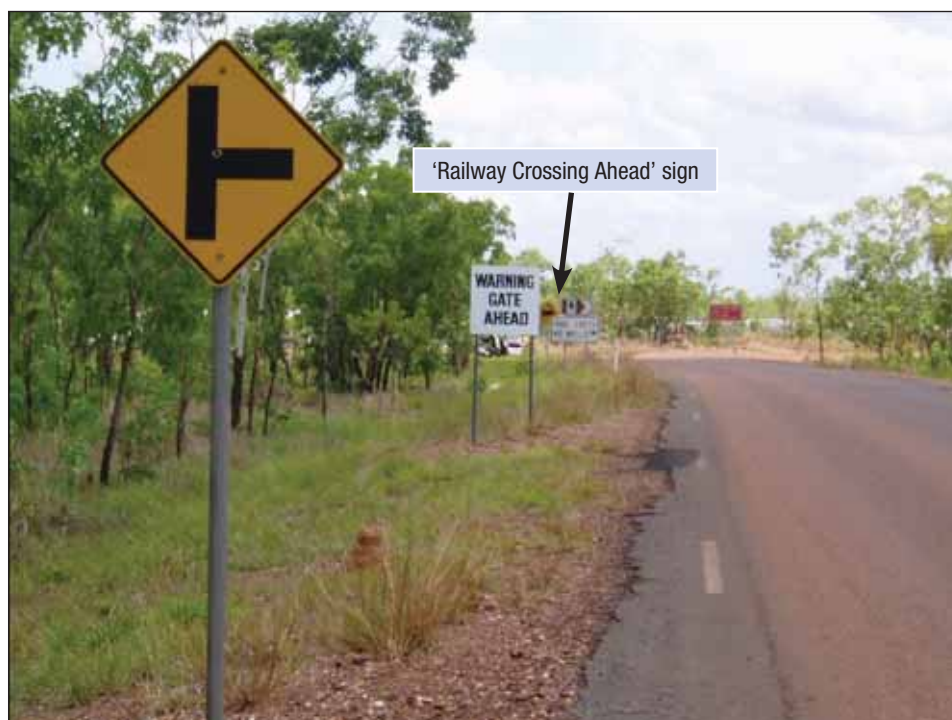
Figure 34: Sign Clutter - Fountain Head Road level crossing, Ban Ban Springs (southern approach)

Also, the southern approach to the level crossing exhibited some 'sign clutter' in that multiple signs, unrelated to the warning signs for the level crossing, were in place. At times, these signs restrict the view of the advance level crossing warning sign. However, the 'Stop Sign Ahead' and the 'Stop' signs were both unobstructed and clearly visible.
