ATSB TRANSPORT SAFETY INVESTIGATION REPORT  
Rail Occurrence Investigation No. 2006/004  
Final

Collision between  
**Rigid Tipper Truck/Quad Axle Trailer  
and Freight Train 4AM3**

Lismore, Victoria

25 May 2006

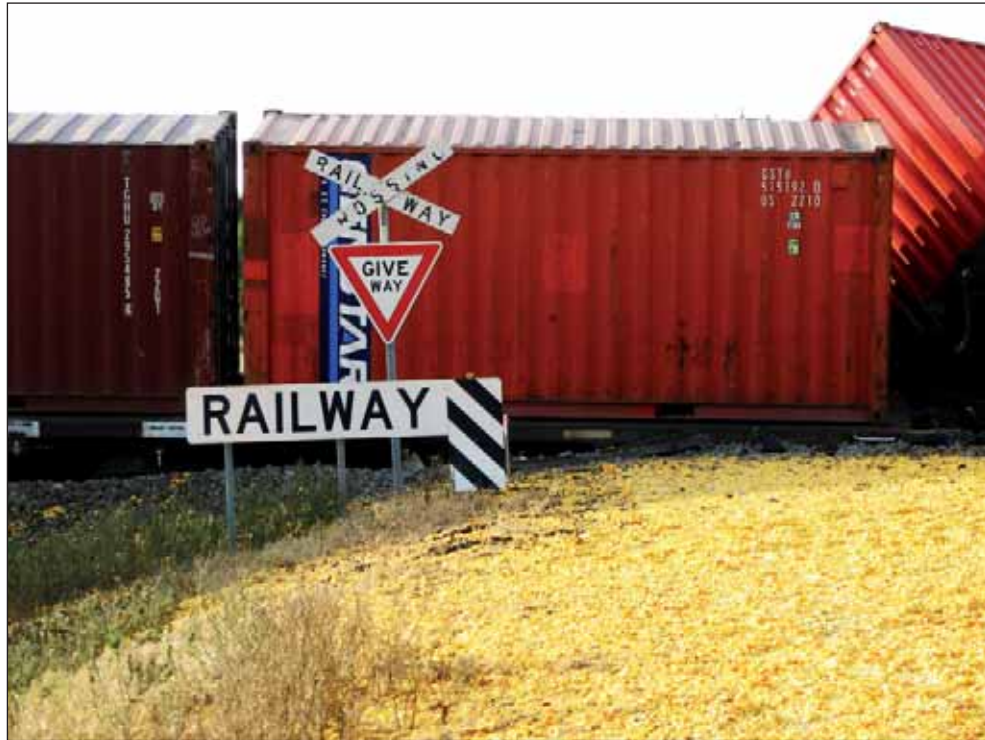
Figure 2: Give way assembly and left side railway level crossing width marker assembly located on the southern approach to the level crossing (northern side destroyed)

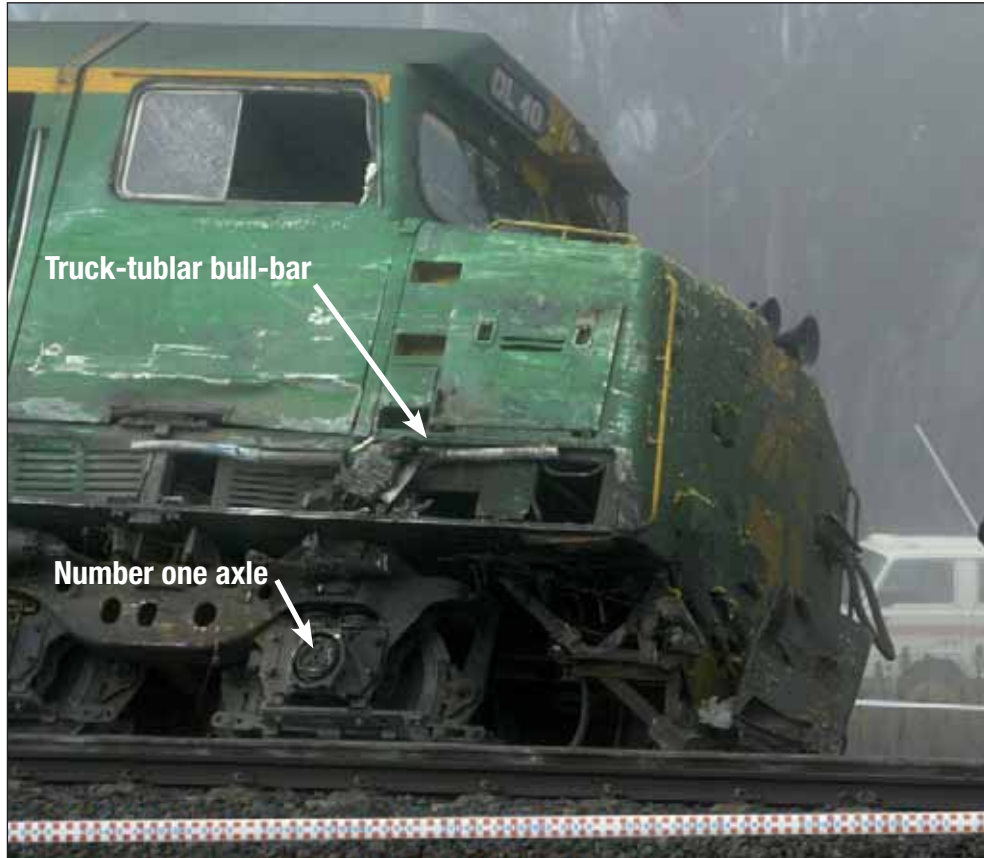
The force of the collision was such that all wheels of the second locomotive were derailed and the citrus pulp being carried in the quad axle trailer was thrown to the opposite side of the level crossing. Part of the truck's 'bull-bar' was imbedded in the side of the second locomotive and the locomotive's number one axle was bent 1.6 mm by the collision (four times the condemning limit of 0.4 mm).

Figure 7: Tubular bull-bar imbedded in DL 40

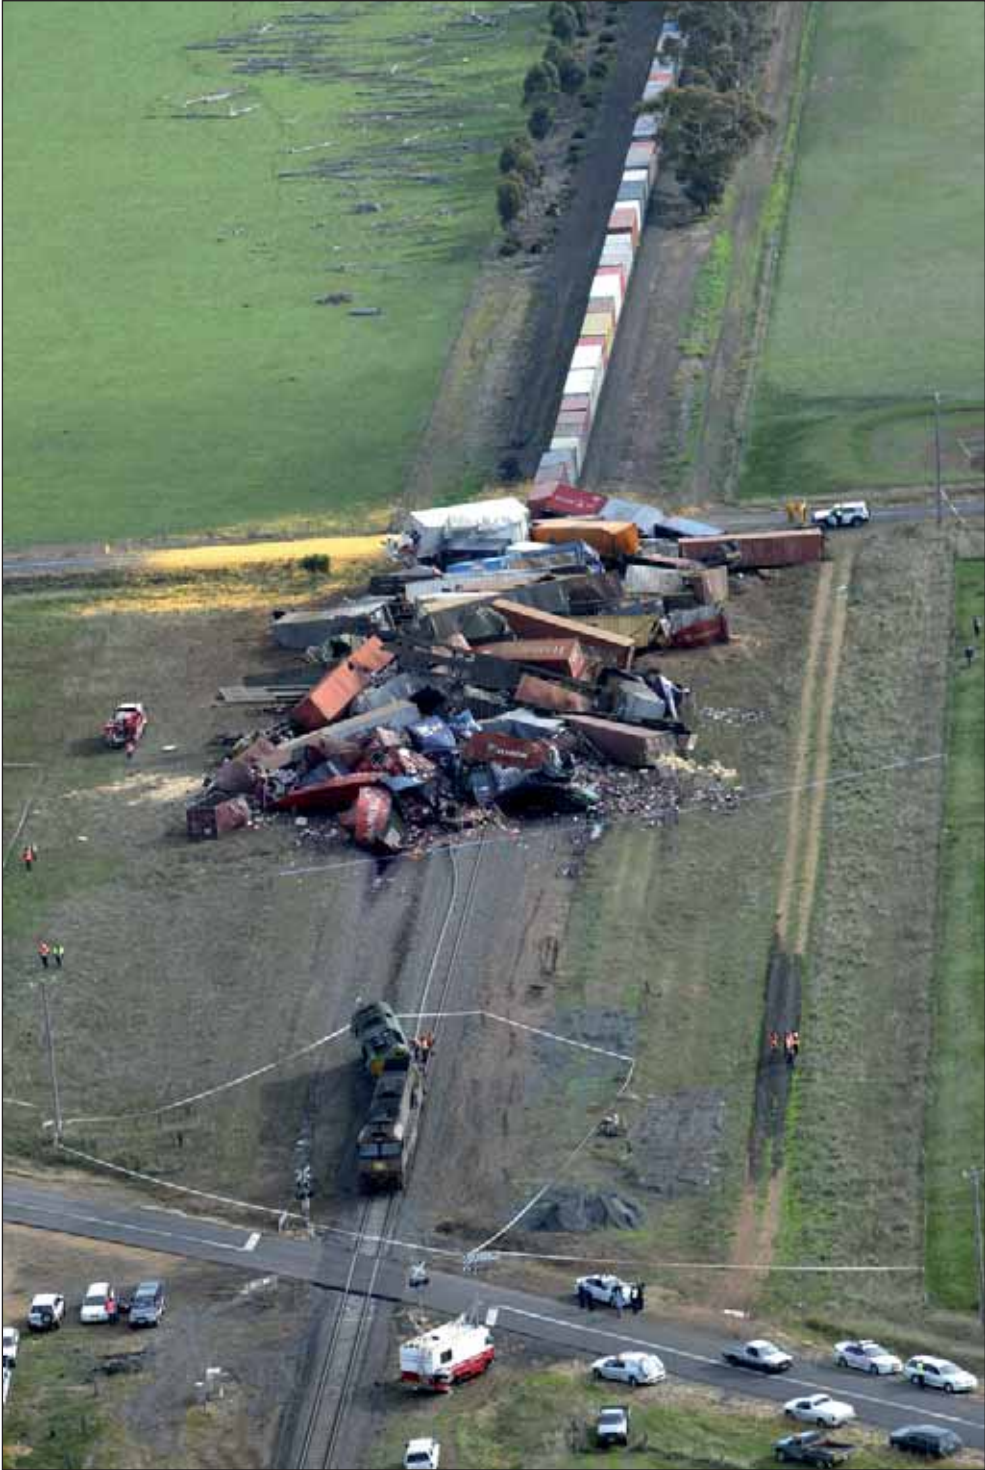
Figures 8, 9 and 10 are aerial photographs of the wreckage. These photographs show that very little of the citrus pulp that was being carried in the truck and trailer combination remained on the northern (impact) side of the level crossing. The bulk of the citrus pulp can be seen to reach almost to the white guide posts on the southern side of the level crossing and there are scatterings at a greater distance immediately adjacent to the eastern side of the road. Dual tyre skid marks were found on the road on the northern approach to the level crossing. These skid marks were 29 m long and extended beyond the holding line and veered slightly to the right.

Figure 8: Compressed wreckage of train 4AM3

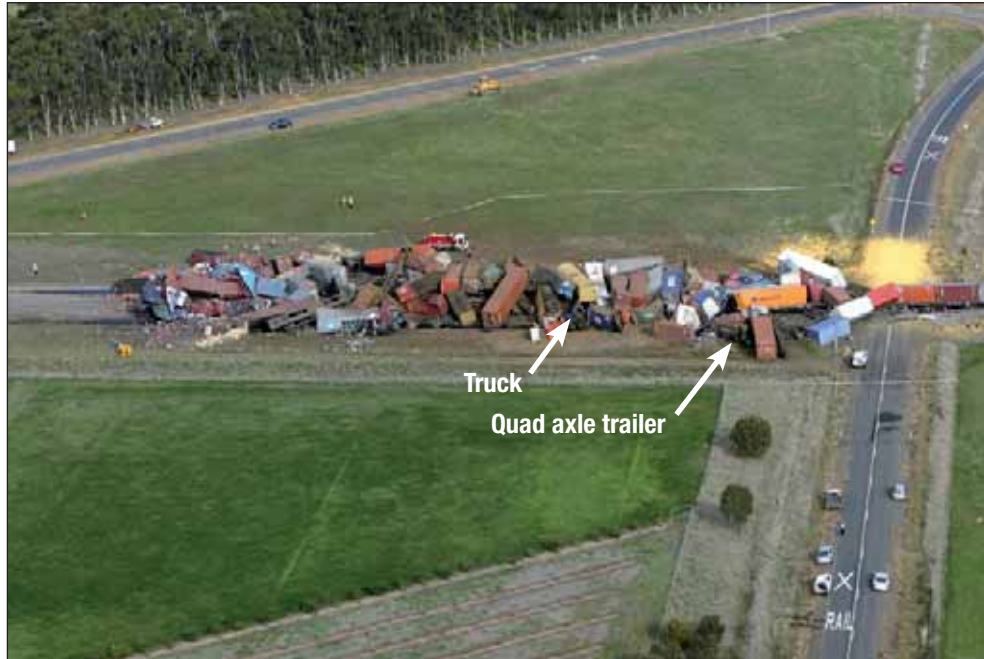
Figure 9: Aerial view looking south

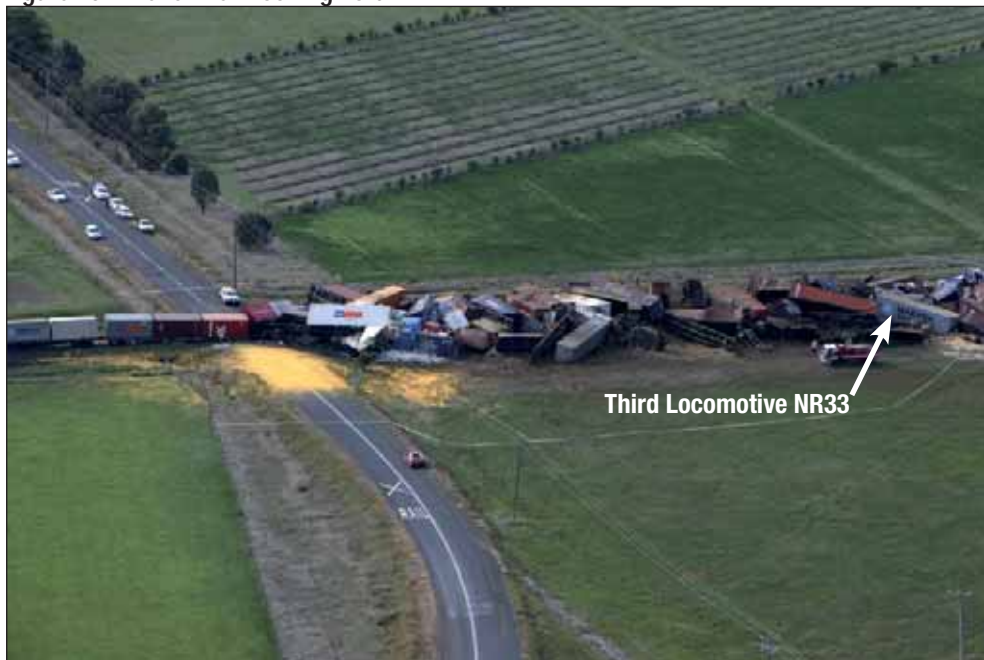
Figure 10: Aerial view looking north

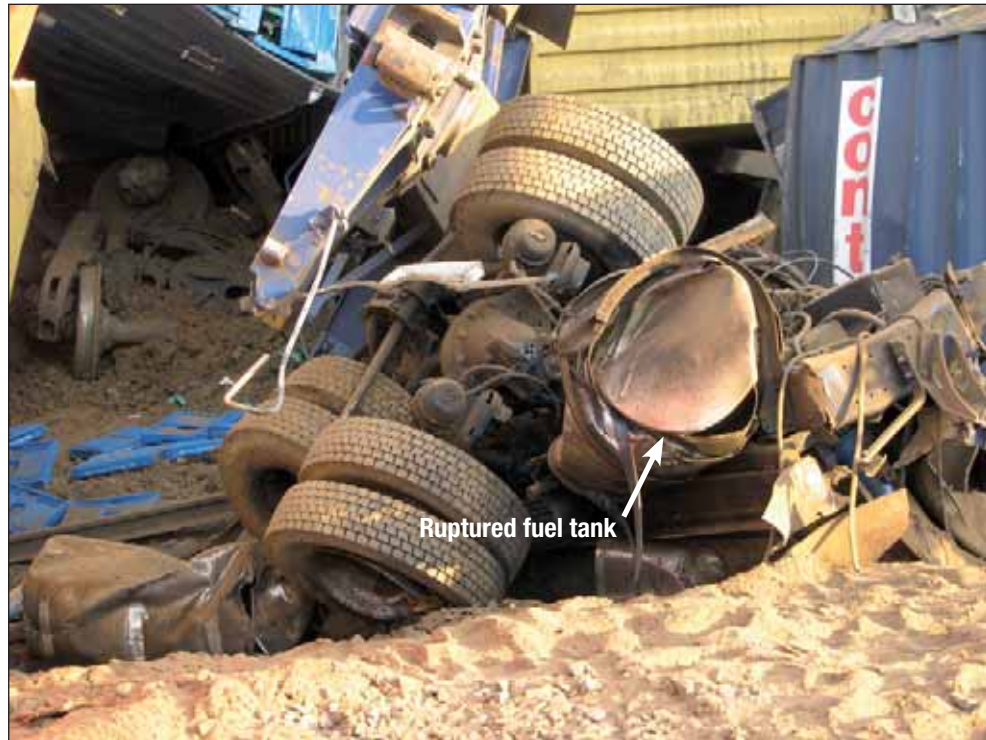
Figure 11: Remnants of truck

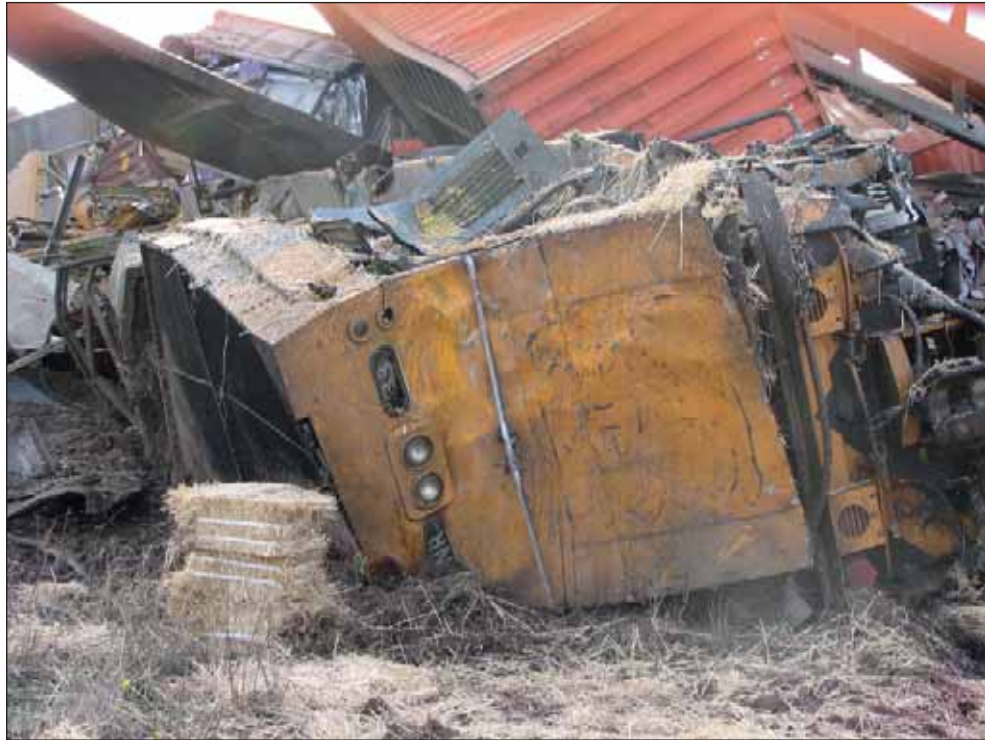
**Figure 12: Locomotive NR 33, subsequently written off**

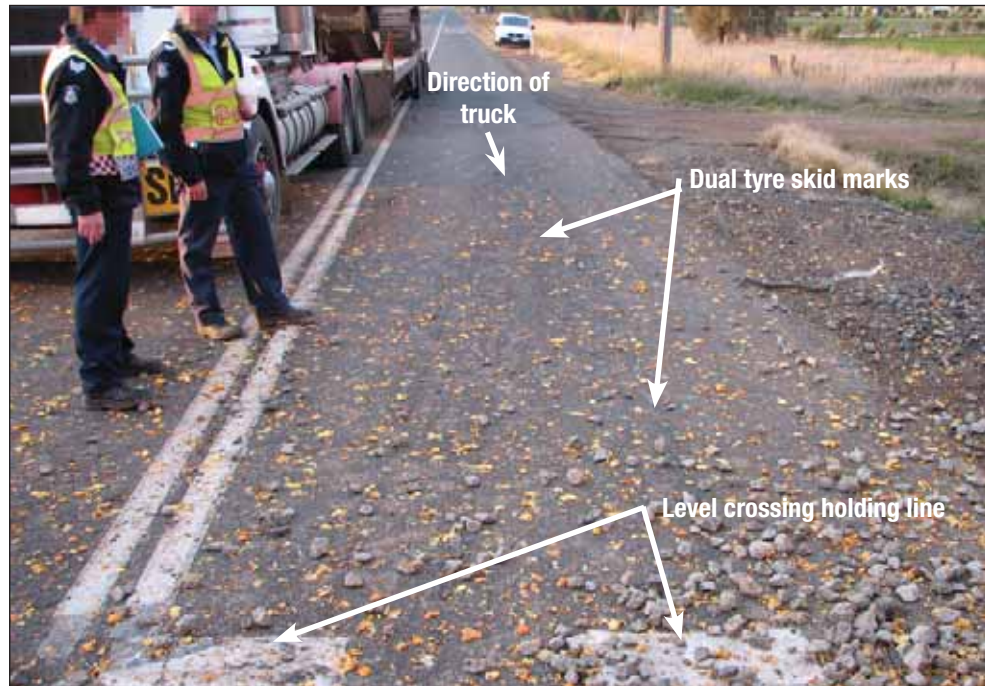
On the northern side of the Lismore Skipton Road level crossing dual tyre skid marks were found. The length of these skid marks was about 29 m and they veered slightly towards the centre of the road beyond the holding line until obscured by damage caused by the wreckage.

Given the length of these skid marks and visibility at the time of the accident, it is likely that the dual tyre skid marks are an indication of the truck driver's reaction to the impending collision.

Figure 15: Dual tyre skid marks on the immediate approach to level crossing

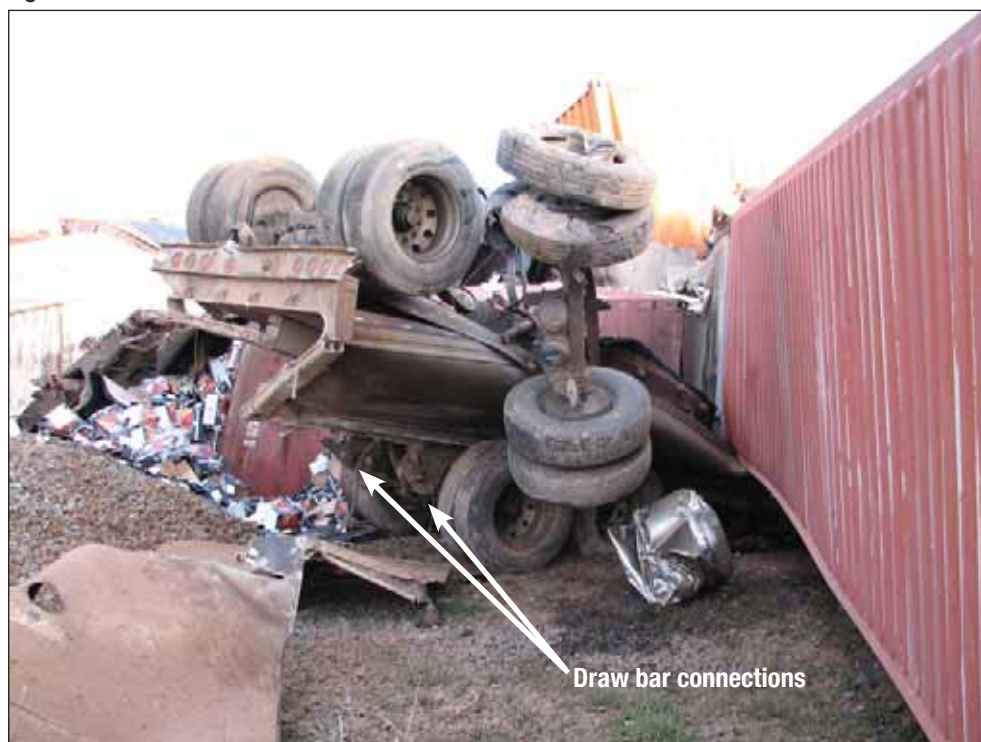
Figure 17 shows the wreckage of the trailer after the collision. The front bogie axles and wheels are those on the ground. This bogie has rotated and come to a rest 180 degrees from its original position with the result that the connections for the draw bar face towards the rear of the trailer. The body of the trailer has turned over with the underside of the trailer facing upwards. The front axle of the rear bogie has been torn from its mountings and the rear axle remains intact. The position of the trailer body and crushed side panels support the hypothesis that the trailer pivoted and then rotated in an anti-clockwise direction.

Figure 17: Wreck of trailer

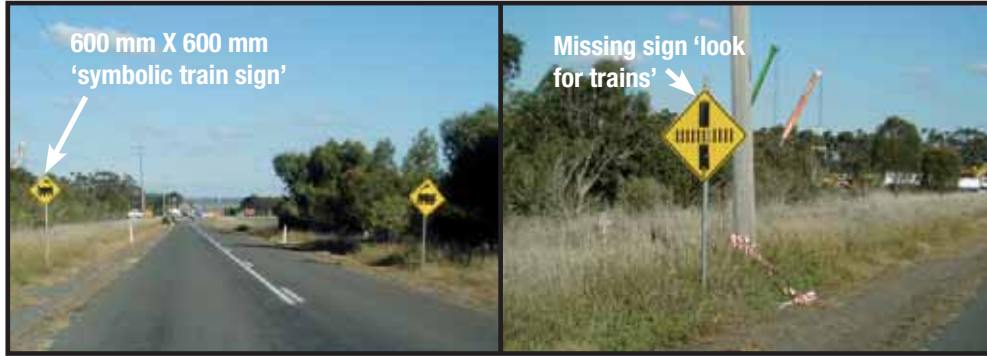
- the diagrammatic warning assembly RX-3-1 was missing the supporting ‘look for trains’ sign G9-48
- the lower edge of diagrammatic warning assembly RX-3-1 was 1.44 m from the ground. The standard says that, in rural areas, the sign should not normally be less than 1.5 m above the height of the nearest edge of the ‘travelled way’. This slight non-conformance is exacerbated when it is considered that a 750 mm X 750 mm ‘look for trains’ G9-48 sign should have been mounted below the diagrammatic warning sign

Figure 18: Left photograph of advance warning sign W7-7, right photograph W7-8 sign

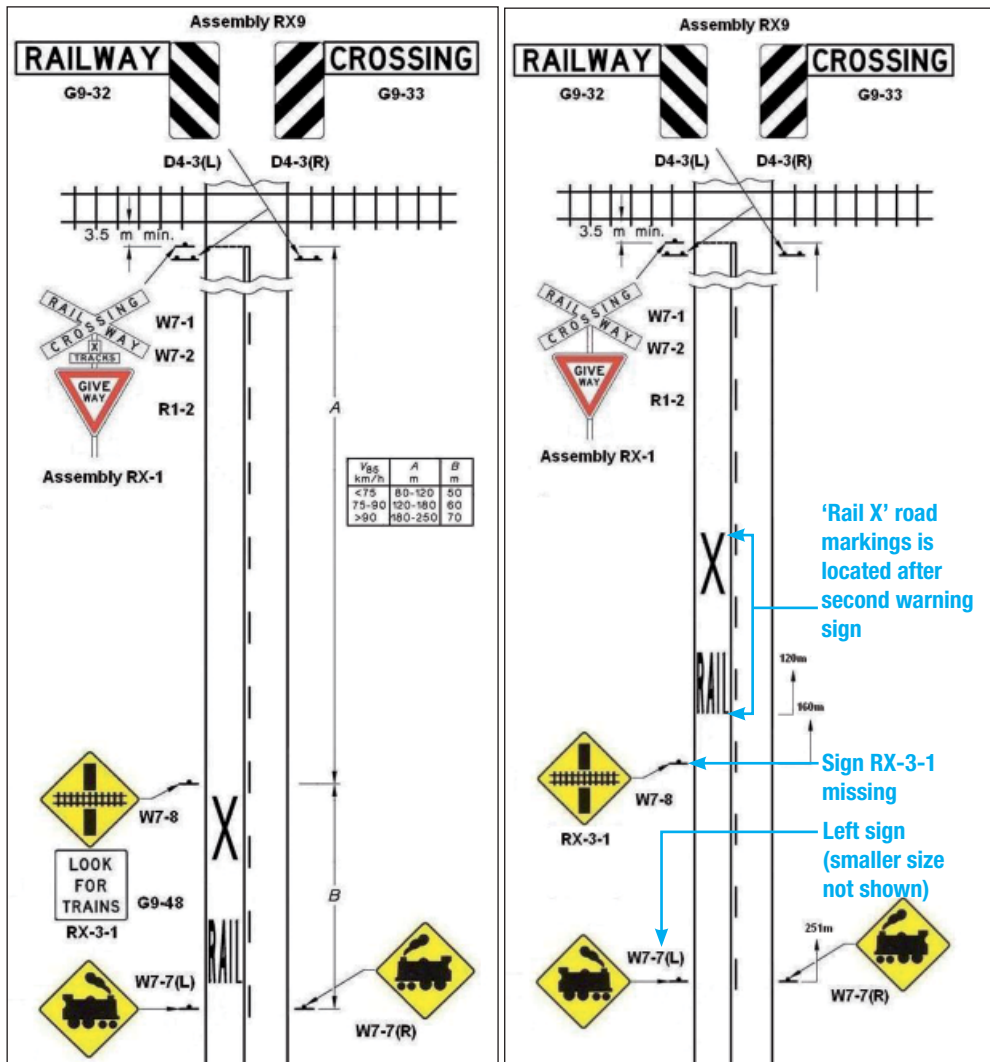
The following non-conformances with Standard 1742(7) were found with the signage and devices on the northern approach to the Lismore Skipton Road level crossing.

Figure 19: AS 1742.7 – 1993. The left figure shows the standard signage and road marking layout for level crossing controlled by Give Way signs with straight approach. The right figure shows the Lismore Skipton Road level crossing as of 25 May 2006

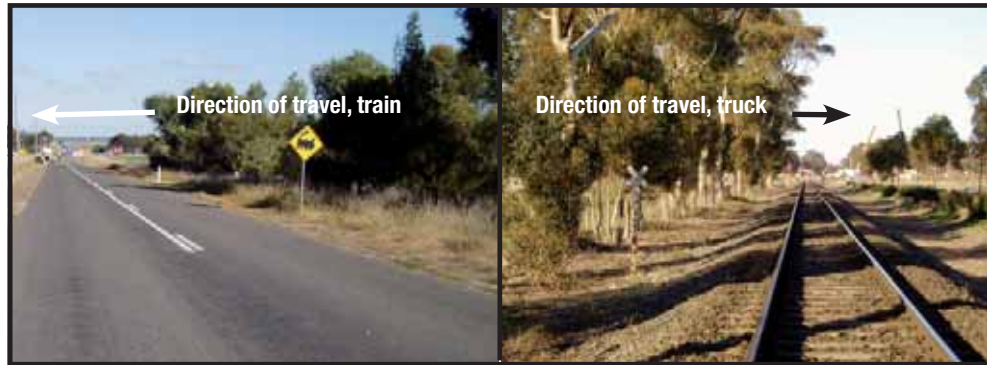
There was a line of trees on private property on the western side of the Lismore Skipton Road that ended 145 m from the nearest rail line at the level crossing. Also, there was a line of trees on the northern side of the rail line on the western approach that ended 172.5 m from the centre line of the level crossing (see figure 21). The combined effect of both stands of trees restricted the view that the driver of a southbound road vehicle had of a train approaching from the west.

Figure 21: Road and rail approach to the Lismore Skipton Road level crossing, note close proximity of trees
