ATSB TRANSPORT SAFETY INVESTIGATION REPORT
Rail Occurrence Investigation No. 2006/009
Final

Collision between
**Prime-mover/low loader combination and
Ballast train 4MR1**

Tailem Bend, SA

4 October 2006

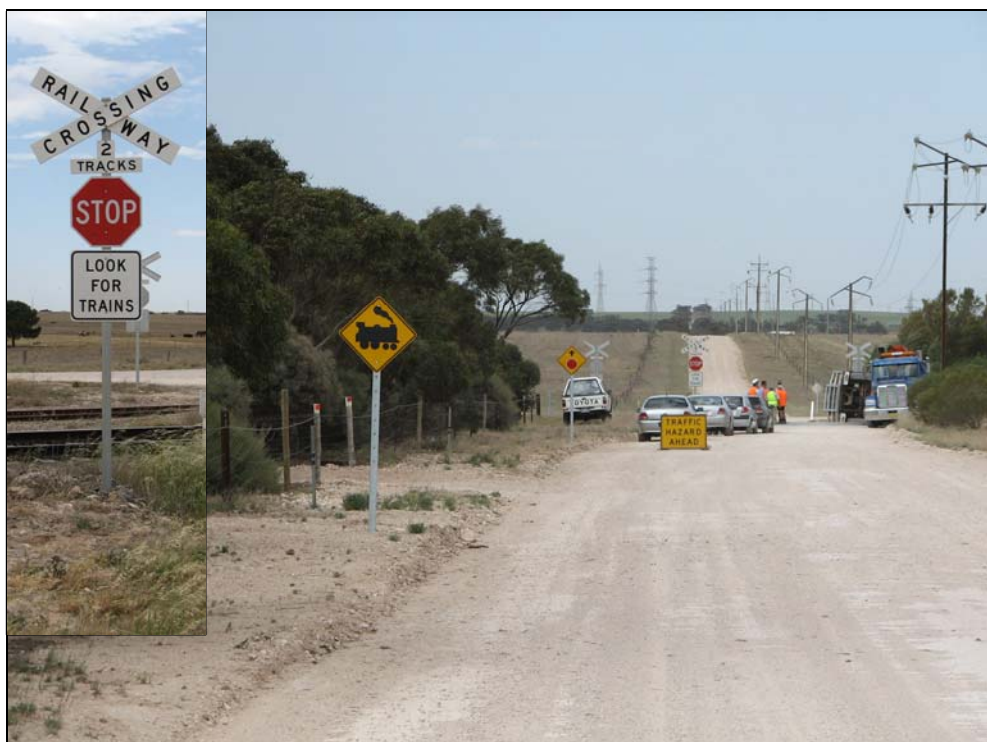
Travelling along Magpie Drive, in an easterly direction, the visibility of the rail line and rail traffic is obstructed by vegetation bordering the northern side of Magpie Drive and the north-western side of the rail corridor. Magpie Drive (Fig. 2) intersects with the Adelaide to Melbourne rail line and the Pinnaroo line at an angle of close to 60 degrees. After passing over the level crossing, Magpie Drive intersects with Lime Kiln Road and is re-named as Substation Road.

Figure 3: Stop and approach warning signs (Inset 'Stop' sign assembly) approaching the level crossing.

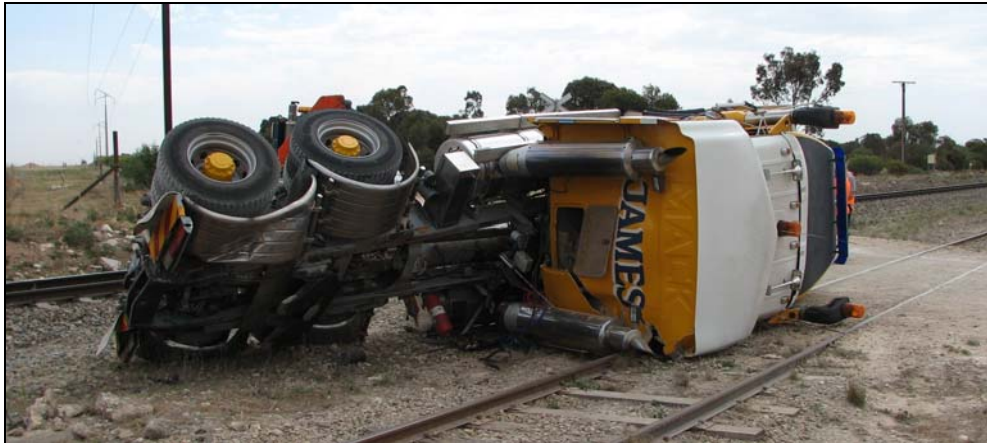
Figure 5: Photo of damaged prime-mover.

Damage to the locomotive comprised crushing of the drag box, onboard electrical systems and brake gear along the length of the leading locomotive. The truck was heavily damaged with notable twisting of the chassis, extensive body distortion and associated panel damage. The trailer was written off. Figures 5, 6 and 7 are photographs of the truck, trailer and damage to the front of locomotive NA1874. The truck driver suffered minor injuries, there were no injuries to the crew of the train.

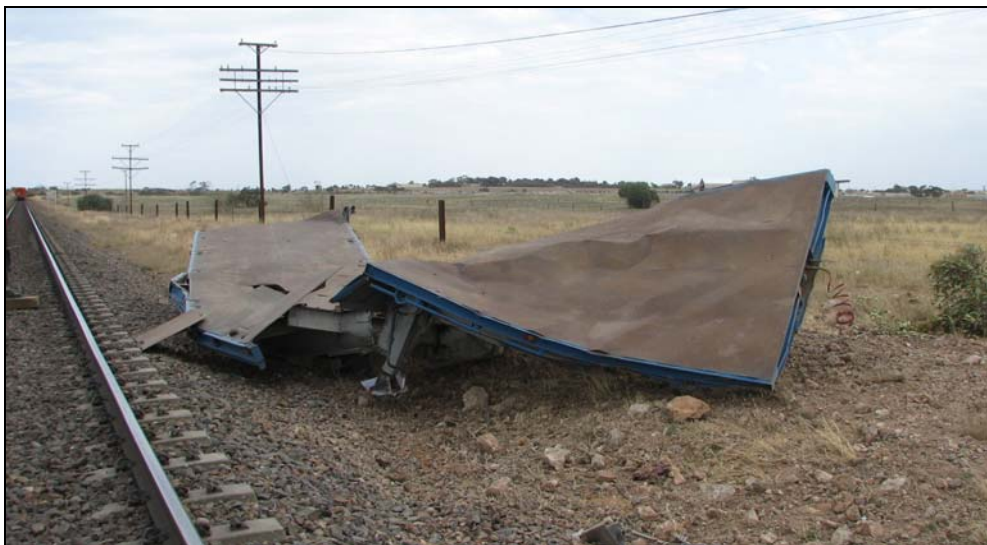
Figure 6: Photo of trailer.

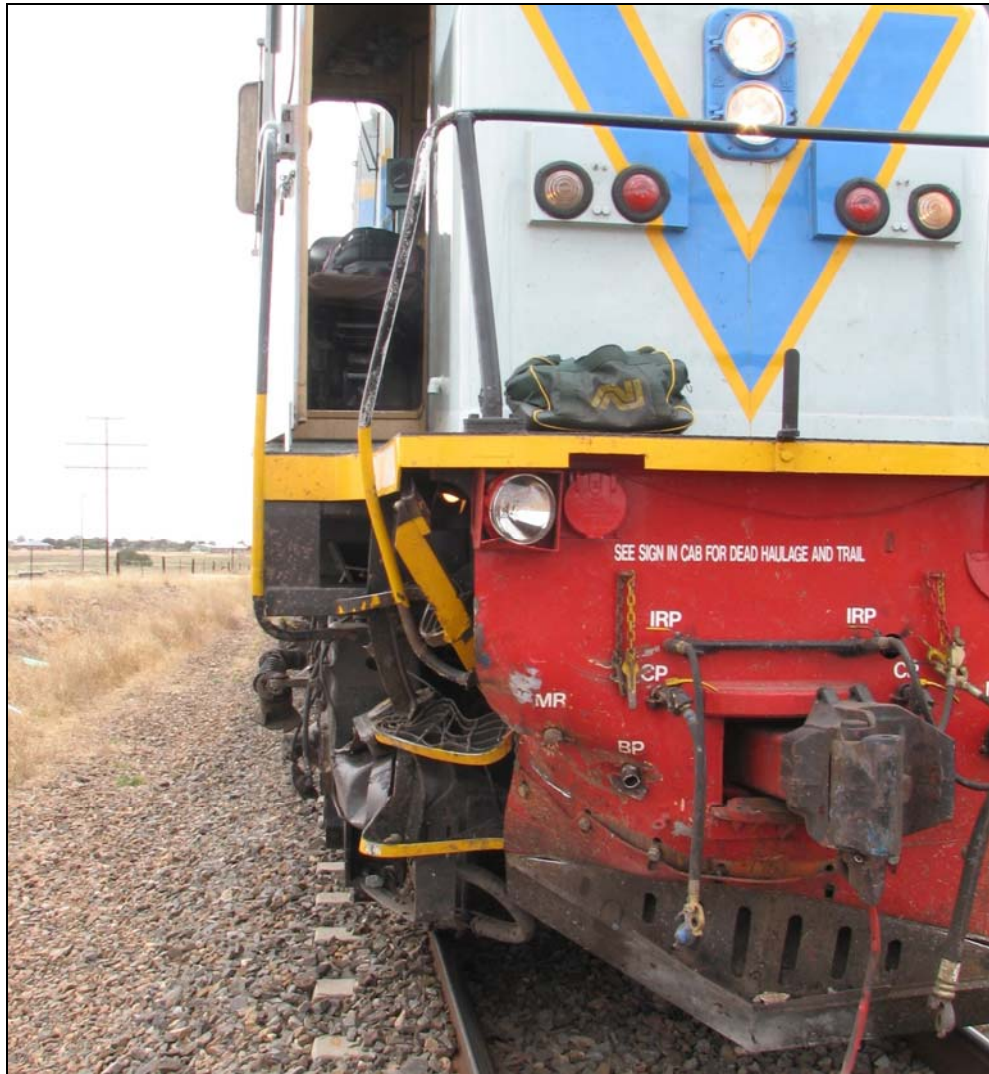
Figure 7: Photo of locomotive, NA1874, showing extent of damage.

South Spur Rail Services incurred combined losses in the order of \$200,000 with damage to the drag box and onboard electrical systems of the lead locomotive.

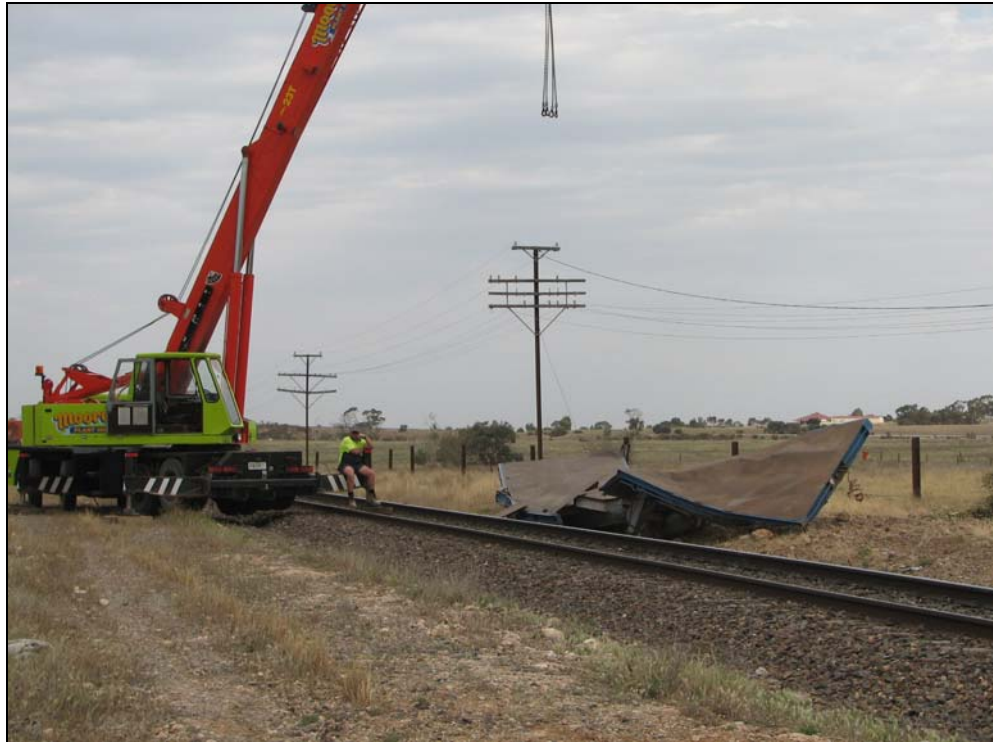
There was only minor damage to train 4MR1 which was carrying ballast for track maintenance purposes, no dangerous goods were being carried at the time of the accident. There was minor spillage of diesel from the truck, this probably occurred at the time of the collision and/or when the truck rolled over. The truck and trailer were lifted/towed (Fig. 8) away from the rail lines and then removed.

Figure 8: Photo of site recovery, damaged trailer approximately 85 m from collision site.

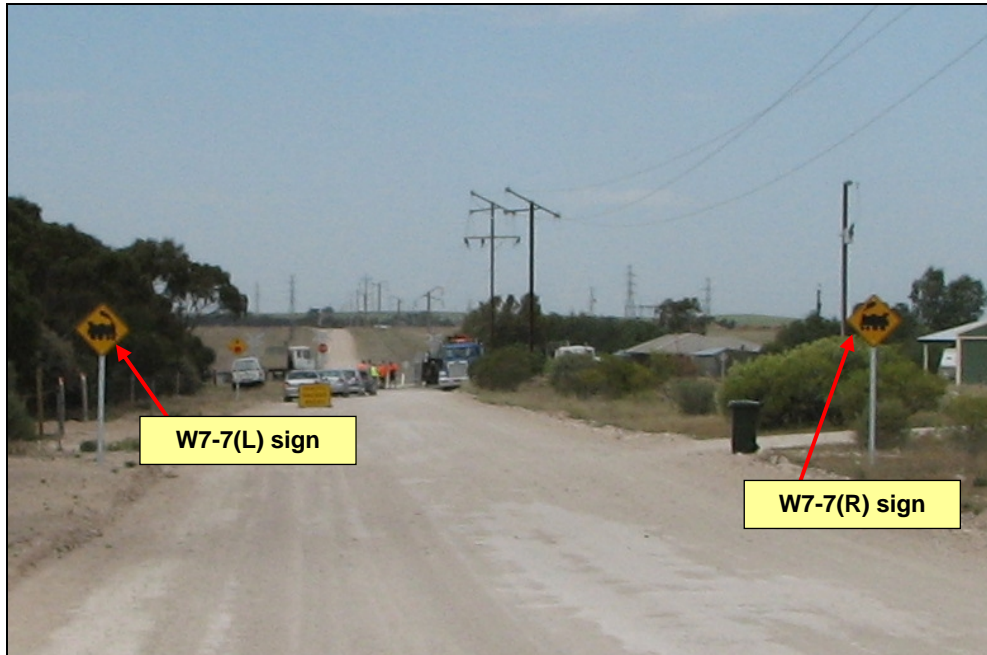
- The distance of the RX-2 assembly was 7.2 m from the crossing, the Standard specifies a minimum distance of 3.5 m. Although this is not a non-conformance, reducing the distance between the 'Stop' sign and railway track does improve sighting along the track. Unfortunately this action also has a negative impact in that it further degrades the viewing angle which is already poor.

Figure 12: Photograph of advance warning sign W7-7, W3-1 and 'Stop' sign assembly RX-2.

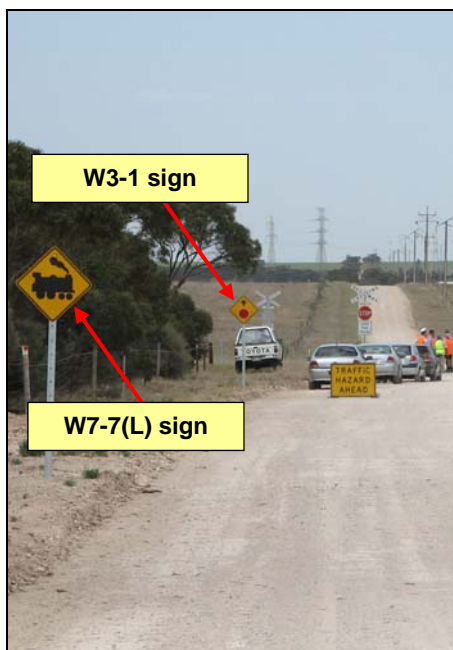
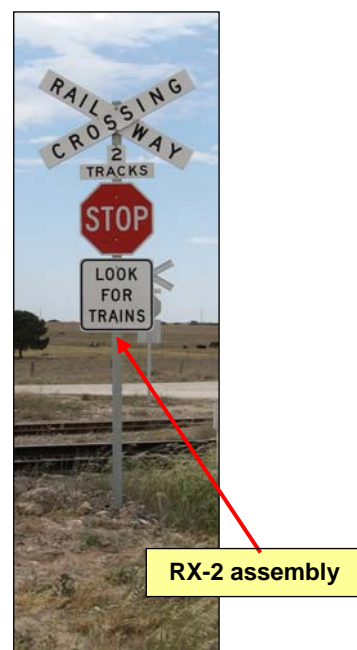
Figure 13: Left photograph of advance warning sign W7-7(L), W3-1 and 'Stop' sign assembly RX-2, right photograph RX-2 assembly.

- the distance between the ‘Railway level crossing ahead’ signs W7-7 (L&R) and the ‘Stop Sign Ahead’ sign W3-1 was 60 m in excess of the requirement specified in the Standard.

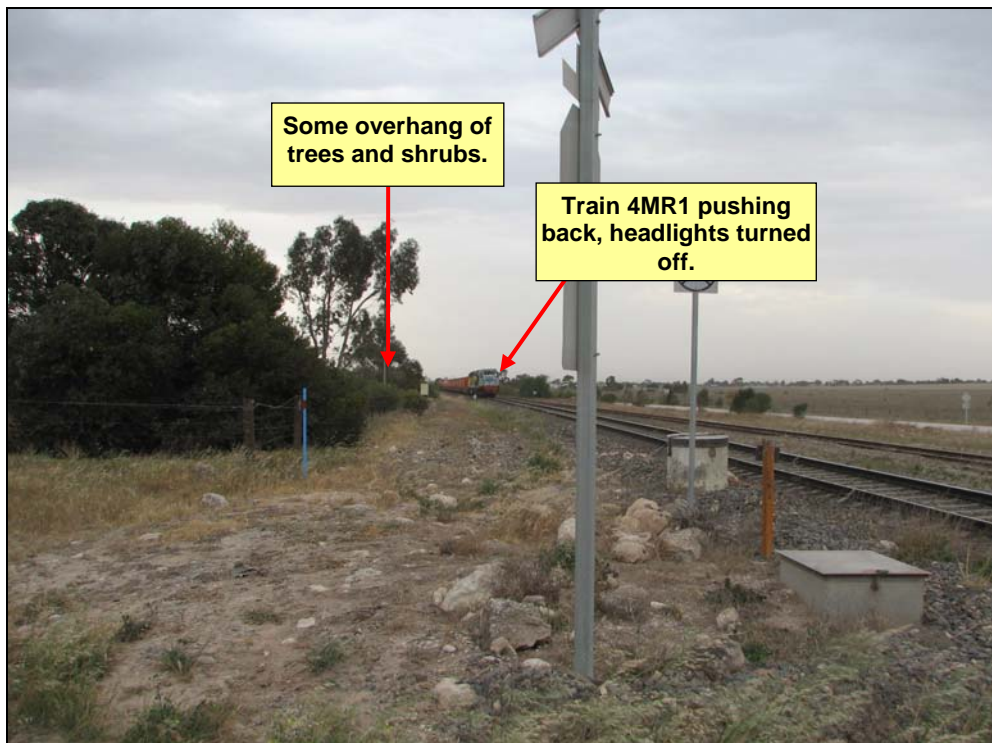
Figure 15: Train 4MR1 pushing back towards Tailem Bend, late afternoon of 4 October 2006.

It was noted that there was a line of trees on private property that parallels the railway line, (north-western side) offset by approximately 9 m to 10 m. Some of these trees were overhanging into the right-of-way (Fig. 15) and impeding on sighting along the track.

The ATSB recommends that the Australian Rail Track Corporation (ARTC) examine opportunities with Genesee & Wyoming Aust. Pty. Ltd. (GWA) and the Coorong District Council (CDC) for reducing the road/rail interface risk at the Magpie Drive level crossing¹³. This should include opportunities for closure of the crossing and/or realignment strategies that will improve both sighting and viewing angles.
