ATSB TRANSPORT SAFETY INVESTIGATION REPORT

Rail Occurrence Investigation No. 2006/012

Derailment of Train 3DA2K – Tarcoola, SA 1 November 2006

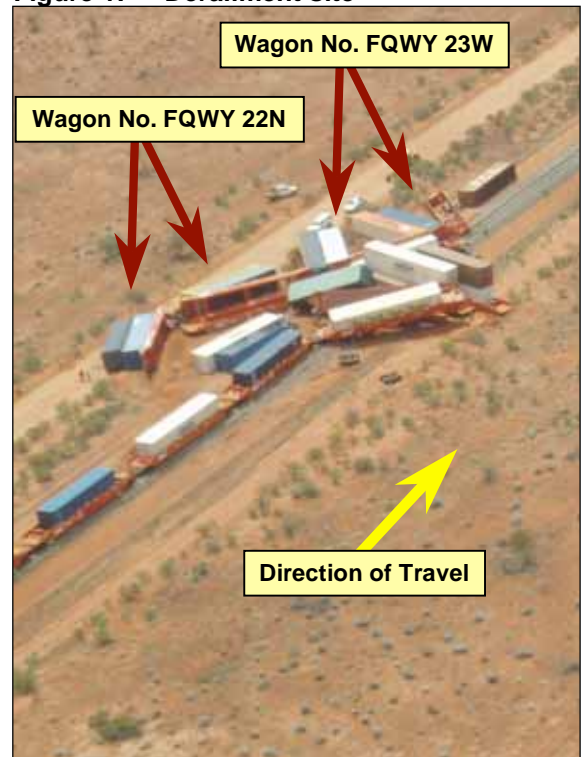
Figure 1: Derailment site

Examination of the derailment site focused on the two wagons (two 2-pack wagons) considered to have derailed first, FQWY-23W and FQWY-22N. The remaining wagons were considered to have derailed as a consequence of damage caused by the wagons in front.

- The distance between the earliest evidence of derailment and the front of wagon FQWY-23W was about 120 m.
- The initial derailment evidence was ballast displacement along the ballast shoulder.

- The first evidence of wheel flange climb was on the northern rail about 30 m beyond the initial evidence of displaced ballast.
- The first evidence of wheel induced damage to the concrete sleepers was about 30 m beyond the initial evidence of displaced ballast.
- Wagons FQWY-23W and FQWY-22N and their double stacked loads had come to rest lying on their left side.
- Wagons FQWY-23W and FQWY-22N were effectively lying in their coupled state.

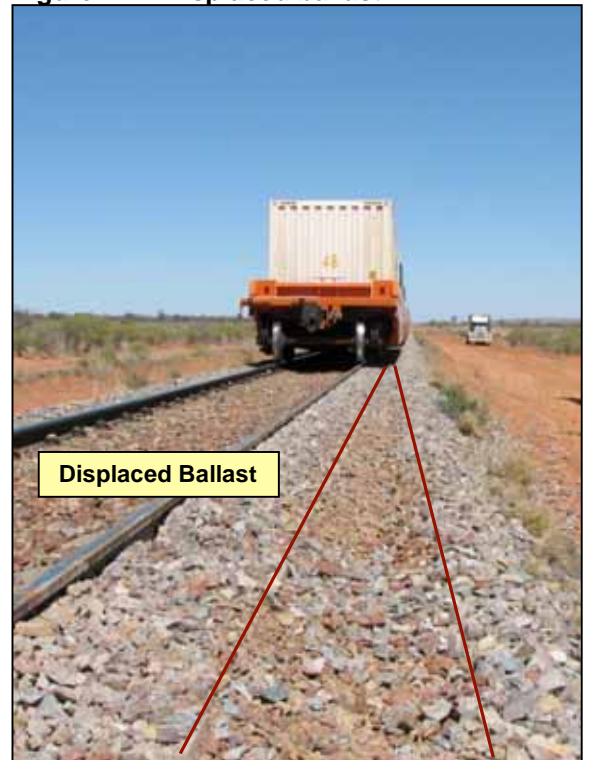
Figure 2: Displaced ballast

The earliest evidence of derailment was displaced ballast along the northern side of the track leading into the derailment site (Figure 2). The displaced ballast was found to begin outside the line of sleepers, generally running parallel to the track and gradually deepening as it entered the main derailment site. That is,

there was no evidence that a derailed wheel had tracked from the rail towards the ballast shoulder, nor was there any evidence of disturbed ballast between the two rails.

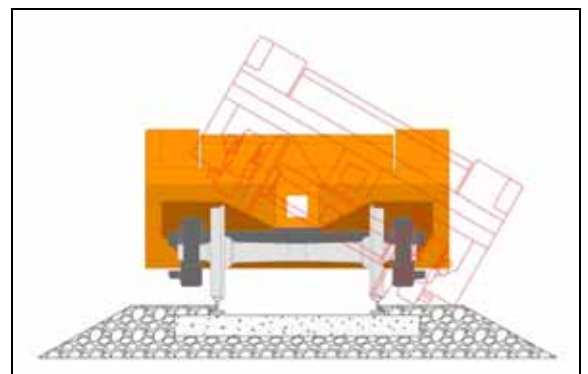
Figure 3: Overlay of rolled FQWY wagon

When considering a roll-over scenario, it is possible that the observed profile of the displaced ballast was caused by the FQWY wagon's side frame as the wagon gradually tipped sideways (Figure 3). It is also possible that the bruises found on the couplers between the 16th (FQAY-25U) and 17th wagon (FQWY-23W) were caused by the FQWY wagon rolling to the left.
