Australian Government
Australian Transport Safety Bureau

Safety of rail operations on the interstate rail line between Melbourne and Sydney

ATSB Transport Safety Report
Rail Safety Issue Investigation
RI-2011-015
Final – 22 August 2013

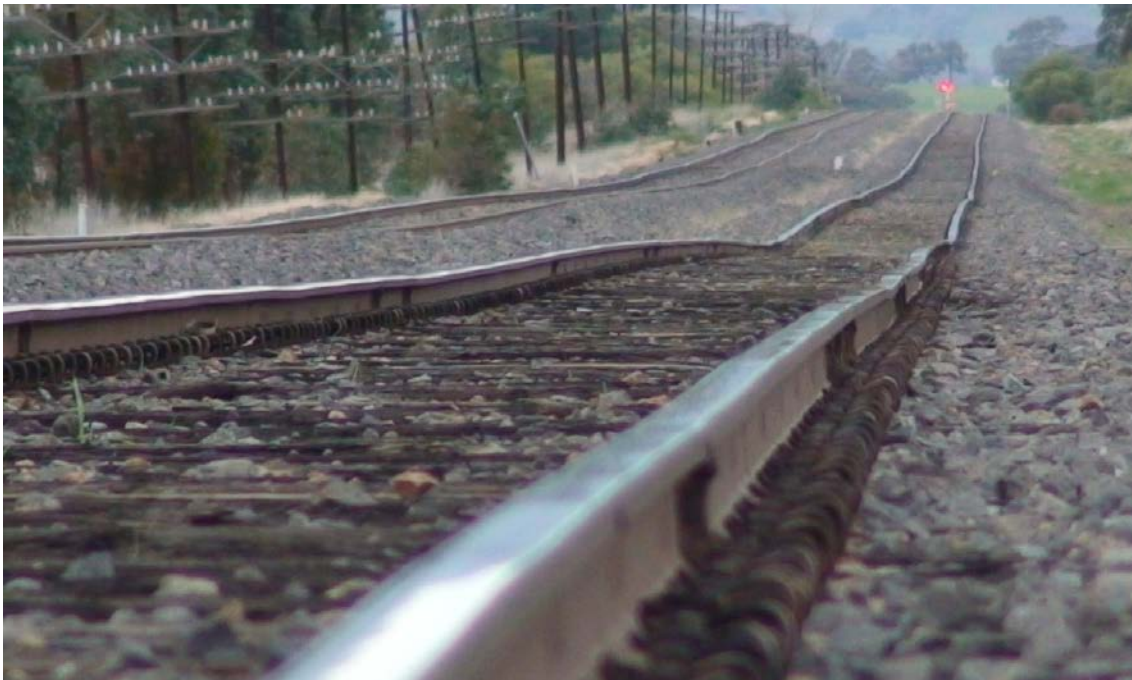
Figure 4: Poor track geometry

More intense public scrutiny developed through 2010 with comments often citing the method of sleeper replacement as the initiator of the problems, but evidence would suggest that a degradation of track condition existed (to various degrees) well before this intense public scrutiny. For example, in July 2008, a freight train derailed near Winton, Victoria²¹. The investigation found that a track condition contributed in part to the derailment. Figure 4 illustrates a section of track near Winton in 2008. The track to the left was the original broad gauge line (which was non-operational at the time of the photograph and later converted to standard gauge) and the track to the right was the standard gauge main line. Similar to more recent times, the area had been the subject of rough-riding reports, though it is evident that the track was yet to be upgraded with concrete sleepers. The wavy track geometry of both lines is typical of underlying structural problems.

Note: The angle and magnification of the photograph provides an exaggerated view of the track geometry defects

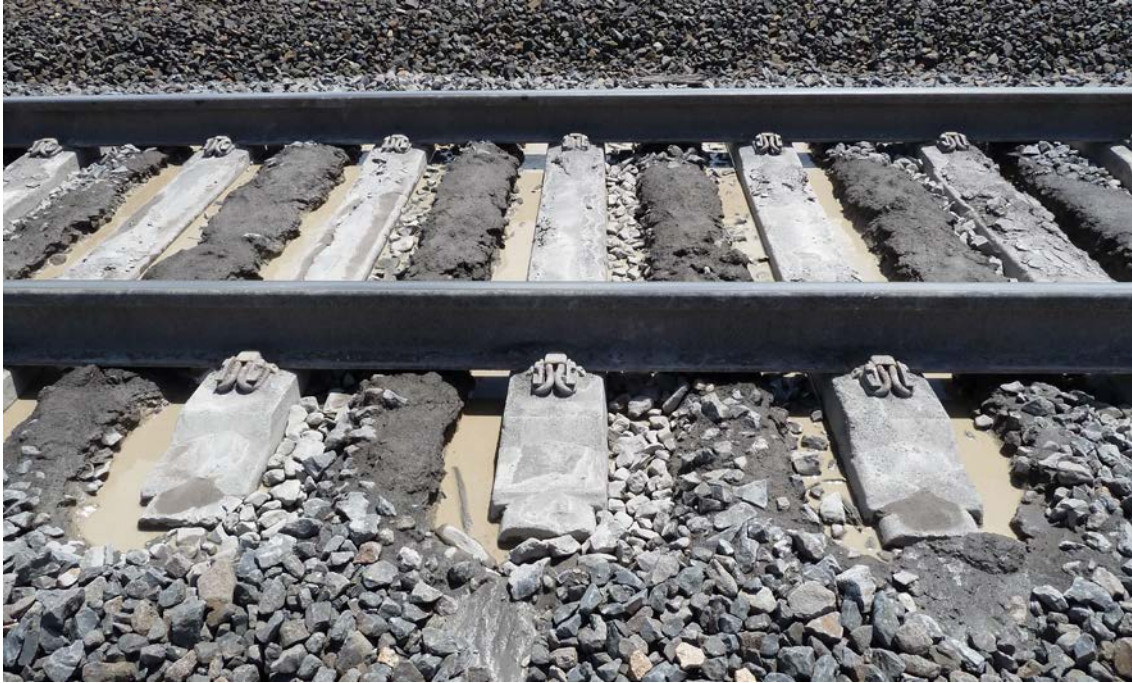
Figure 5: Typical mud-hole due to fouled ballast

with fine materials. This can be due to poor ballast (excessive fines), a breakdown of the ballast material or the formation rising up through the ballast. The fouled ballast retains water (appears like mud), prevents effective drainage and can result in poor track geometry (Figure 5).

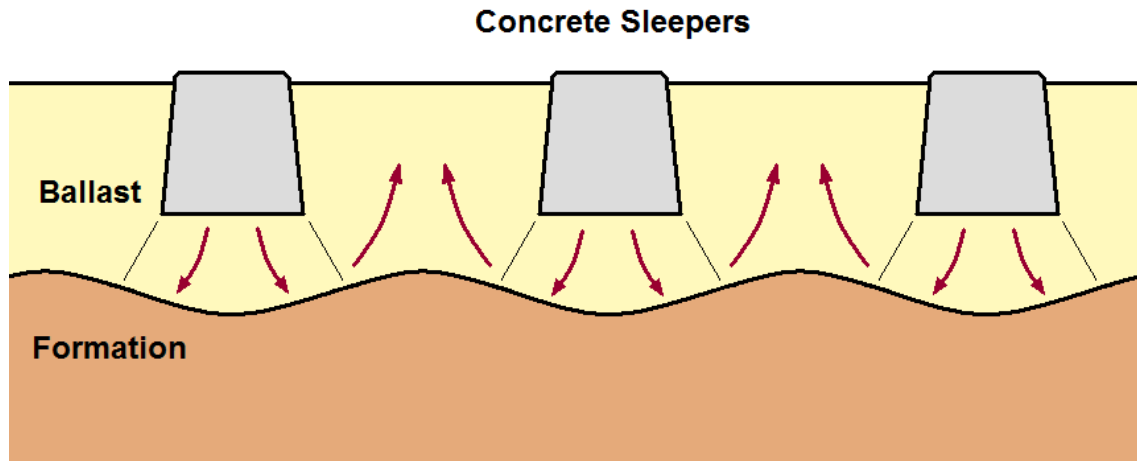
Figure 21: Depression and settling of the formation

The track through many areas in Victoria has historically suffered from soft formation problems (see section titled Track structure - description). The ATSB’s investigation established that until the early 1990s, track maintenance practices recognised the fragile nature of the old formation and tamping rarely lifted the track more than 5 mm due to the relative narrowness of the formation and the presence of other infrastructure such as road crossings and transom deck bridges.

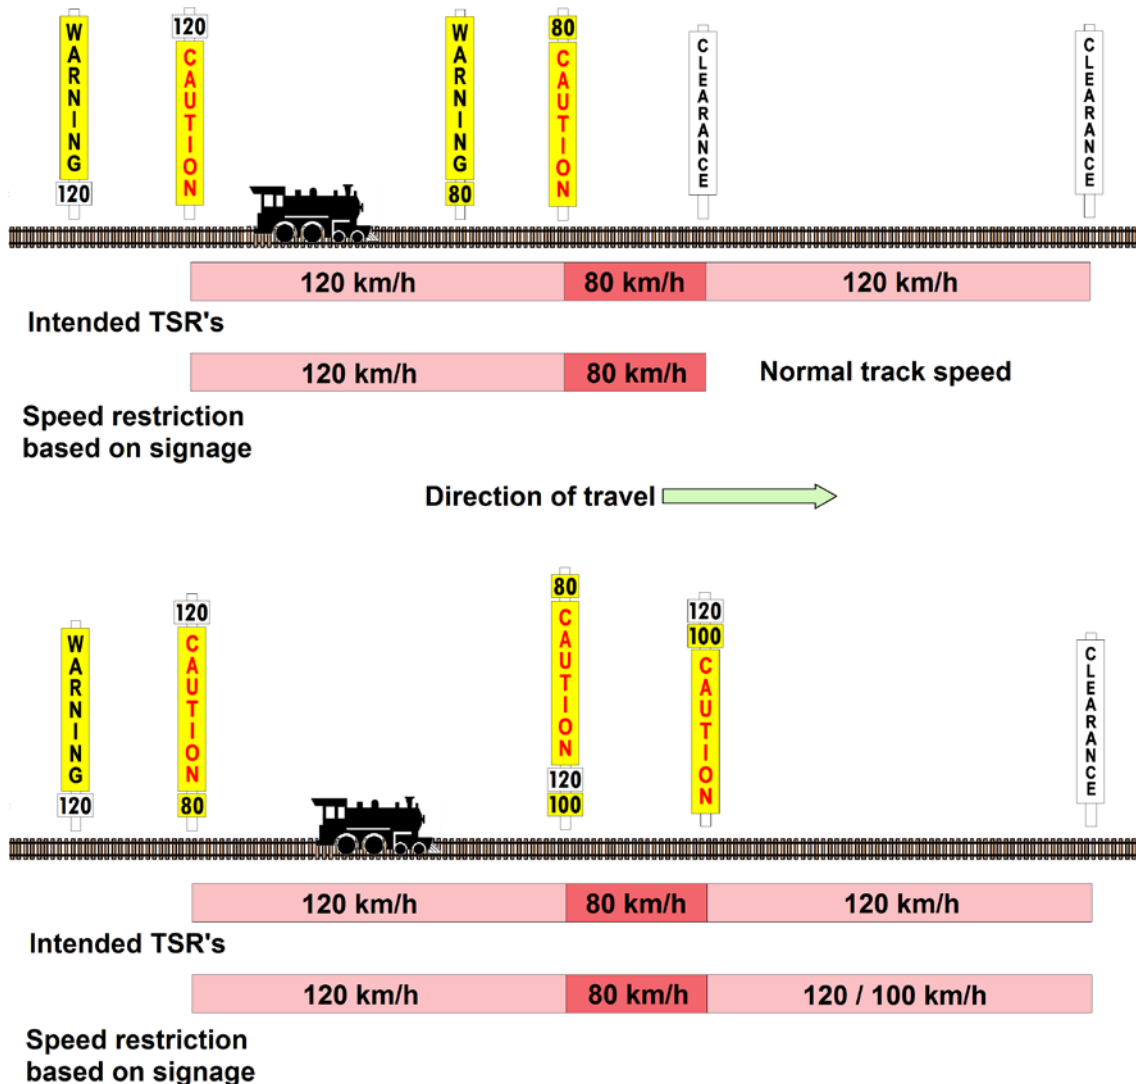
Figure 42: TSR signage between 493.900km and 514.600km

While the ARTC procedure (ANPR-713) does not provide a diagram to illustrate the configuration of signs to be used where a TSR is placed within the boundaries of another TSR, it does clearly state that the clearance sign is to be located 50 m after the 'last' speed restricted area. Based on the information provided to the ATSB, it appeared as though the second (short section) TSRs were applied without knowledge or consideration of the first (long section) TSRs.
