ATSB TRANSPORT SAFETY REPORT
Rail Safety Issue Investigation
RI-2011-015
Interim Factual

RI-2011-015

Interim Factual

**Investigation of the safety of rail operations on
the interstate rail line between
Melbourne and Sydney**

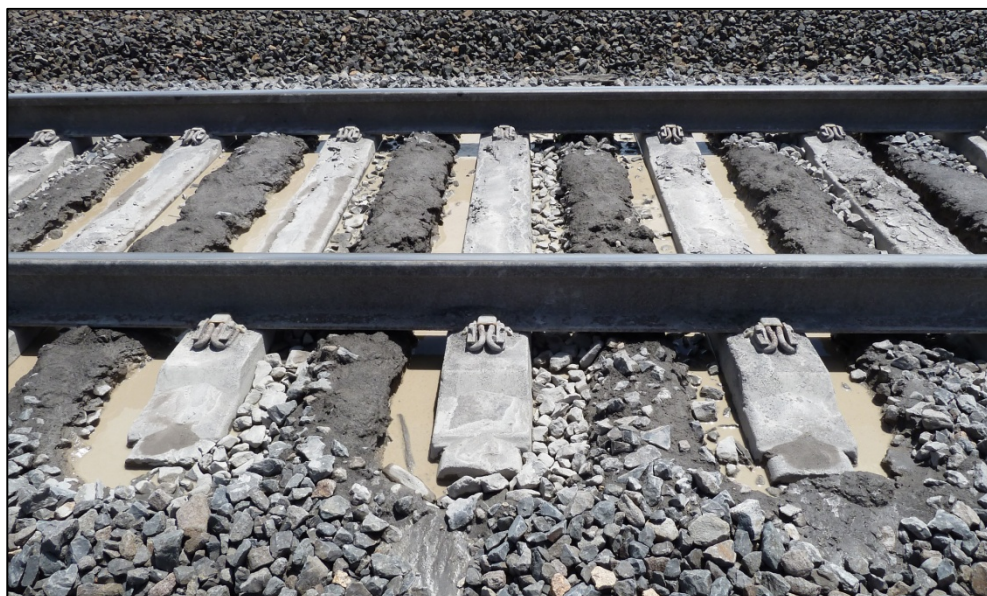
A mud-hole is a generic term used to describe a condition where the sleepers appear to be surrounded by mud rather than ballast. Mud-holes occur when the ballast becomes contaminated (or fouled) with fine materials. This can be due to poor ballast (excessive fines), a breakdown of the ballast material or the formation rising up through the ballast. The fouled ballast retains water (appears like mud), prevents effective drainage and can result in poor track geometry (Figure 2).

Figure 2: Typical mud-hole due to fouled ballast

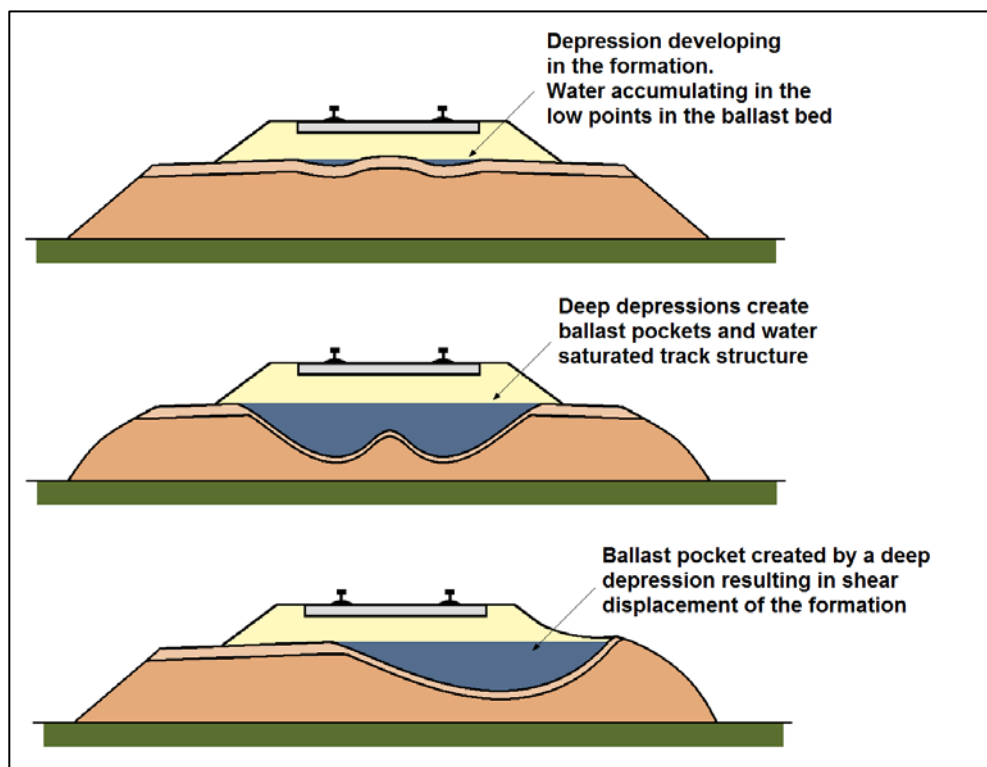
Track defects due to soft formation generally appear due to the formation's inability to support the required train load without deformation. The defect usually begins as a depression in the formation (under one or both rails) and a corresponding dip in the track. To maintain track geometry, the track is lifted and additional ballast forced under the sleepers (a track maintenance process called tamping). However, once a depression develops, water may flow to and sit in the depression. The water will gradually soak through the formation, further weakening the formation and causing the depression to deepen, creating a ballast pocket with shear displacement causing bulging of the formation shoulders (Figure 3). Additional ballast and further tamping to maintain track geometry will usually result in a continued cycle of track dips and deepening ballast pockets. The result of extensive and continuous ballast pockets is uneven, wavy track geometry. This would probably result in a rough ride unless train speeds were reduced to a level appropriate to the severity of the track condition.

Figure 3: Ballast pockets

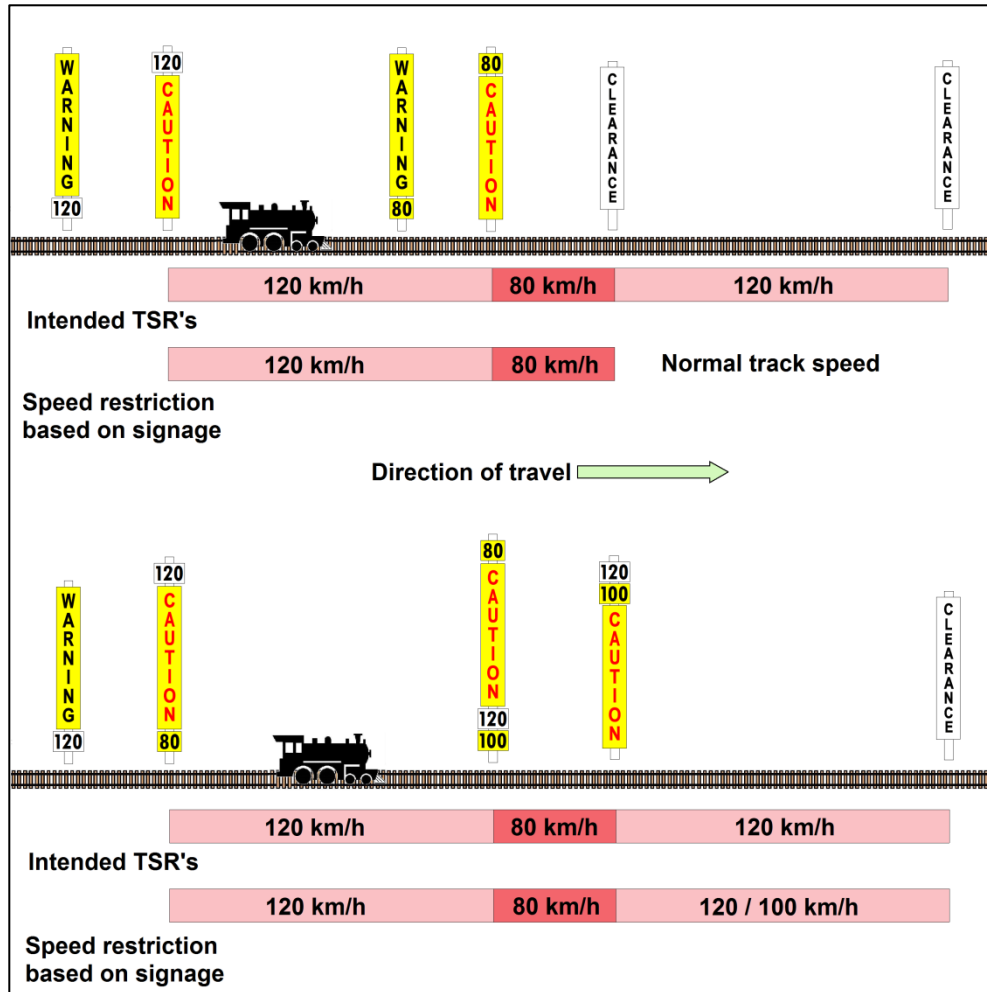
Figure 7 shows an example of the TSR signage as installed on 22 August 2011 (upper image) and an alternative layout that is consistent with the rules and procedures (lower image)¹¹. The figure illustrates how an additional clearance sign removes the speed restriction from a section of track that was intended to have a TSR limit of 120 km/h for passenger trains. The solution illustrated in the alternative layout returns the limit for XPT passenger trains to 120 km/h while also allowing freight trains to travel at up to 100 km/h.

Figure 7: TSR signage between 493.900km and 514.600km

While the ARTC procedure (ANPR-713) does not provide a diagram to illustrate the configuration of signs to be used where a TSR is placed within the boundaries of another TSR, it does clearly state that the clearance sign is to be located 50 m after the 'last' speed restricted area. Based on the information provided to the ATSB, it appeared as though the second (short section) TSRs were applied without knowledge or consideration of the first (long section) TSRs.

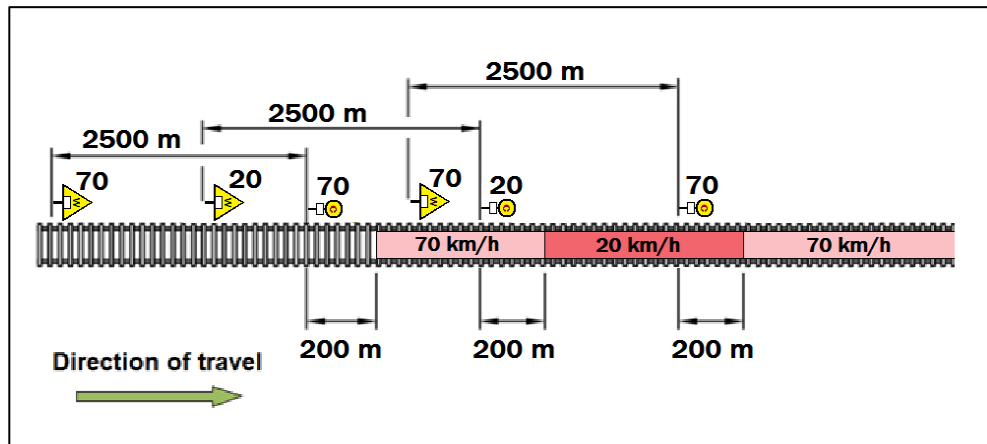
Figure 9: Multiple speed restrictions (Victoria)

Examination of TSR records found that multiple TSRs were often applied within 5 km of each other. Considering that many freight trains are over 1.5 km long, it is evident that after clearing one restriction, trains would almost reach the next. Consequently, there is limited opportunity for trains to increase speed, and if they did, rarely could they reach maximum track speed before needing to slow in preparation for the next restriction.
