Derailment of bogie on freight train 4PM6

Port Augusta, South Australia | 6 May 2011

ATSB Transport Safety Report
Rail Occurrence Investigation
RO-2011-008
Final

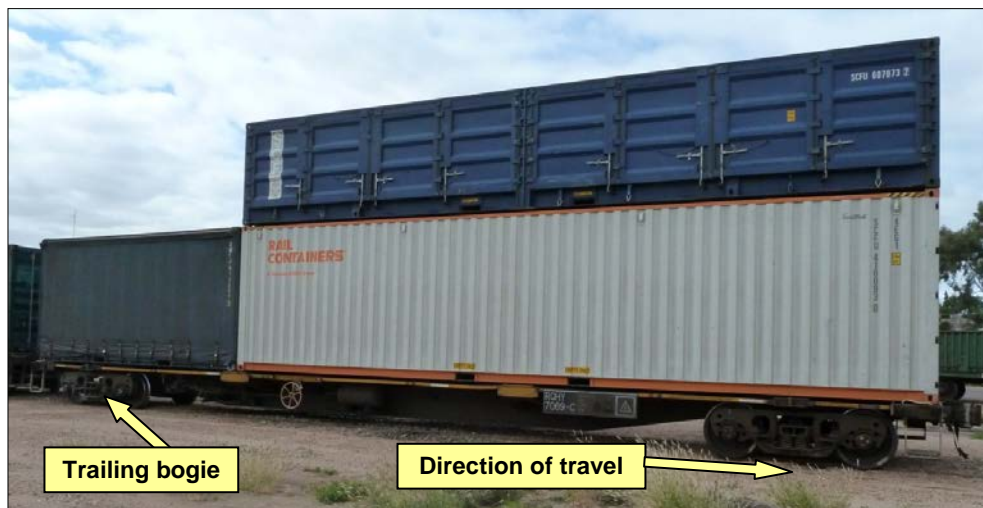
Figure 2: Loaded freight wagon RQHY 07069C following the derailment

At 2115 the driver of train 4PM6 contacted the network controller and reported that following an examination of the train, damage was visible on wagon RQHY 07069C the 47th in the consist. The driver reported that the wheels and outer bearing surfaces on the left-hand side of the trailing bogie had sustained damage from impact with the ballast, sleepers and other track components.

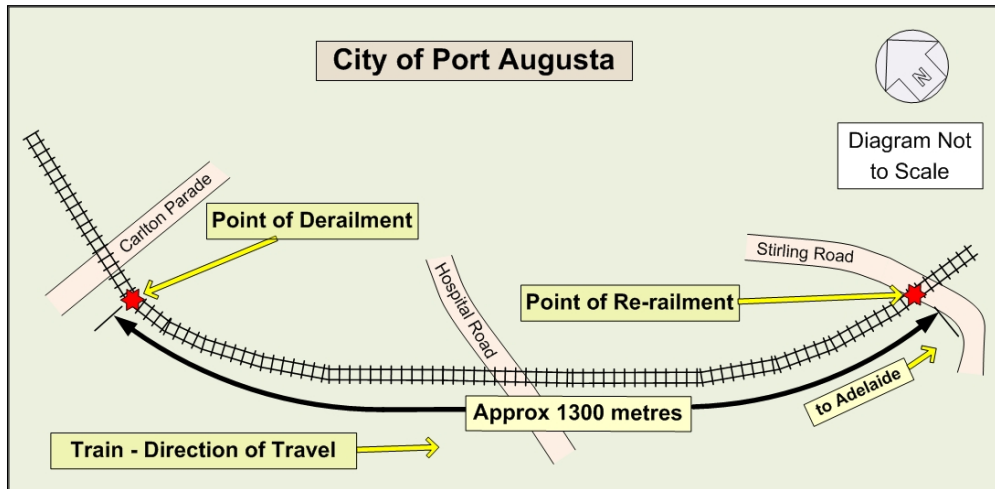
Figure 3: Diagram showing point of derailment and re-rail of wagon RQHY 07069C on train 4PM6.

At about 2016, the 47th wagon (RQHY 07069C) derailed the trailing bogie shortly after travelling over the level crossing.

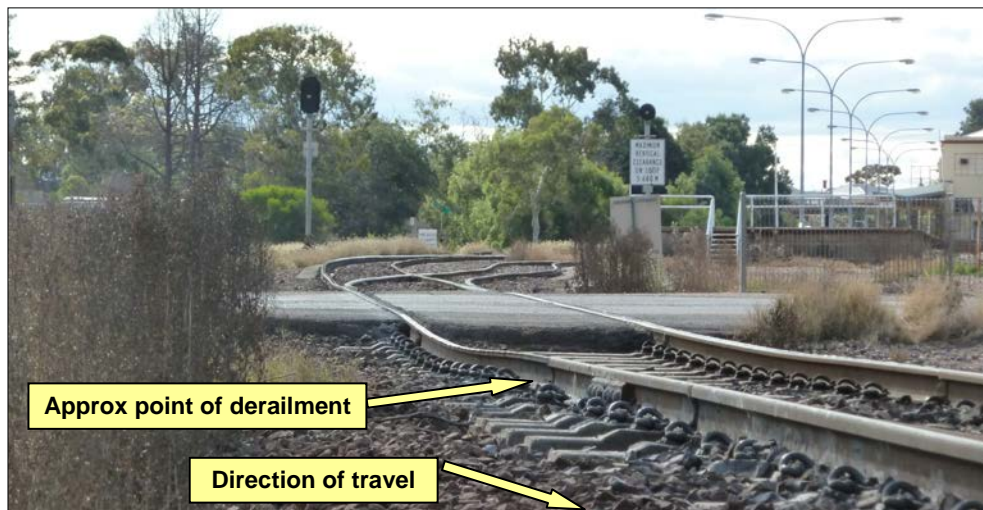
Figure 4: Track within the temporary speed restriction near the Carlton Parade level crossing.

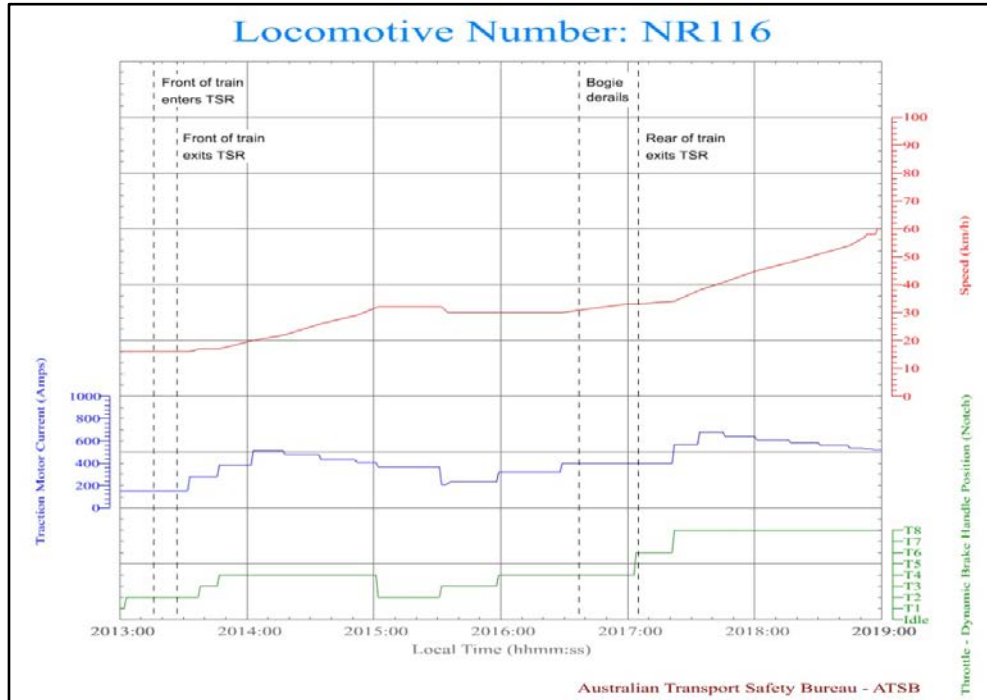
At 20:17:05, with the throttle set at notch T6, the train continued to accelerate with the rear of the train passing the 30 km/h TSR end board (91.500 km) at an average speed of 34 km/h, 4 km/h above the posted TSR. (Figure 5)

Figure 5: Locomotive NR 116 throttle position and speed through TSR

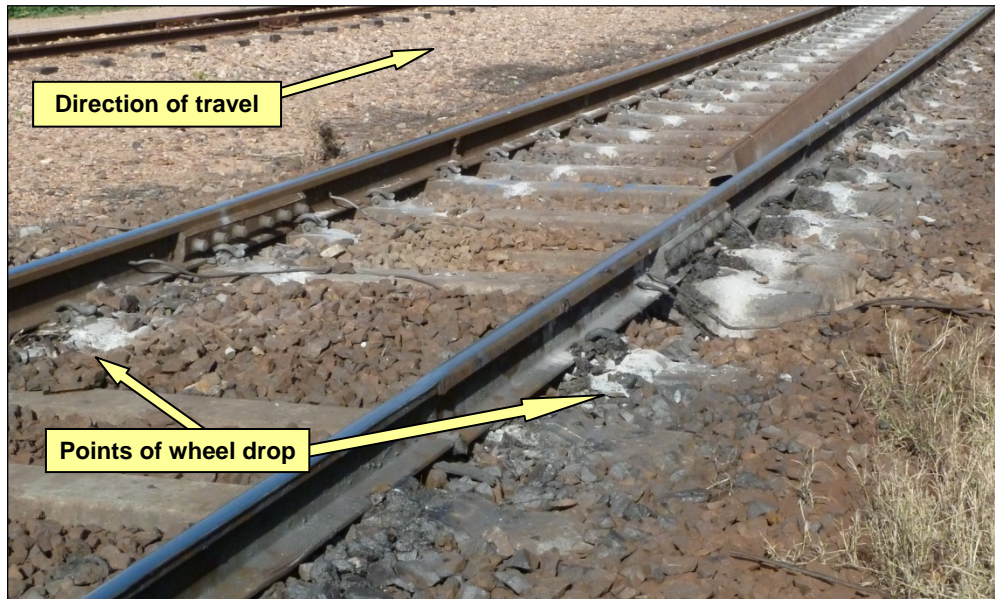
Figure 6: Witness marks on concrete sleepers resulting from contact with RQHY 07069C wagon wheels.

No wheel flange rolling contact marks were visible on the right rail head nor were there any tread marks on the left rail head. It is likely that post derailment witness marks on the rails were erased by other rail traffic following the recommencement of operations before the arrival of investigators the following day.

Near the left rail, witness marks on the sleepers had been made by the corresponding wheel flange of that axle set. Single wheel marks continued between, and to the right, of both rails towards the Hospital Road level crossing. Between the Carlton Parade and the Hospital Road level crossings, the trailing wheels of the trailing bogie had also derailed.

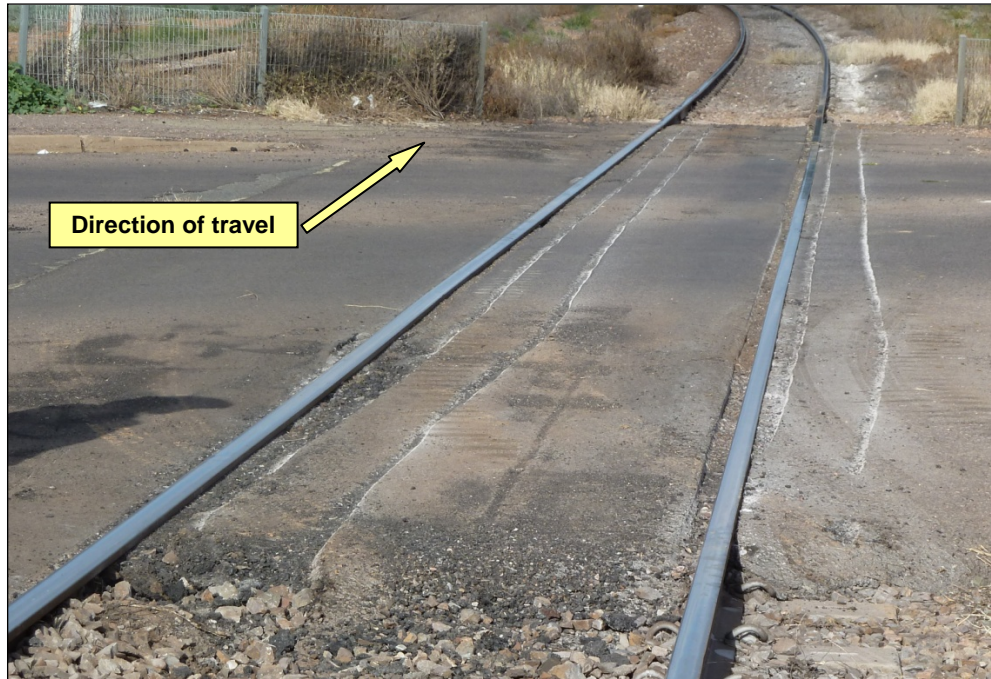
At the Hospital Road level crossing four separate rotating wheel witness marks were observed over the full width of the bitumen road surface that were running near parallel (about 400 mm apart), indicating that the trailing bogie remained skewed to the right. (Figure 7)

Figure 7: Wheel witness marks across the Hospital Road level crossing.

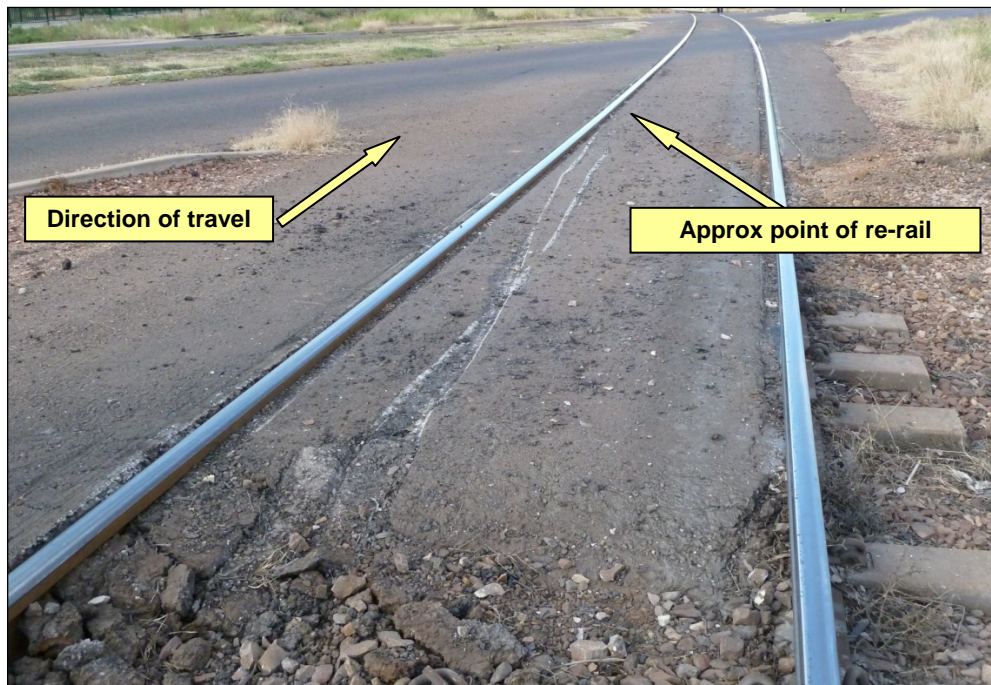
The trailing bogie remained derailed after Hospital Road and continued across the sleepers towards the Stirling Road level crossing. On contact with the raised bitumen road surface leading into Stirling Road, the bogie rotated in an anticlockwise direction and the wheels traversed the road surface progressively re-railing itself (Figure 8).

Figure 8: Wheel witness marks leading into Stirling Road level crossing

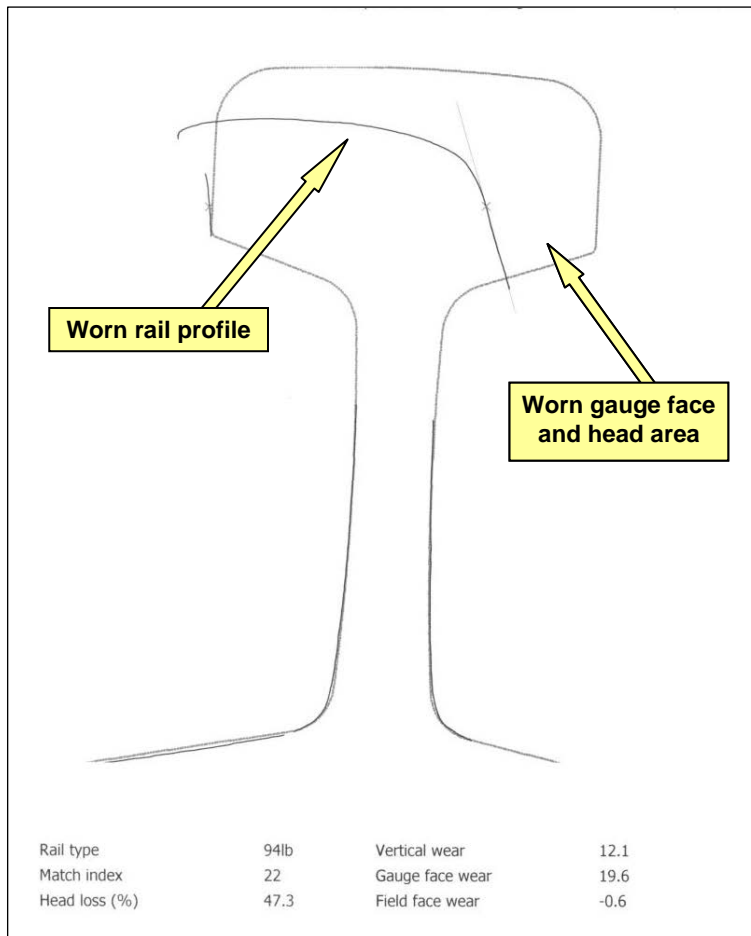
Cross section profile measurements were taken on both rails to determine the amount of wear at three locations before the point of derailment (91.549 km, 91.554 km and 91.557 km) to determine head loss, vertical wear and gauge face (rail side) wear. Visually the right rail showed a high level of metal loss from the head and gauge face surfaces. (Figure 9)

Measurements for side wear are taken 16 mm below the running surface. At the 91.557 km side wear was 19.6 mm when compared with a new rail profile.

Figure 9: Right rail profile and gauge face wear at 91.557 km

Table 1.3 of the CoP specifies that for a section of 94 lb/yd rail (47 kg/m) the loss of head area limit should be no more than 34 percent. From the rail profile taken at the 91.557 km it showed the head loss was 47.3 percent. (Figure 9)

Although the right rail had a worn profile and an excessive loss of head area, the investigation found that it was unlikely these factors significantly contributed to the derailment of train 4PM6.

Where the prescribed wear limits are exceeded a rating of the rail may be carried out taking into account local factors and applied speed restrictions. Alternatively the action should be to re-rail the affected section.
