Failure of wheel on locomotive SCT 008

near Fisher, South Australia | 28 May 2011

Rail Occurrence Investigation

RO-2011-009

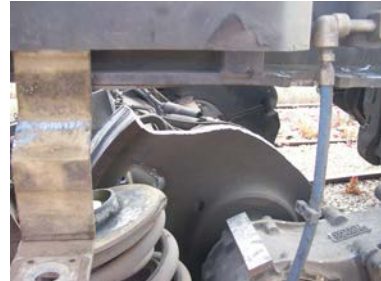
View of fractured wheel on locomotive SCT 008

The investigation found that a fatigue crack had initiated at a small indentation on the inside of the wheel rim and then radiated towards the flange and tread regions before the wheel completely failed.

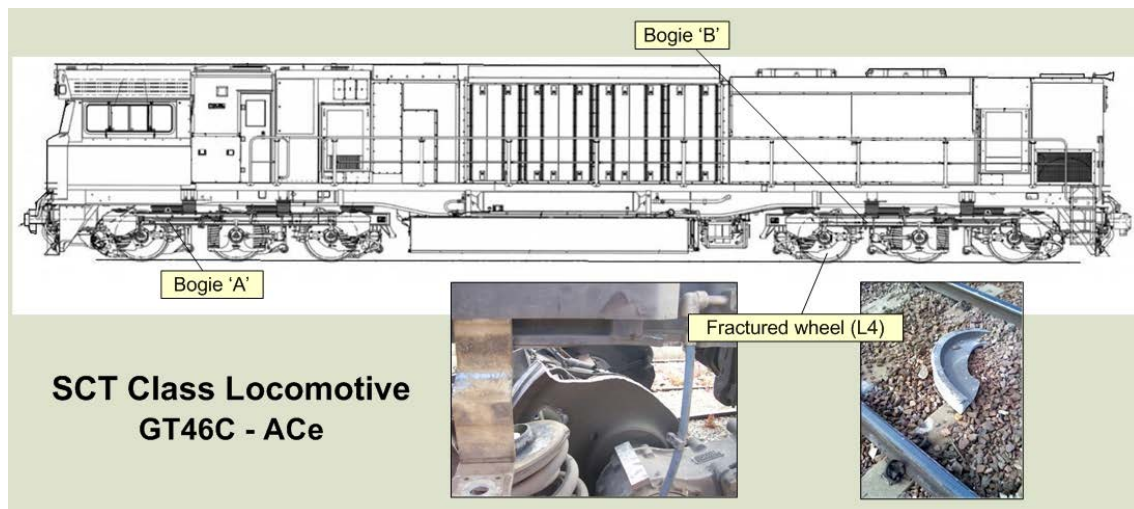
Figure 1: Diagram showing position and fractured components on SCT Class locomotive

The driver made a brake application and 1 minute and 40 seconds later brought the train to a stop near the 851.500 km mark. An inspection of the lead locomotive by the train crew revealed that the left wheel on the leading axle in the trailing bogie (L4³) had failed catastrophically (Figure 1). The train had travelled about 1976 m after the failure of the wheel.

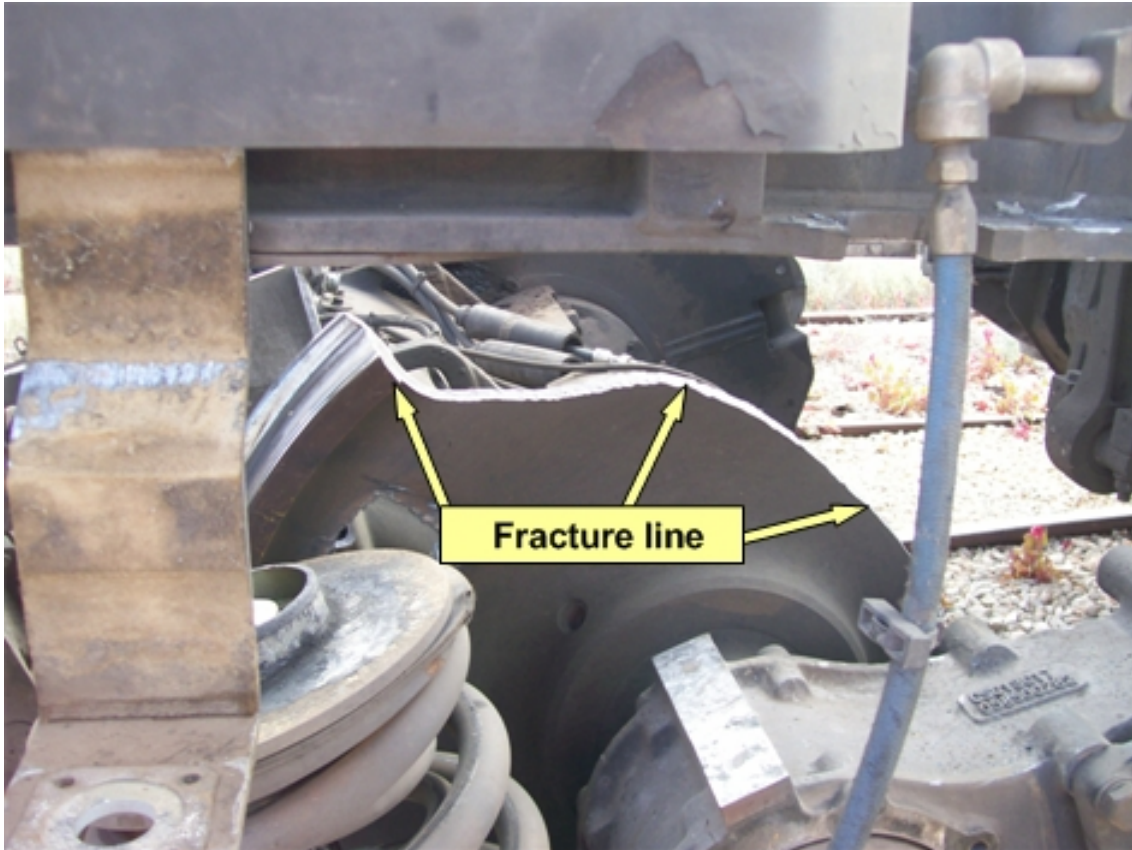
Figure 2: SCT 008 fractured locomotive wheel L4 in situ

Locomotive maintenance workers were despatched from Port Augusta to carry out temporary repairs. They arrived on site about 10 hours after the incident. After being uncoupled from the train, locomotive SCT 006 was used to push locomotive SCT 008 at low speed into the crossing loop at Fisher. Locomotive SCT 006 was later re-coupled to the remaining portion of the train near the incident site and departed at 1924 on Sunday 29 May 2011.

Locomotive SCT 008 was temporarily repaired while stabled on the crossing loop at Fisher and the damaged traction motor wheel/axle assembly was removed and replaced with a working axle/wheel set. On Thursday 2 June 2011 the locomotive was attached to SCT train 4PM9 whereupon it travelled to Port Augusta for further repairs.

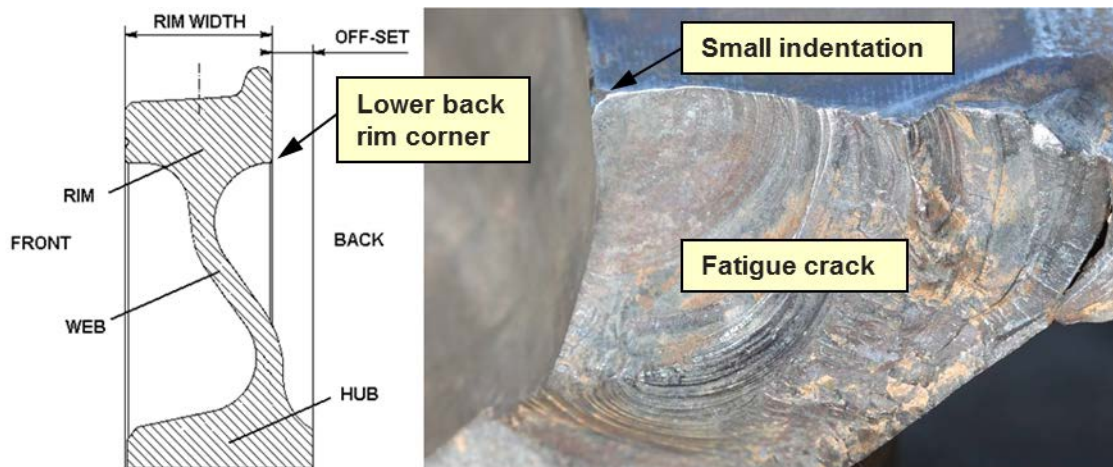
Figure 3: Wheel terminology and small indentation

It was concluded that the failure of wheel L4 resulted from a fatigue crack that initiated on the lower back rim face corner at a small indentation measuring about 1 mm in depth⁵ (Figure 3). The crack had propagated towards the wheel flange and tread regions before the wheel catastrophically failed in overstress. The failure of wheel L4 was considered to have occurred primarily under the influence of stresses developed as a result of mechanical loading during service. Surface damage was observed at four other locations around the circumference of the rim, probably as a result of operational use or maintenance handling activities, however, no other crack defects were found in the wheel.

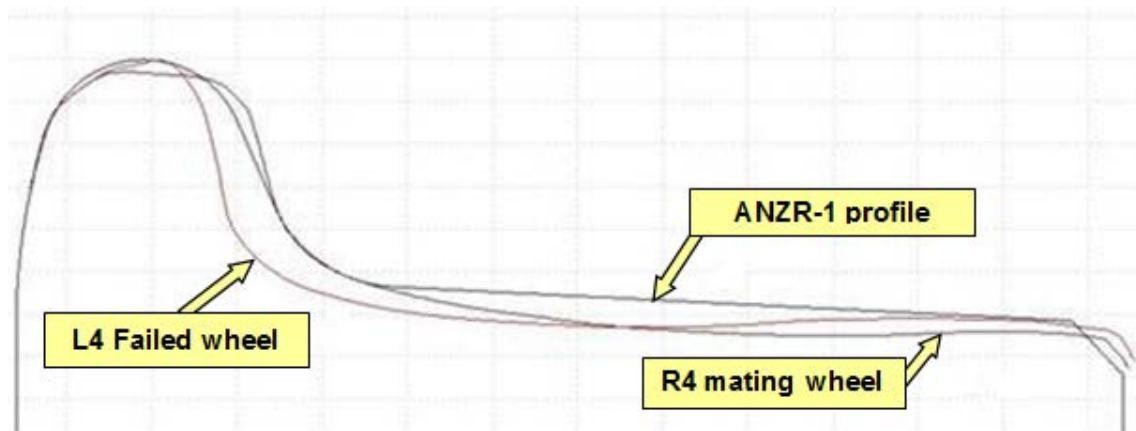
Figure 4: Locomotive SCT 008 overlaid profile comparisons of wheels L4 and R4 with ANZR-1 reference profile

SCT 008 wheel profiles for the failed and mating wheels were measured using a Miniprof®⁸ instrument and these dimensions were each overlaid and compared with the original ANZR-1 profile. The traced profiles (Figure 4 and 5) showed that there was an increased level of wear on the wheel flange of failed wheel L4 when compared to the mating wheel R4. Flange thickness measurements showed that L4 was 22.5 mm thick and had worn 5.4 mm more than R4 (27.9 mm). The reduced flange thickness of wheel L4 was however greater than the minimum thickness and specified condemn limit of 19 mm. DEDI reported that about 20% of the SCT class fleet have wheels with reduced flange thicknesses.

The increased level of flange wear on L4 indicated that there was an asymmetrical tracking bias⁹ estimated to be about 19-20 mm towards the flange of wheel L4. DEDI indicated this may have been caused by slight variances in wheel diameter (for wheels mounted on the same axle) as a result of the machining and measurement accuracy of the wheel lathe. Reports by DEDI and the IRT noted that the "... in-service loading conditions which resulted in increased flange wear may have also contributed to the high stress levels in the rim". The ATSB found no additional evidence to indicate that the increased flange wear contributed to the failure of the wheel on SCT008.

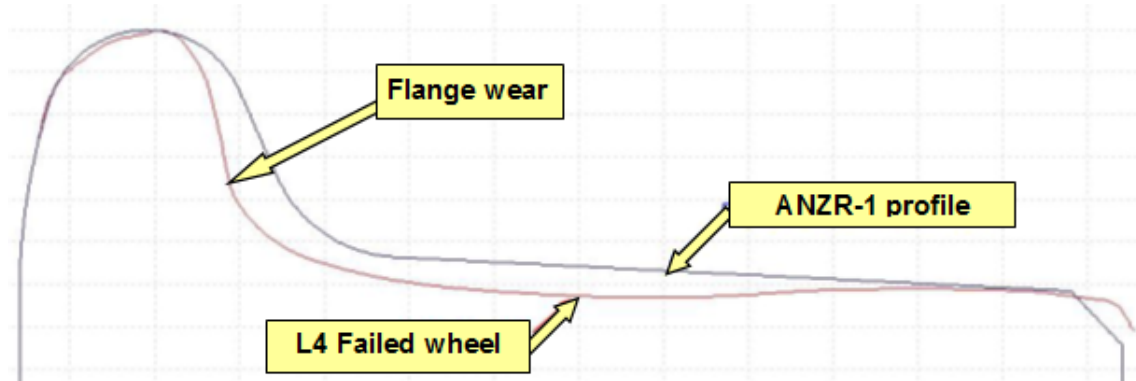
Figure 5: Locomotive SCT 008 overlaid profile comparison of wheel L4 and with ANZR-1 reference profile showing greater flange wear

The maintenance record for SCT 008 showed that on 30 January 2010 the wheels on ‘A’ bogie (axles 1, 2, 3) were machined for tread hollowing and wheels on the ‘B’ bogie (axles 4, 5, 6) were machined for flange restoration. The differing wheel wear types that were specific to each bogie were indicative of a tracking bias and the asymmetrical flange wear found on the wheels of the ‘B’ bogie.

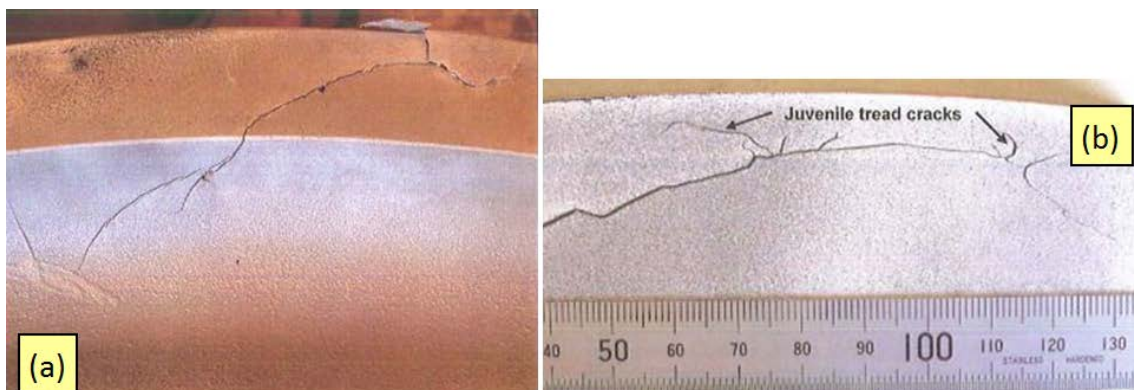
Figure 6: SCT 006 magnetic particle indications (a) - at rim and transition face. (b) – juvenile cracks branching towards wheel tread

During routine maintenance on locomotive SCT 006 in June 2010, wheel L3 was found with a fatigue crack that had initiated from an inclusion located 8 mm below the tread surface. The crack was about 180 mm in length radiating towards the hub (Figure 6). No other cracks were identified within the wheel.

- The wheel rim was well above condemning thickness.
- Ultrasonic scans of the wheel rim, web and boss found no additional internal defects.
- The rim hardness was within the specified Brinell¹² hardness range.
- The crack originated 8 mm below the wheel tread surface and 55 mm from the rim face.
- Circumferential cracking at the tread extended for about 140 mm and progressed to a depth of about 75 mm from the rim face.
- Fatigue was the cracking mechanism as the wheel had been subjected moderate levels of cyclic stresses.
- It was likely that with wheel wear the defect came closer to the rolling contact stress zone and the fatigue cracking was initiated.
- The internal fatigue crack originated from a material defect that was probably present in the steel billet prior to the manufacture of the wheel.

The material analysis of wheel L3 for chemical composition, hardness and microstructure revealed that it generally conformed to AAR M201 Class B¹³ however metallurgical defects had contributed to the fatigue cracking within the wheel.

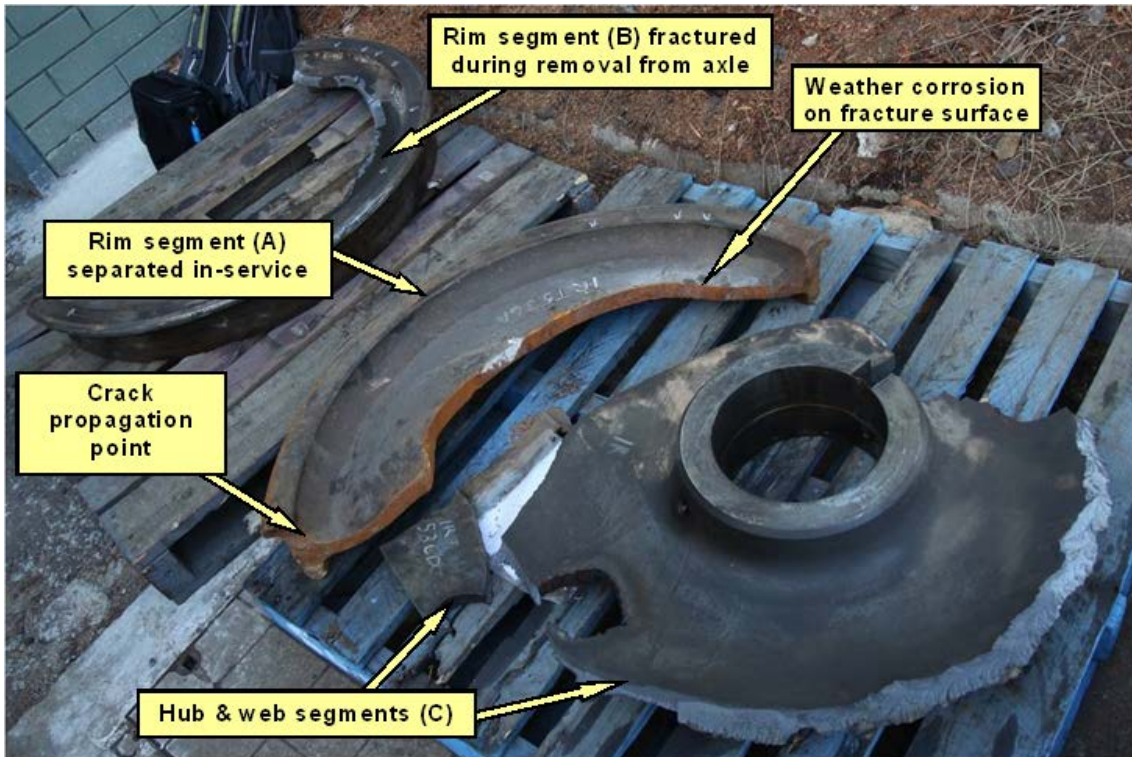
Figure 9: SCT 008 fractured wheel L4 (ID# 21052) after removal from the axle

The first segment that separated from wheel L4 comprised about 50% of the wheel circumference (Segment A in Figure 9). This piece was recovered from the centre of the track near the point of failure near Fisher, SA.

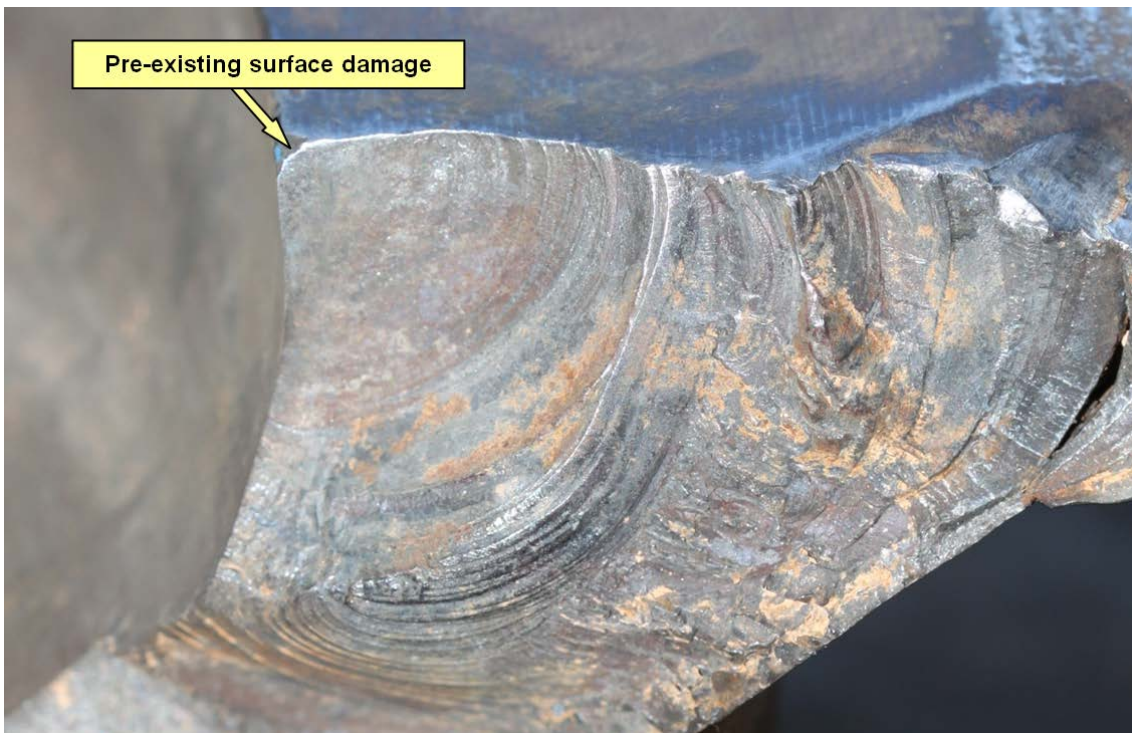
Figure 10: Detached section (A) showing pre-existing surface damage on corner of back rim face and radial propagation point of the fatigue crack

The separated segment (A) showed significant corrosion on the fracture surface. However this was associated with post event weather exposure and had not contributed to the failure of the wheel.

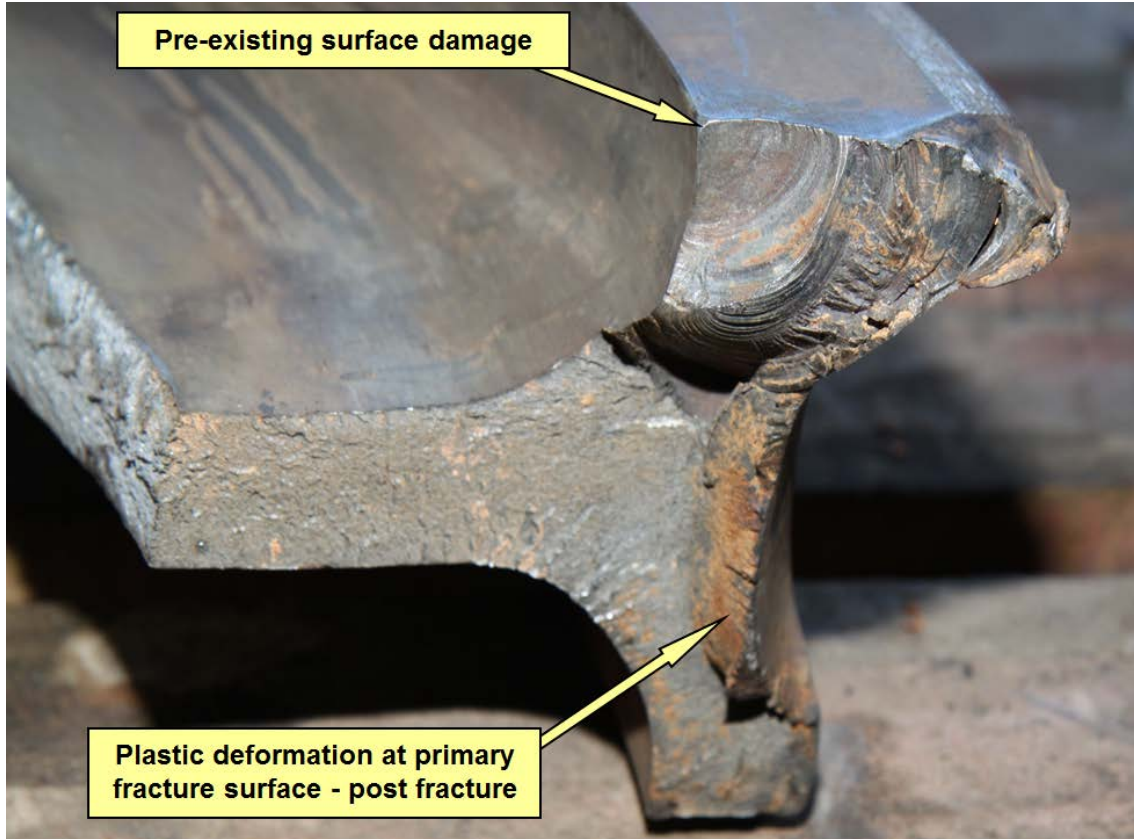
Figure 11: Detached section (A) showing pre-existing surface and post fracture damage

- A small indentation on the lower back rim face corner of wheel L4 acted as a fatigue crack initiation point.
- Wheel L4 fractured due to the initiation and propagation of a fatigue crack. After the crack had grown to critical size, the wheel was unable to sustain the operational stresses, resulting in an overload of the remaining section which caused a complete fracture and disintegration of about half of the wheel disc and rim.

A large fatigue crack on the primary fracture surface had initiated from the lower back corner of the rim face (Figure 11) where there was evidence of pre-existing surface damage in the form of a small indentation measuring about 1 mm in depth (Figure 10 and 11). The indentation was visible on both pieces of the fractured rim.

- Increase the level of visual inspections at wheel turning and during scheduled maintenance intervals, principally for evidence of impact damage.
- Perform ultrasonic testing at each wheel machining after travelling 400,000 km, principally for evidence of cracking .
- Where integral ultrasonic testing facilities are not available at wheel machining facilities, testing should start after midlife of the wheel when risk of wheel cracking increases.

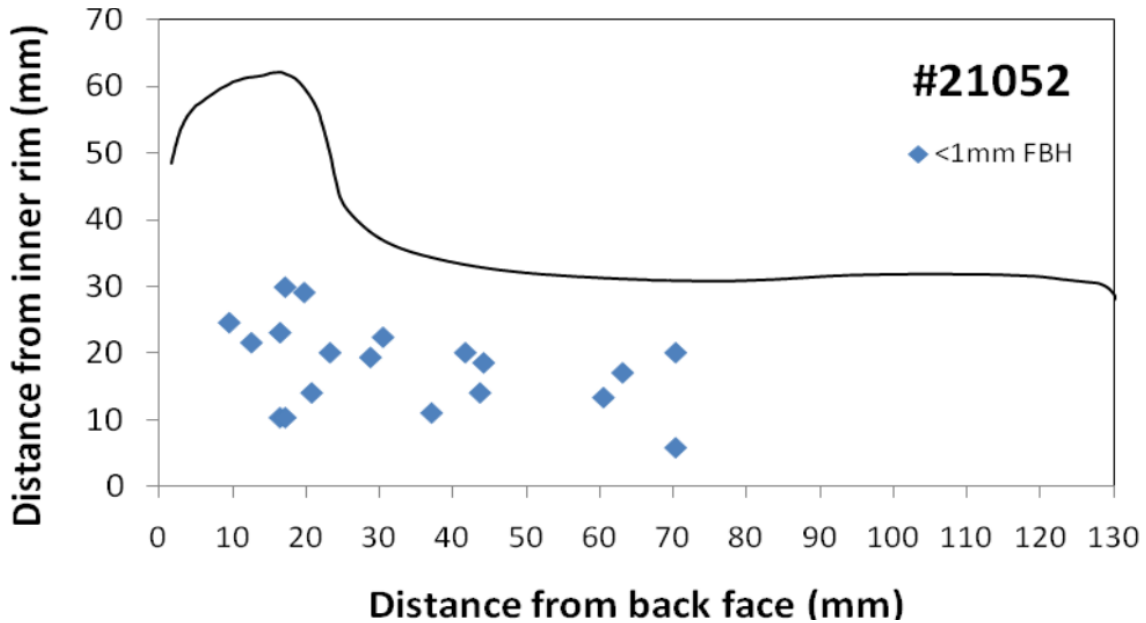
Figure 12: Distribution of ultrasonic reflections on failed wheel L4 (#21052)

The IRT ultrasonically scanned SCT 008's rims on wheels L4 and R4 every 1.4 mm of rim circumference and the results were assessed against the AAR standard M-107/M-208¹⁷. Failed wheel L4 showed a small number reflections that were less than 1.0 mm in size¹⁸ and these were within the acceptance criteria (Figure 12).

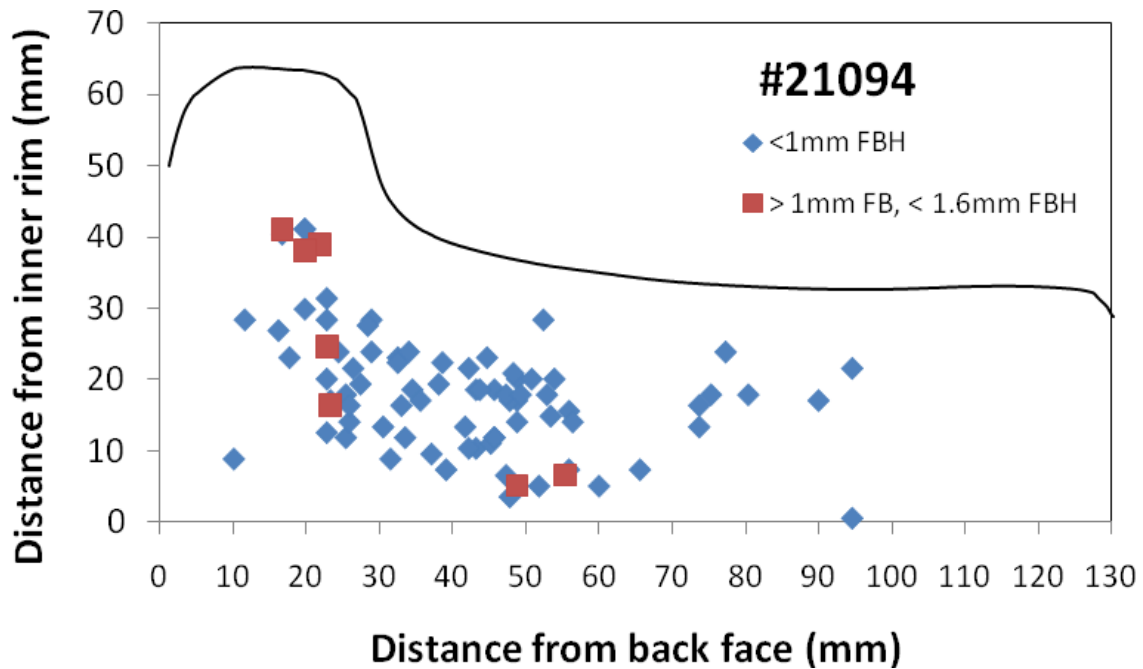
Figure 13: Distribution of ultrasonic reflections on mating wheel R4 (#21094)

Mating wheel R4 contained a greater number of reflections below the 1.0 mm size and a small number between 1.0 mm – 1.6 mm in diameter (Figure 13).

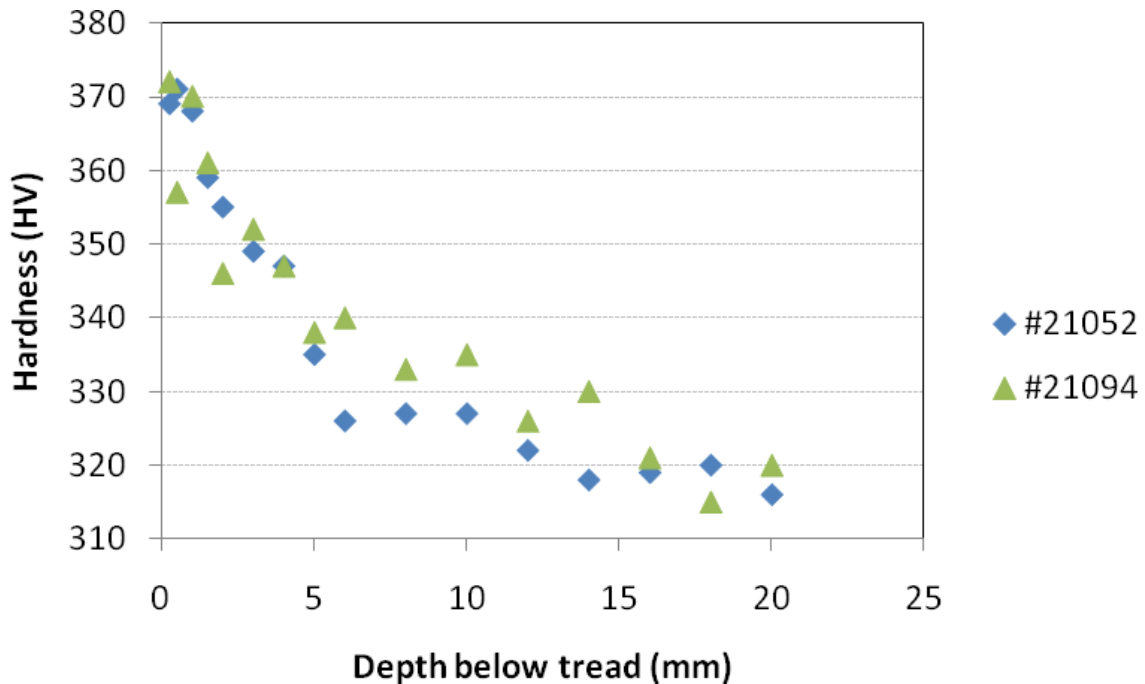
Figure 14: Distribution of hardness (Vickers 10 kg) for wheels L4 and R4

Tensile tests were carried out on specimens of L4 and R4 rim sections. Measurements were taken about 15 mm below the worn tread surfaces and results were slightly below the specified minimum values. This was expected, due to the location of samples on the worn wheel when compared to that specified for a new wheel.
