# Derailment of train 7SP5

between Caragabal and Wirrinya NSW | 23 October 2011

**ATSB Transport Safety Report**  
Rail Occurrence Investigation  
RO-2011-017  
Final – 14 March 2014

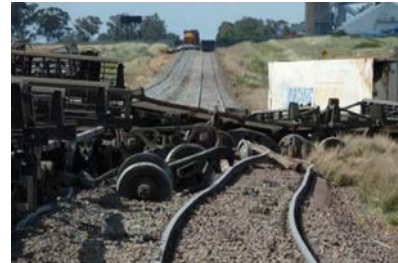
### Wirrinya derailment site

The train crew were not injured. The last six wagons (all of which were multiple platform type) derailed. The derailment caused significant damage to the track and the turnout at Wirrinya.

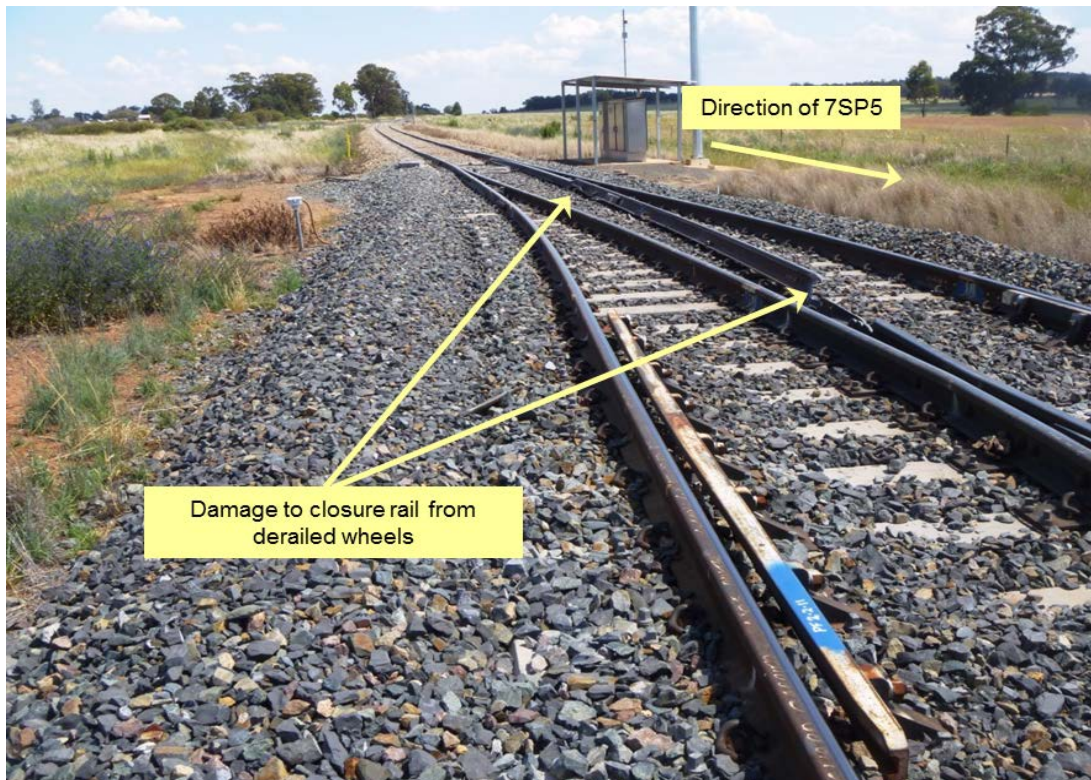
**Figure 1: Damage to turnout at southern end of Wirrinya**

Shortly after passing through Caragabal, the leading bogie of the 42nd wagon (RRAY07178) derailed at the 538.598 km location. Train 7SP5 was running at 103 km/h (12 km/h below the posted track speed). Setting this speed was the last change to throttle/brake controls prior to the derailment and was done 2 minutes before the bogie derailed by stepping the throttle up from notch 6 to notch 8. The drivers did not notice the derailed bogie, which ran in the derailed state for approximately 15 km until it reached the turnout<sup>1</sup> at the southern end of the Wirrinya crossing loop (553.443 km) (Figure 1).

The derailment damaged the concrete sleepers along the 15 km section of track between the derailment point at the 538.598 km and the southern end of Wurrinya. The turnout and approximately 400 m of track on the loop and main line were damaged.

Staff from Pacific National, the Australian Rail Track Corporation (ARTC), Transfield Services, the Office of Transport Safety Investigations (NSW), and the ATSB attended the site to investigate. The damaged turnout was removed and repairs undertaken on the damaged loop track. The mainline was slewed across to the loop to allow re-opening of the track on the evening of 25 October 2011, two days after the derailment.

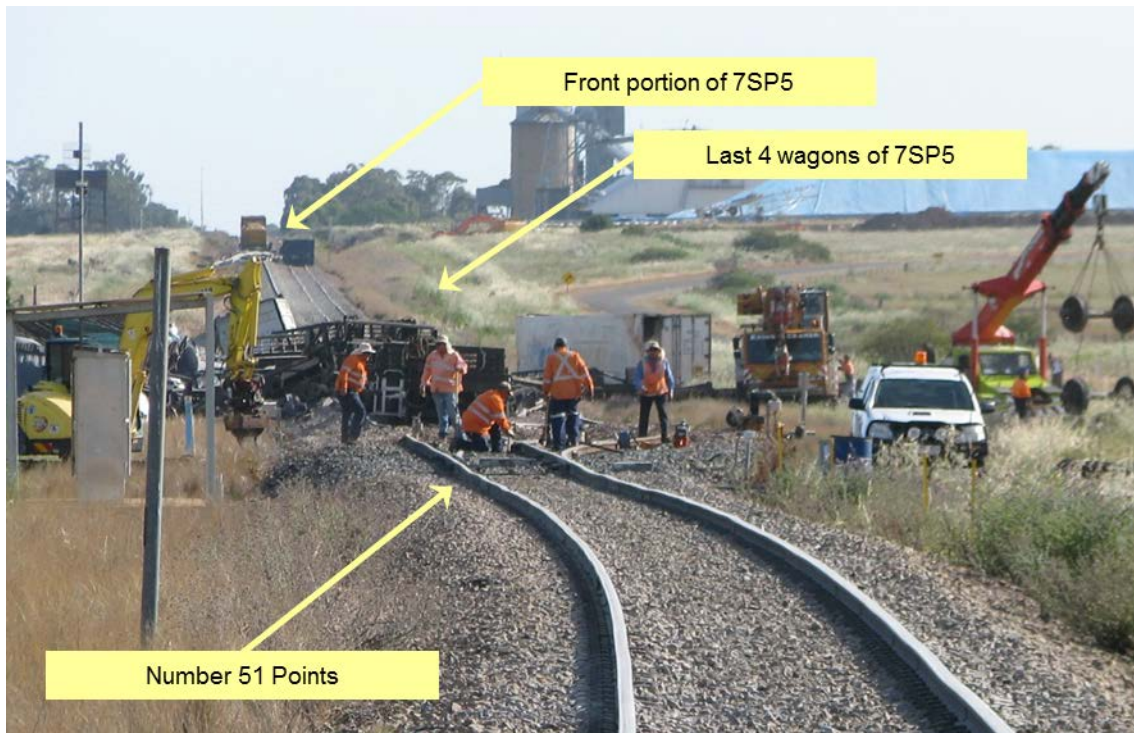
**Figure 2: Derailment at Wurrinya showing front and rear sections of train 7SP5**

Lateral movement of derailed wagon RRAY07178 caused the trailing bogie of the wagon in front (RRAY07256) to also derail, but the bogie remained connected under the wagon. As the train continued, the dislodged bogie and wheel-sets (wagon RRAY07178) stripped the remaining five bogies from under RRAY07178 and caused its load to be dislodged. The four wagons trailing RRAY07178 were all RKKY wagons which detached from the train, derailed and piled up on top of each other at the southern end of Wurrinya (Figure 2).

Train 7SP5 continued to slow as it travelled along the main line through Wurrinya, dragging the bogie-less wagon RRAY07178. As the train came to a stand at the northern end of Wurrinya (about the 555.940 km location), the container on the last platform of RRAY07256 fell from the wagon onto the adjacent loop track (Figure 3). In total, the last six wagons of train 7SP5 derailed and a number of containers were thrown from their respective wagons.

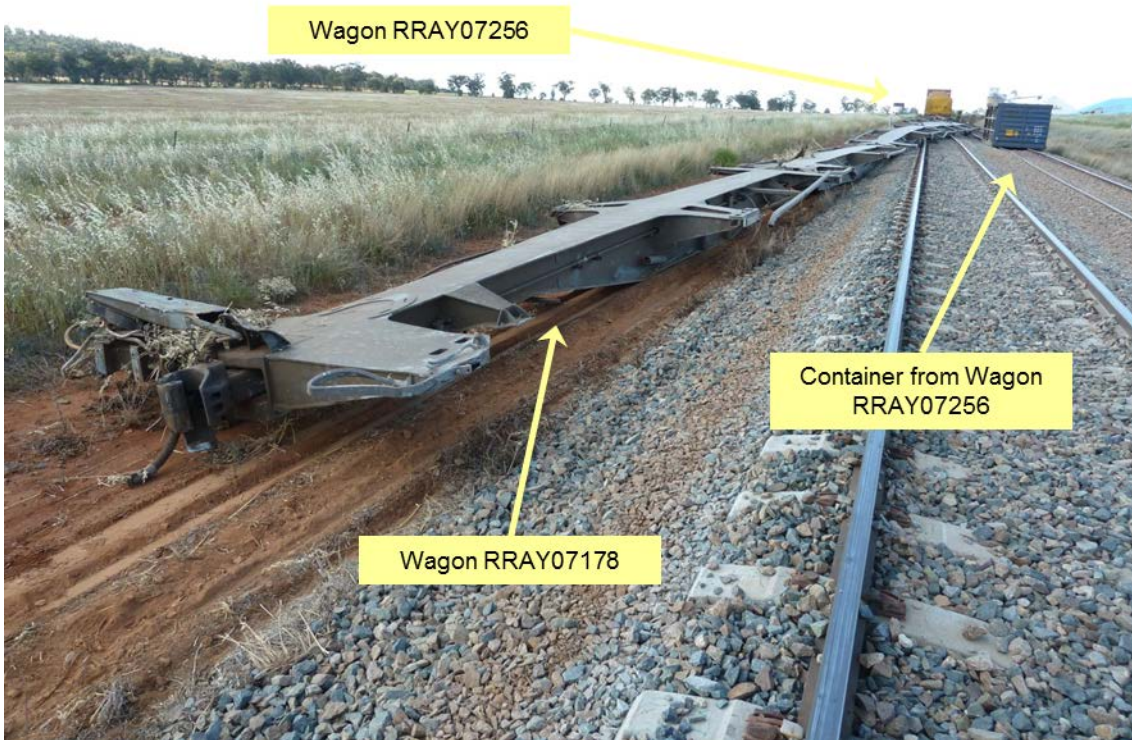
**Figure 3: Derailed wagons at northern end of Wirrinya**

ATSB investigators examined the derailment site and found the front portion of the train at the northern end of Wirrinya with the last two wagons of this section of train derailed (RRAY07256 and RRAY07178). The last four wagons of the train (RKKY wagons) had detached and were derailed approximately 200 m north of the turnout at the southern end of Wirrinya. The derailed wagons had suffered varying degrees of damage (Figure 5) with their components scattered across the rail corridor. The containers from wagon RRAY07178 were found lying adjacent to the RKKY wagons.

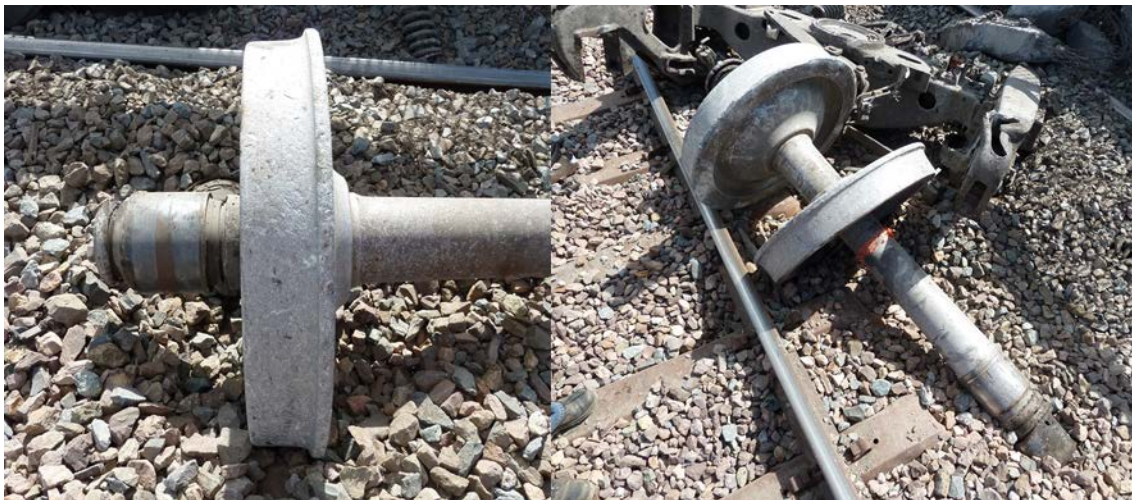
**Figure 6: Wheels from southern end of Wirrinya with damage indicative of having run derailed for some distance**

Both tracks (the main line and the crossing loop) at the southern end of Wirrinya were significantly damaged with the damage leading back to the mainline turnout (number 51 points). Witness marks and the damage to number 51 points indicated that, when entering the turnout, two wheel-sets were already derailed.

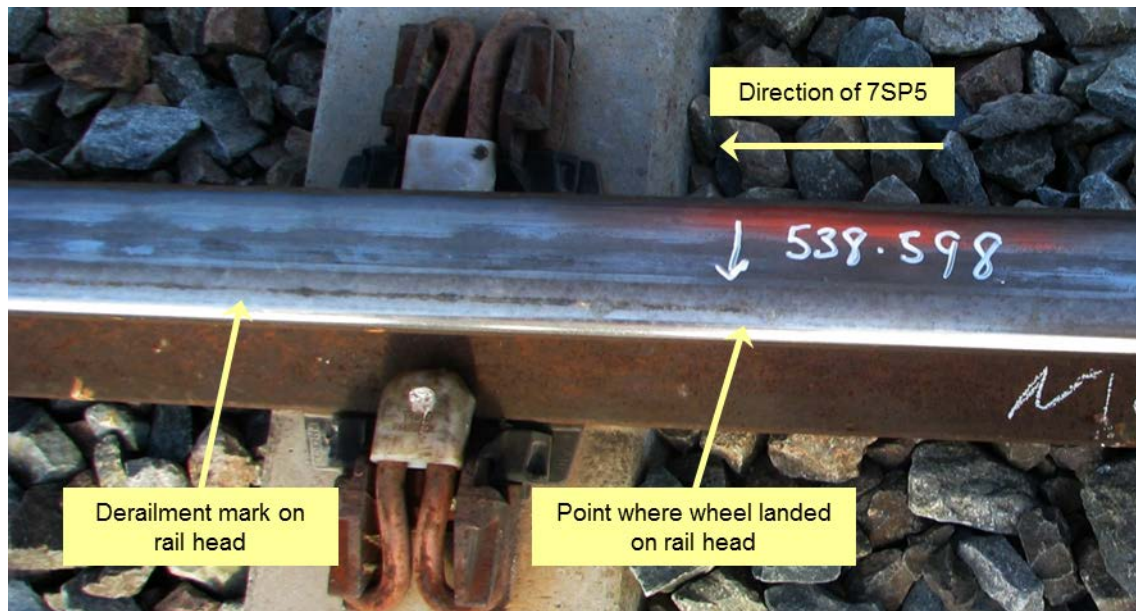
Figure 8: Derailment marks on right-hand rail at 538.598 km

The first derailment witness mark (caused by a wheel flange) was found on the head of the right hand rail approximately 4 m past the track dip. The witness mark started about 12 mm in from the gauge face and extended for about 6.5 m along the rail before ending on the field side<sup>5</sup> of the rail (Figure 8), followed by rail wheel witness marks on the sleepers and in the ballast. The marking indicated that a wheel had unloaded, lifted off the rail, and landed with its flange on the head of the right-hand rail. This wheel then ran along the head the rail, dropping off on the field side of the rail and onto the right-hand sleeper ends, causing the left hand wheel to drop into the four-foot.<sup>6</sup>

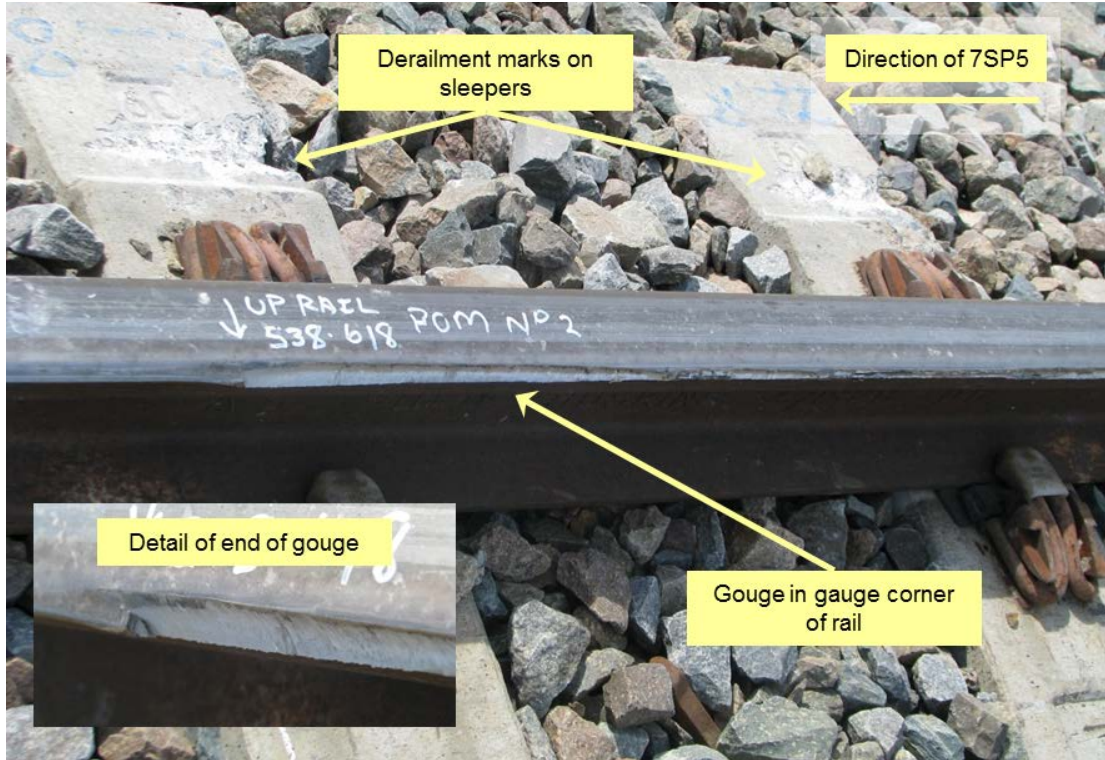
**Figure 9: Gouge in right-hand rail**

Approximately 15 m after the first witness mark a gouge mark was evident on the gauge corner of the right hand rail (Figure 9). The gouge ran for about 5 m, progressively increasing in depth, along the gauge corner, leading to a mark over the rail head that ran to the field side of the rail. The markings lead to second pair of marks on the sleepers and ballast. It was evident that, with

the first wheel-set running with one wheel on the right-hand sleeper ends and one in the four-foot, the bogie had yawed, steering the trailing wheel-set (on the same bogie) so that the front of the flange on the right-hand wheel was running against the gauge face of the right-hand rail. This wheel-set had remained railed for a short distance and continued to attack the gauge face of the right-hand rail. It then climbed over the rail, following the first wheel-set onto the sleepers approximately 26 m after the dip in the track.

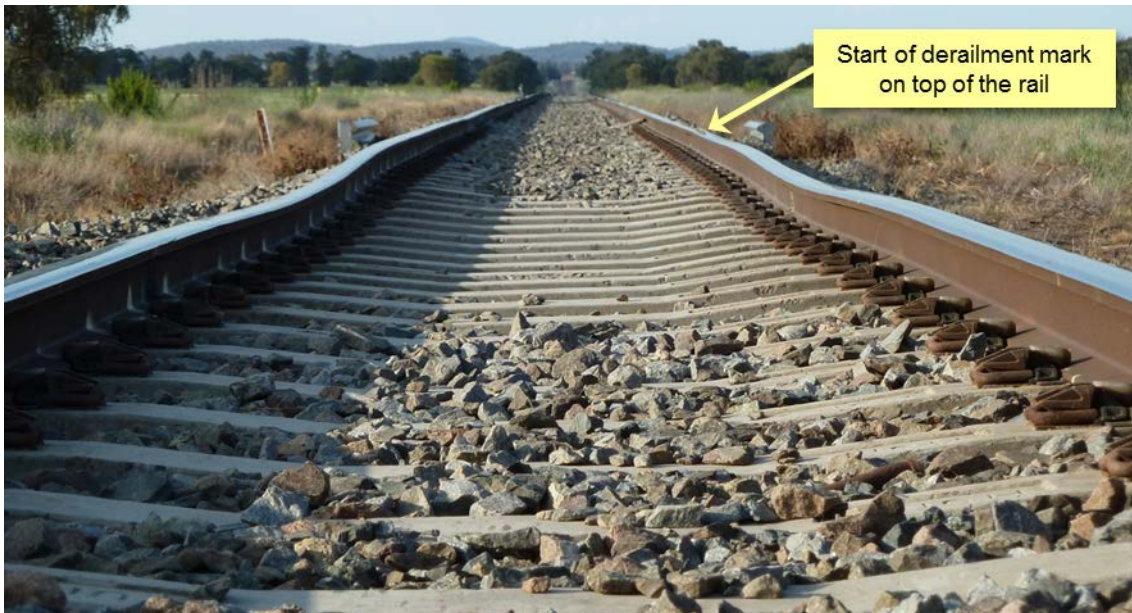
**Figure 10: Track dip at the 538.588 km mark looking in the direction of travel**

The ATSB examined the point of derailment and the dip in the track which extended over a distance of approximately 10 m. Through the dip, the ballast profile (both shoulder and crib) was noticeably reduced compared to the track on either side (Figure 10). On the southern side of the formation there was evidence of heaving or movement to the side of the formation fill material (Figure 11).

Post-derailment observations found that the ballast profile through the dip (both shoulder and crib) was noticeably reduced compared to the track on either side of the dip. There was also evidence of heaving or movement within the formation fill material on the southern side of the formation, an indicator that the formation had subsided under the track. These are indicators of localised formation weakness resulting in an inability for the formation to support the track structure above.

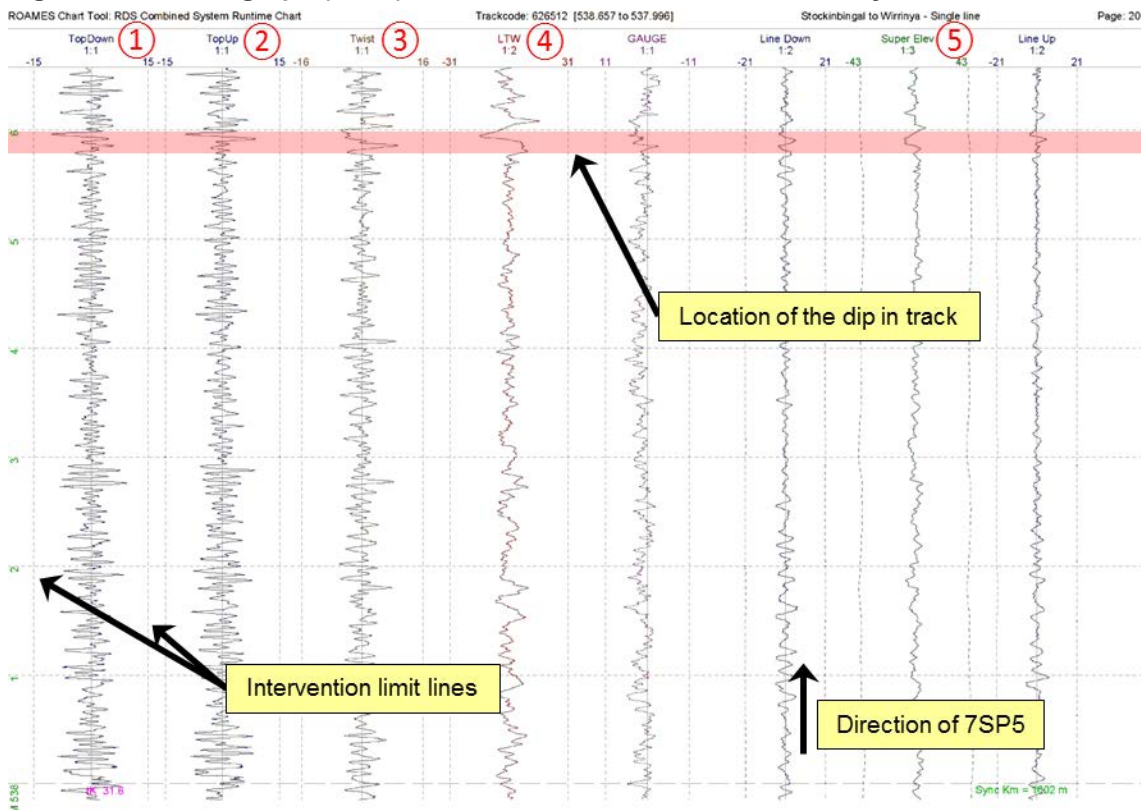
**Figure 12: AK Car graph (chart) from 538.000 km to 538.650 km – July 2011**

The red band on Figure 12 shows the location of the dip in the track that was found at the 538.598 km mark. The top (vertical alignment), gauge, line (horizontal alignment) and super elevation graphs near the track dip are generally consistent with the graphs on the rest of the page. There are no points on the graph that would have resulted in them being listed on the AK Car exception report for follow-up inspection or action. There are minor spikes in the twist and long twist plots but neither has reached a level that would warrant immediate action.

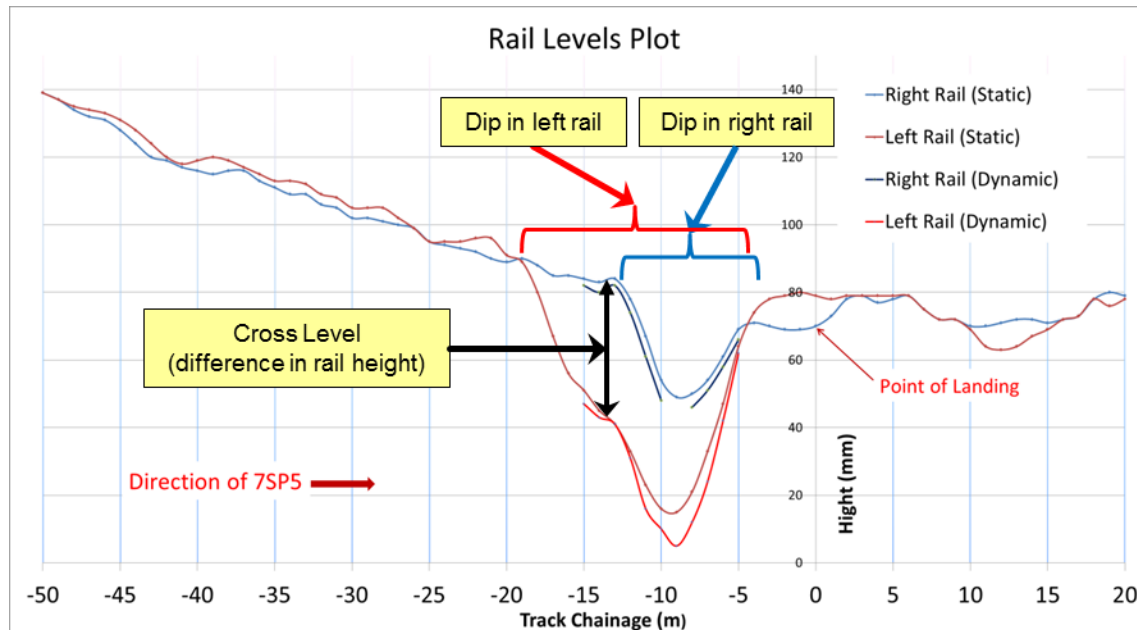
**Figure 13: Plot of rail levels taken by investigation team after derailment**

An asymmetrical shape is evident for the dip with the left hand rail dropping before, and deeper, than the right hand rail. What is also apparent is how steep the ramp is on the left hand rail climbing out of the dip and where the wheel landed relative to the dip (illustrated in Figure 13).

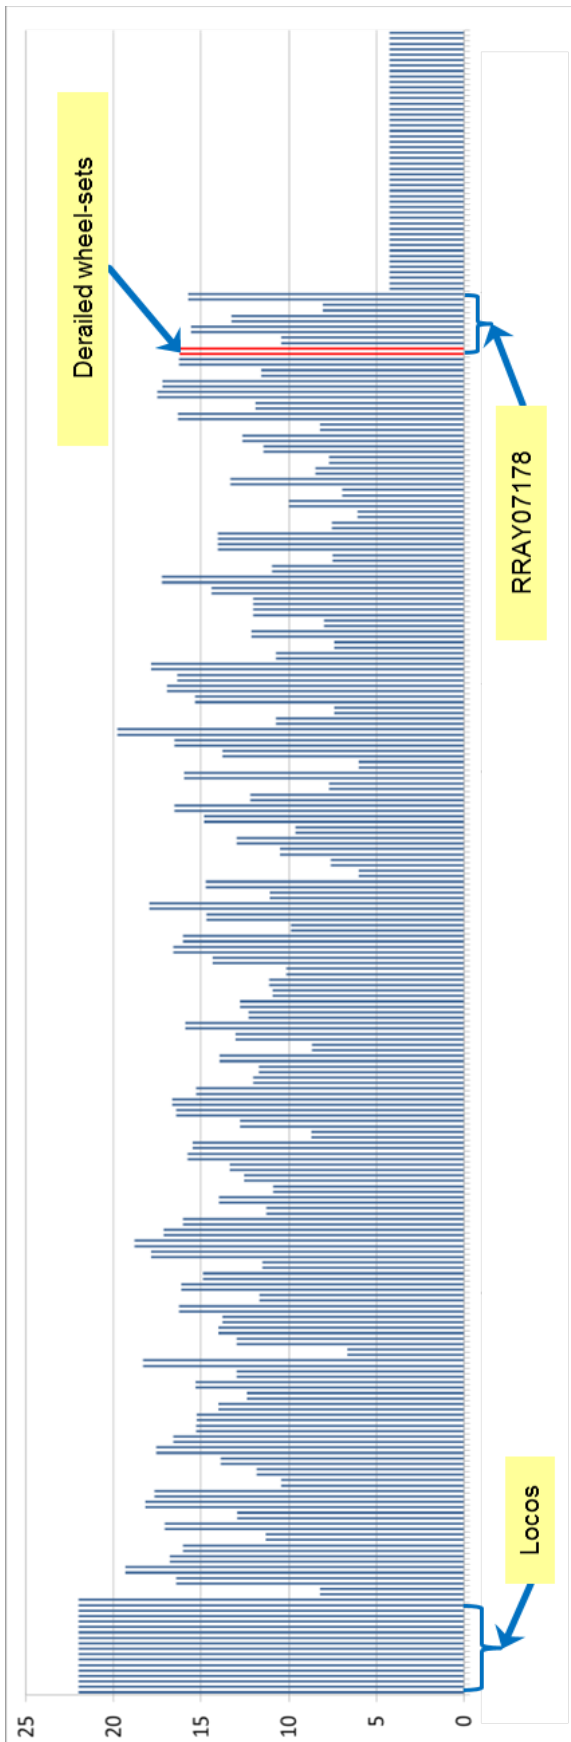
Figure 15: Plot of axle loads of 7SP5

PN's procedure, 'FLM01-10\_06 *Freight Loading Manual* and the ARTC CoP both state that the maximum weight variation between adjacent bogies must not exceed 20 t. The load differential between bogies either side of the first bogie to derail (the lead bogie of wagon RRAY07178) was calculated to be 5.8 t. The loading of the wagons around the axles that derailed was in accordance with PN's 'Loading Manual' and procedures in the ARTC CoP.
