# Derailment of 7SP5 between Caragabal and Wurrinya NSW

23 October 2011

## Abstract

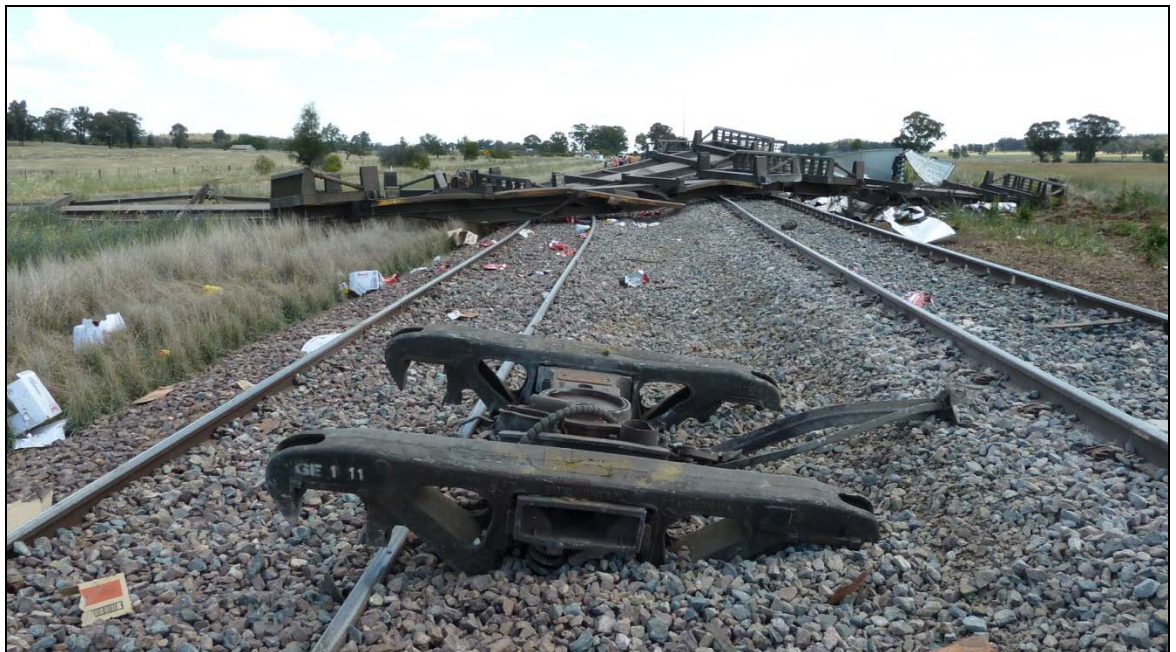
Figure 1: Last four wagons of train 7SP5 at the Wurrinya derailment site

An inspection of the train revealed that the last six wagons had derailed at the southern end of the loop, and the last four of these six wagons had separated from the train. The six wagons and several shipping containers were significantly damaged.
