Collision between two road rail vehicles

Rinadeena, Tasmania | 4 June 2013

ATSB Transport Safety Report
Rail Occurrence Investigation
RO-2013-014
Final – 11 June 2014

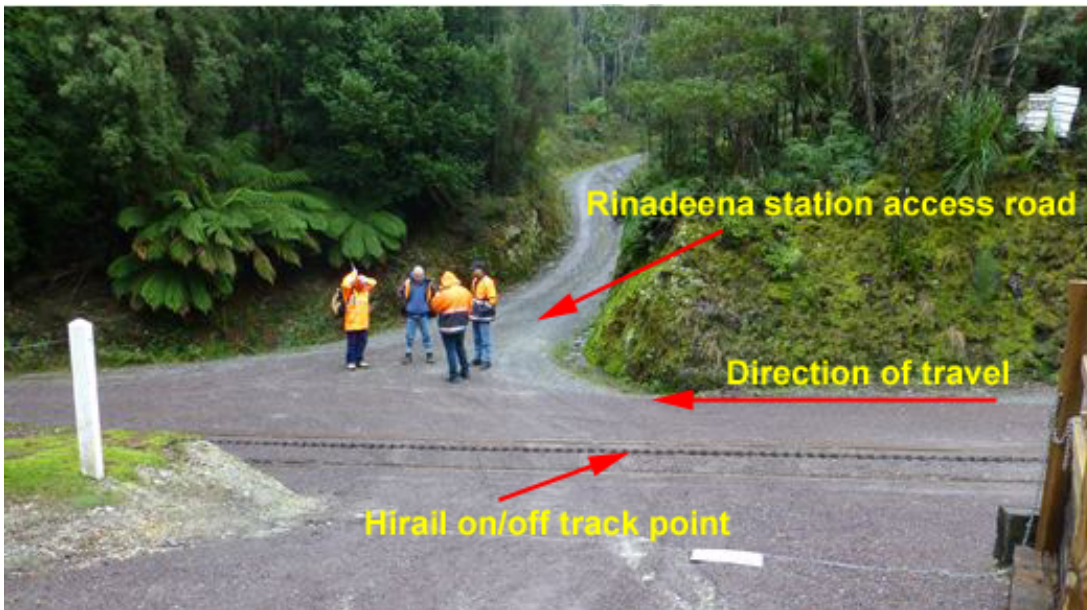
Figure 3: Rinadeena Station access road and vehicle on/off point

When Hirail 1 arrived at the Rinadeena Station on/off-track point (Figure 3), it was off tracked, turned around and then on tracked again in readiness for reversing down the 1:20 grade to the worksite. The driver again called the crew in Hirail 3 via VHF radio to confirm their location before moving off travelling in reverse at about 5 km/h. Hirail 3 was not far behind and as it arrived at Rinadeena Station the driver could see Hirail 1 as it disappeared around the bend on the falling grade.

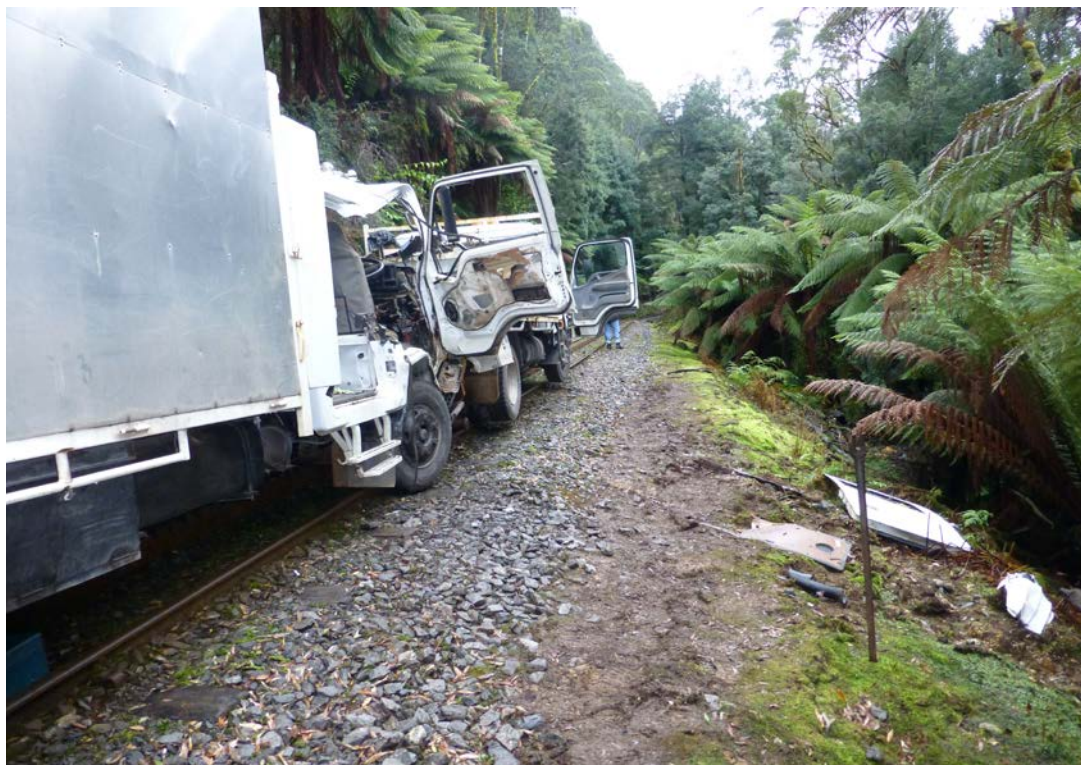
Figure 4: Hirail 1 (foreground) and Hirail 3 (background) after the collision

Hirail 3 continued on, passing the two workers who had jumped clear, before colliding with Hirail 1 and pushing it about 40 m along the track (Figure 4).

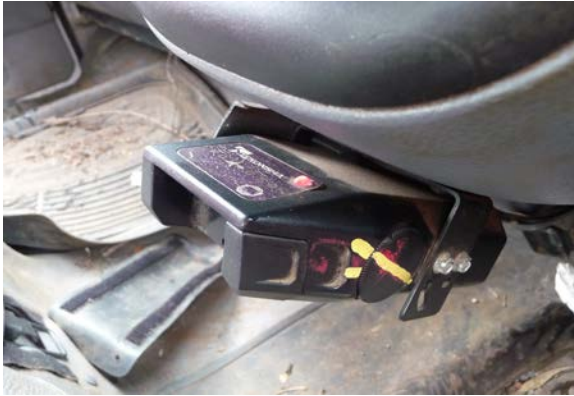
Figure 10: Brake controller orientation

The manufacturer stated that the controller must be installed with a mounting angle of -20° to 70° (Figure 11). In this case, the controller in Hirail 3 was mounted at about 45° (Figure 10), in line with this requirement.

Following the incident, the brake controller power knob was found to be positioned in the upper quadrant (Figure 10). Post incident testing conducted with Hirail 3 on a similar grade to Rinadeena at Carswell Park in wet conditions (low adhesion) concluded that with the power knob adjusted to this position, the amount of braking force that was applied to the rail guidance wheels was not sufficient to keep Hirail 3 stationary when the weight of the vehicle was lifted off the rear road wheels.

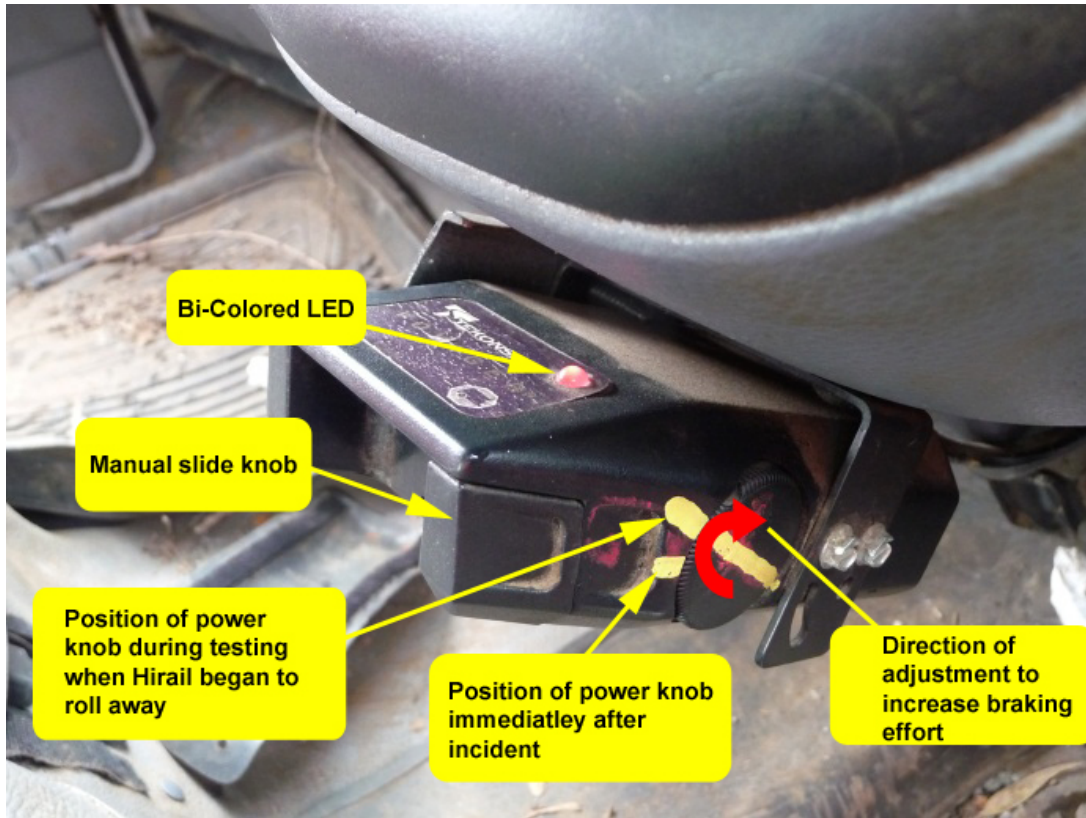
Figure 13: Brake controller Power Knob marks and position

While the brake controller was not designed specifically for on rail operations, when set correctly, the rail wheel braking system met the applicable Railcorp standard ESR 001-700 in achieving the specified deceleration rate. However, a braking system that required constant driver attention to achieve acceptable braking performance was not appropriate, especially for the steep grades of the WCWR.

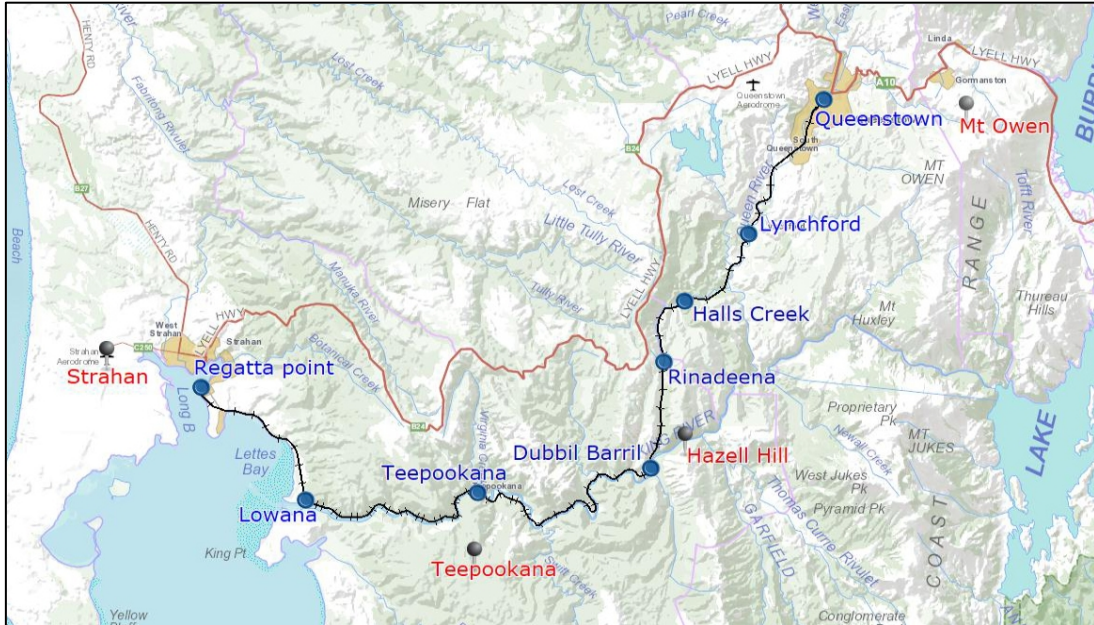
Figure 14: Map of WCWR track, stations and repeater tower locations

West Coast Wilderness Railway used VHF radios for all its rail safety work. Radio repeaters were located at Mount Owen, Teepookana and Strahan (Figure 14). Previously, there was a repeater located at Hazels Hill in the Rinadeena area, but it was removed as the location was susceptible to lightning strikes and constant damage. The repeater was relocated to Queenstown in an attempt to improve the overall communications across the railway. As a result, radio coverage in the Rinadeena area was problematic with reception being difficult in some areas, including the section of track where the collision took place.

However, Rinadeena Station was the only emergency meeting point between Queenstown and Strahan and the only road access point on the rack between Halls Creek and Dubbil Barril. Therefore, it was important that an effective and reliable communication system was always available at that location.
