Collision between two road rail vehicles

Rinadeena, Tasmania | 4 June 2013

ATSB Transport Safety Report
Rail Occurrence Investigation
RO-2013-014
Preliminary – 15 August 2013

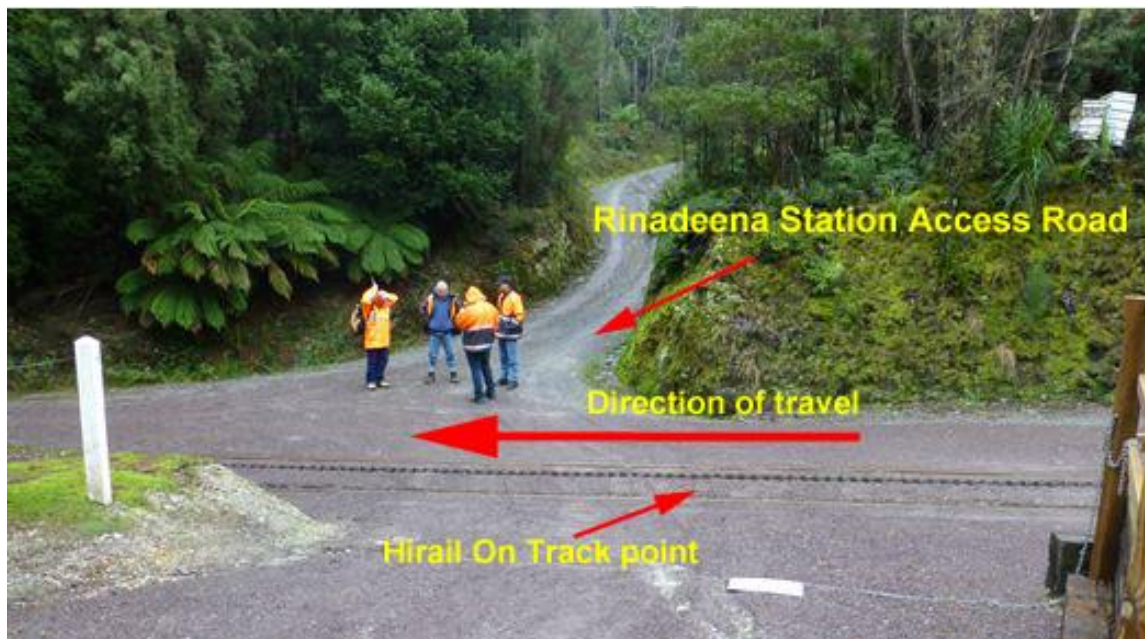
Figure 3: Rinadeena station access road and vehicle take-off point

When Hirail 1 arrived at the Rinadeena Station take-off point (Figure 3), it was off tracked, turned around and then on tracked again in readiness for reversing down the 1:20 grade to the worksite. The driver again called the crew in Hirail 3 via radio to confirm their location before moving off travelling in reverse at about 5 km/h. Hirail 3 was not far behind and as it arrived at Rinadeena Station the driver could see Hirail 1 disappear around the bend on the falling grade.

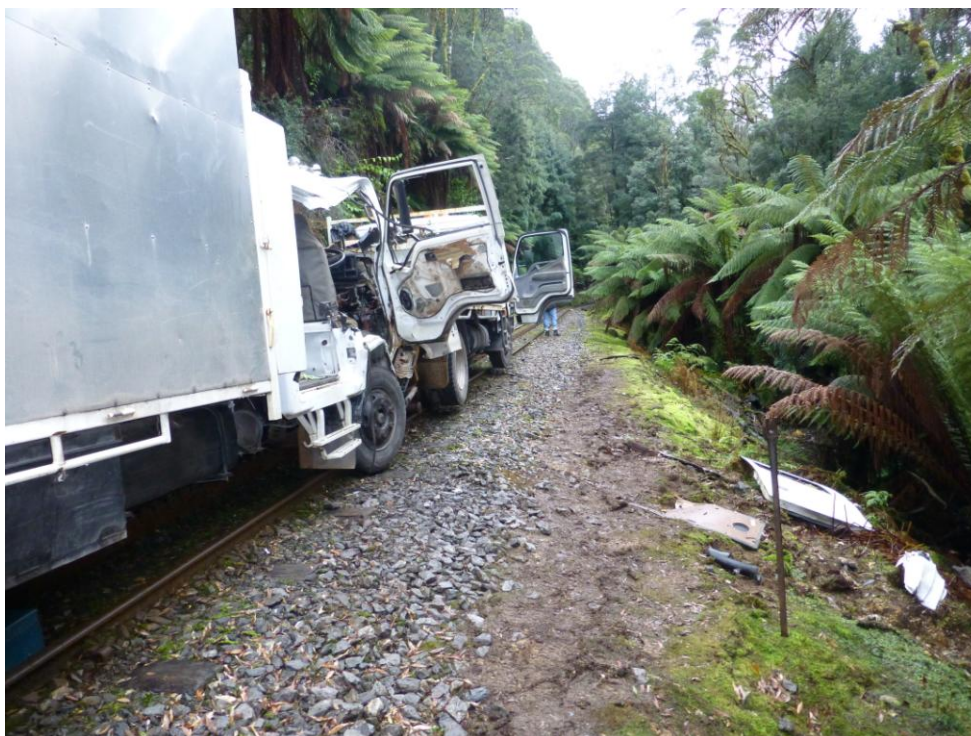
Figure 4: Hirail 1 (foreground) and Hirail 3 (background) after the collision

Hirail 3 continued on, passing the two workers who had jumped clear, before colliding with Hirail 1 and pushing it about 40 m along the track (Figure 4).

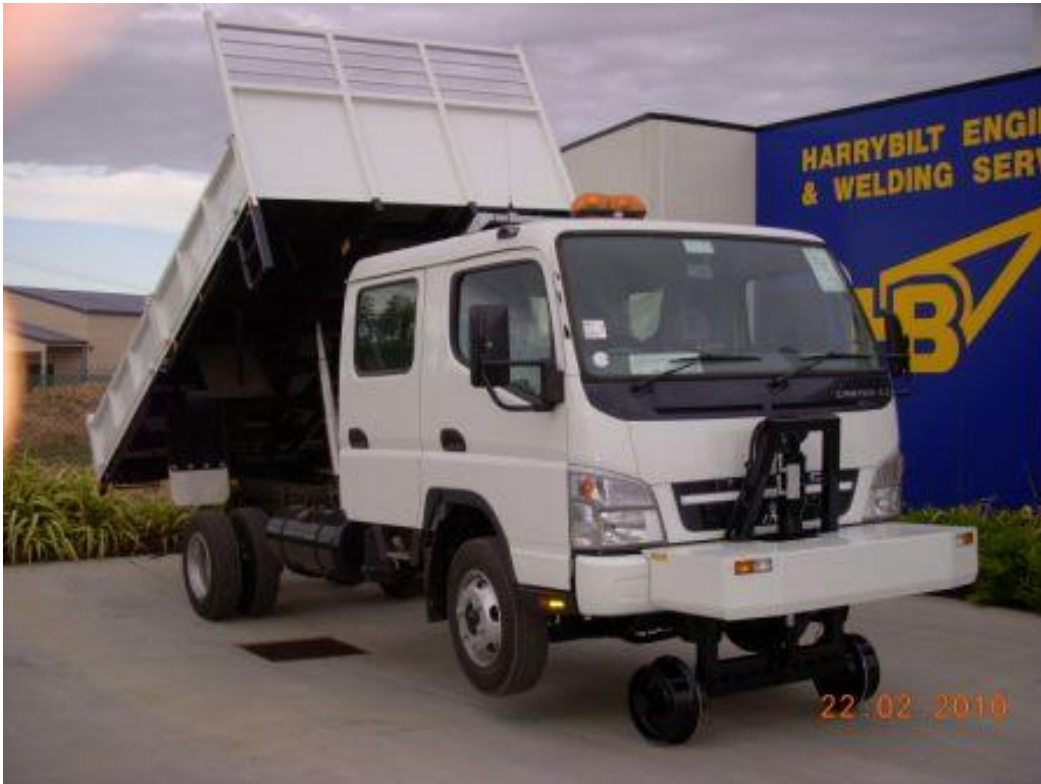
Figure 6: Hirail 3 with rail guidance wheels lowered

The road rail vehicles that were involved in the incident were a 1995 Mazda T4600 known as 'Hirail 1' and a 2009 Mitsubishi Fuso Canter tip truck known as 'Hirail 3' (Figure 6). The front of Hirail 1's rail guidance wheels were hydraulically braked through the operation of the vehicle's brake pedal. All four of Hirail 3's rail guidance wheels were electrically braked via a controller that received an input signal from the tail light switch on the brake pedal.
