Safeworking irregularity involving train 5SM2

Springhurst, Victoria | 6 March 2014

ATSB Transport Safety Report
Rail Occurrence Investigation
RO-2014-004
Final – 13 June 2014

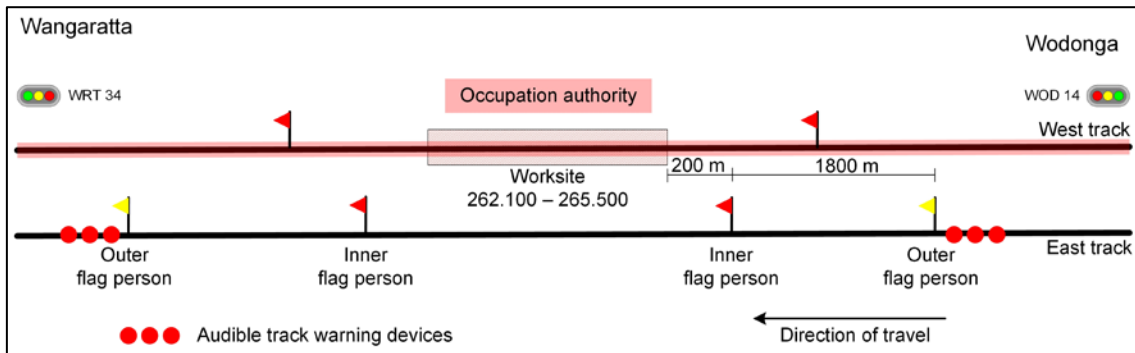
Figure 2: Protection for the West and East Tracks

The East Track protection documentation contained some inconsistencies that made it difficult to determine exactly where the flagmen were placed. However, the ARTC’s initial investigation of this incident found that the outer flagman was located 2,000 m from the worksite and an inner flagman was located 200 m from the worksite (Figure 2) in accordance with the ARTC’s requirements.

While the available data shows that the train crew prepared the train in anticipation of stopping before the worksite, had the driver applied more braking effort sooner, the train may have stopped before it passed the inner flagman.

- The Australian Rail Track Corporation will review the placement of outer and inner warnings given to train crews approaching worksites within Victoria as a priority. The review will consider the requirements specified in the rules applicable to other areas of the Defined Interstate Rail Network with the preferred outcome being alignment across all jurisdictions.
- All ballast rehabilitation program staff have been reminded of the requirement under TA44 to immediately report incidents to Network Control.

This incident demonstrates the need for Track Force Protection Coordinators to appropriately consider local factors such as grade and sighting of flagman when positioning the inner and outer flagman; and for train crews to take early and appropriate action in readiness for stopping the train.
