Level crossing collision between a school bus and train 7GP1 near Moorine Rock, Western Australia

23 March 2009

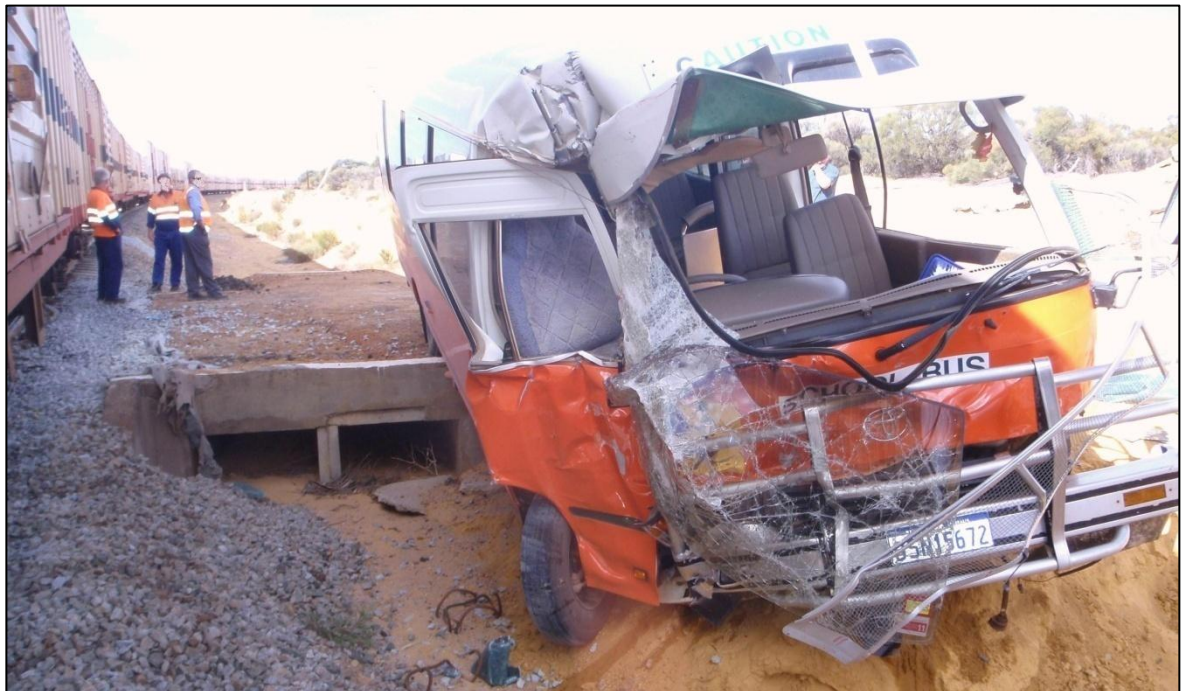
Figure 1: Nulla Nulla South Road level crossing collision site

At about 1540¹ on 23 March 2009, freight train 7GP1 collided with a school bus after the bus drove onto, and became stuck on, an excavated section of railway track at the Nulla Nulla South Road level crossing near Moorine Rock, Western Australia. There were no injuries as a result of the collision but there was significant damage to the school bus.

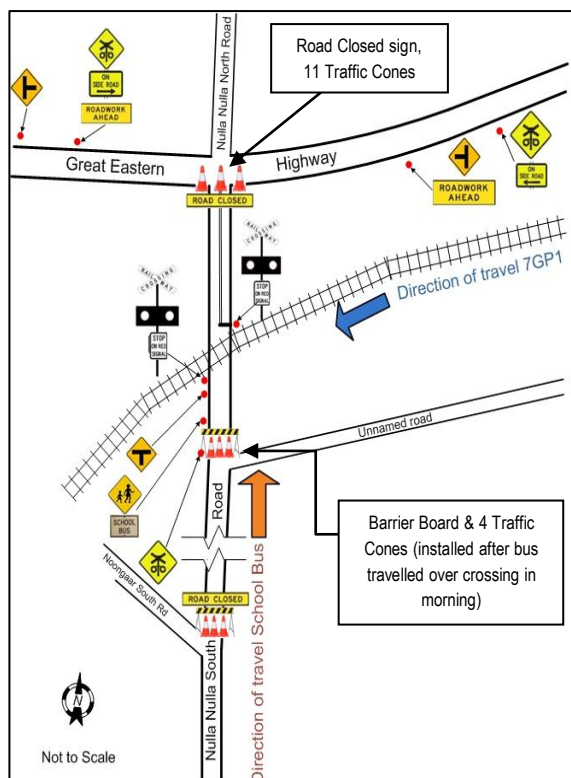
Nulla Nulla South Road generally runs in a north-south direction and has a maximum speed limit of 110 km/h. Roadside advance warning signs for the Nulla Nulla South Road level crossing are managed by the Shire of Yilgarn (Shire). Nulla Nulla South Road has an unsealed gravel surface and when travelling from the south, the road crosses the rail line at an angle close to 60 degrees (Figure 3).

Figure 3: Diagram showing road layout, road signs and direction of travel for school bus and train
