ATSB TRANSPORT SAFETY REPORT
Rail Occurrence Investigation
RO-2010-011
Final

**Derailment of train 3PW4
Wodonga, Victoria
23 October 2010**

The investigation concluded that an axle bearing on wagon RKWY-4125C failed and completely seized, causing the inner rings to spin on the axle journal, generating and transmitting sufficient heat to the journal to make it 'plastic' and causing it to separate from the axle (commonly referred to as a screwed journal). The most likely cause of bearing seizure was a loss of interference fit between the inner rings and journal which allowed the inner rings to turn or spin on the axle journal leading to increased wear and ultimately generating significant heat and damage until the bearing completely seized. It was possible that fretting and rotational creep contributed to the loss of interference fit.

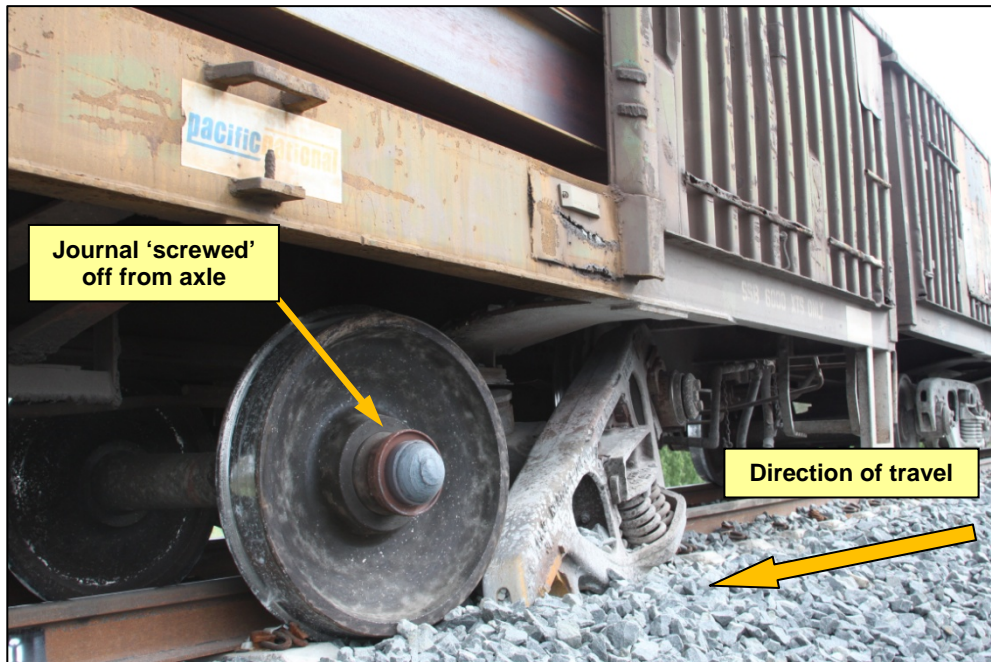
Figure 3: Rear bogie of wagon RKWY-4125C

the lead axle of the bogie had failed, resulting in the bearing journal separating from the axle (commonly referred to as a screwed journal - Figure 3).

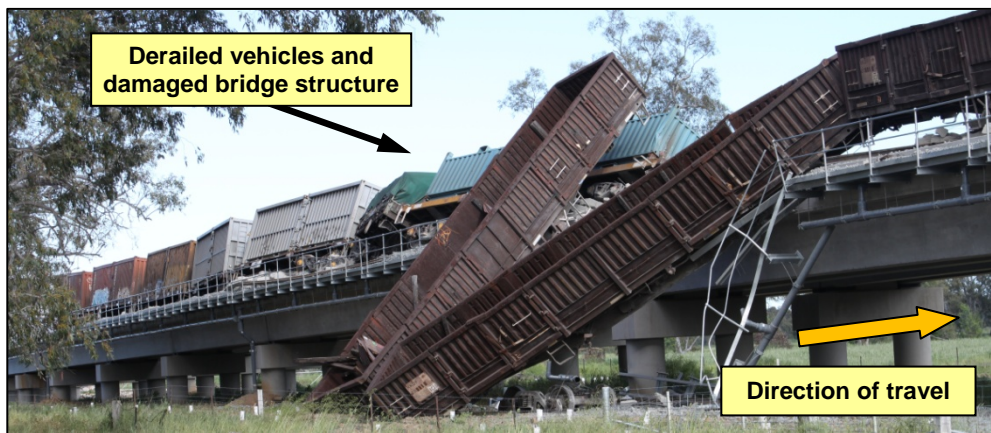
Figure 4: Derailment site

Bogies under three of the following four wagons had also derailed, beyond which a gap of about 140 m existed before the remainder of the train. Most of the derailed wagons had come to rest on one of the Wodonga bypass bridges (spanning the Wodonga Creek). In total, 15 wagons had derailed and were lying at various angles to the track, including two which had fallen, each with one end resting on the ground and one end on the bridge (Figure 4).

along the track. However, two wagons (27th and 28th) fell off the bridge structure, each with one end resting on the ground and one end on the bridge.

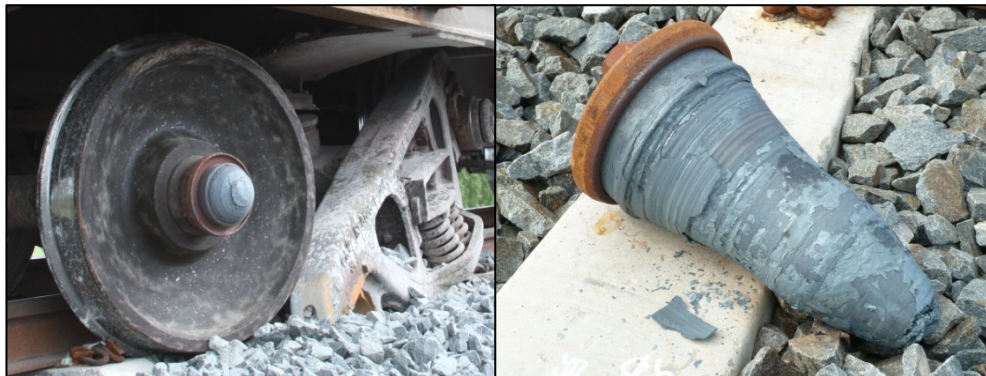
Figure 5: Axle journal

It was evident from site observations that the bearing journal had separated from the axle of wagon RKWY-4125C as it began to traverse the 3rd (in direction of travel) and longest (about 400 m) bridge of the new Wodonga bypass. The first sleeper impact point, caused by the journal stub, was about 55 m onto the bridge. The stub was found on the adjacent track, about 25 m further along the bridge. The first evidence of derailed wheels (wagon RKWY-4125C) was adjacent the journal stub, about 80 m onto the bridge. By the time train 3PW4 stopped, wagon RKWY-4125C had travelled in its derailed state for a further 370 m, stopping about 50 m past the end of the bridge. In effect, the derailment occurred over a total distance of about 400 m, almost all of which was on the bridge spanning the Wodonga Creek.

As the train approached Wodonga, it is likely that the condition of the wheel bearing on wagon RKWY-4125C had deteriorated to the point where the bearing had seized, causing it to ‘screw off’ (Figure 5). Once the bearing journal had separated from the axle, the bogie side-frame and axle could not be contained within their normal configuration. The side-frame fell down and dragged along the sleepers and ballast while the wheel-set was permitted to turn sideways and derail. As the train continued, the side-frame and wheels impacted with the concrete sleepers which ultimately failed to maintain track gauge and allowed further wagons to derail.

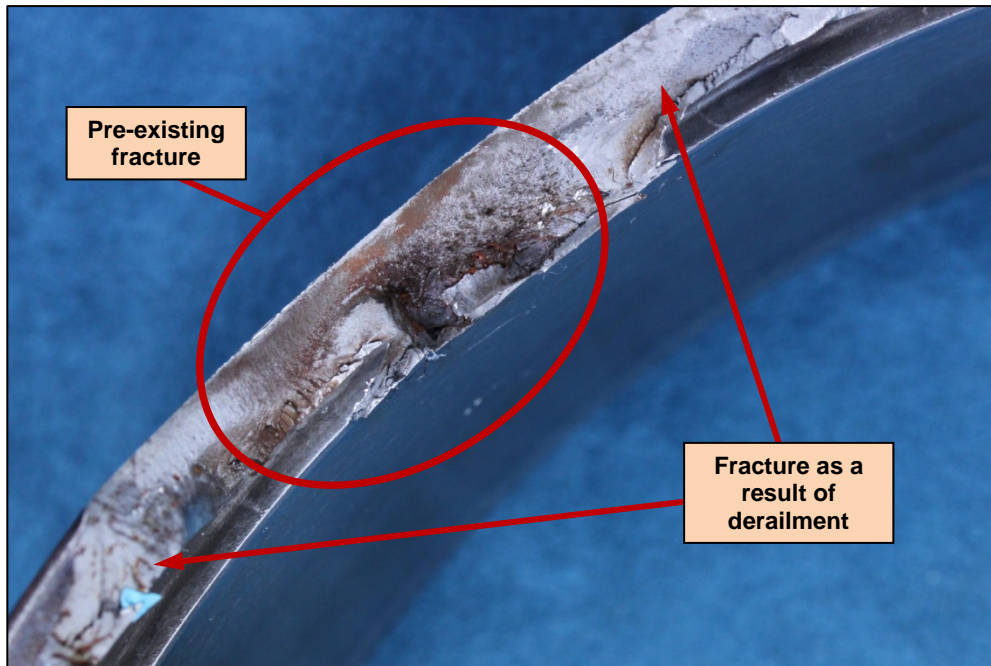
Figure 7: Fracture surface (largest scallop)

Examination found evidence of impact damage to the bearing cup where six scalloped pieces were missing from its outer edge. There was accompanying damage (bruising and abrasive wear) to the adjacent steel areas of the grease seal and it was evident that grease had seeped out in the area of the largest missing piece. Closer examination (after the bearing had been disassembled and cleaned) showed that the area corresponded to some damage to the outer raceway of the cup and a 14 mm wide, flattened indentation of the grease seal.

Five of the fracture surfaces were matt grey/silver in appearance with very low levels of oxidisation, indicating that they probably occurred as a result of the derailment. However, the largest of the six showed higher levels of oxidisation, indicating that it may have occurred before the derailment. Closer examination revealed evidence that each fracture mode was ductile overload as a result of an external overload force acting on the edge of the outer diameter of the cup. The higher levels of oxidation on the larger fracture did not extend over the entire fracture surface (Figure 7), indicating that an earlier overload force may have caused an initial fracture with impacts during the derailment resulting in complete fracture. Additional evidence, in the form of grooving and wear at the edges of the initial fracture, suggested that rollers had rotated in both directions, providing further support to the possibility of pre-existing damage.

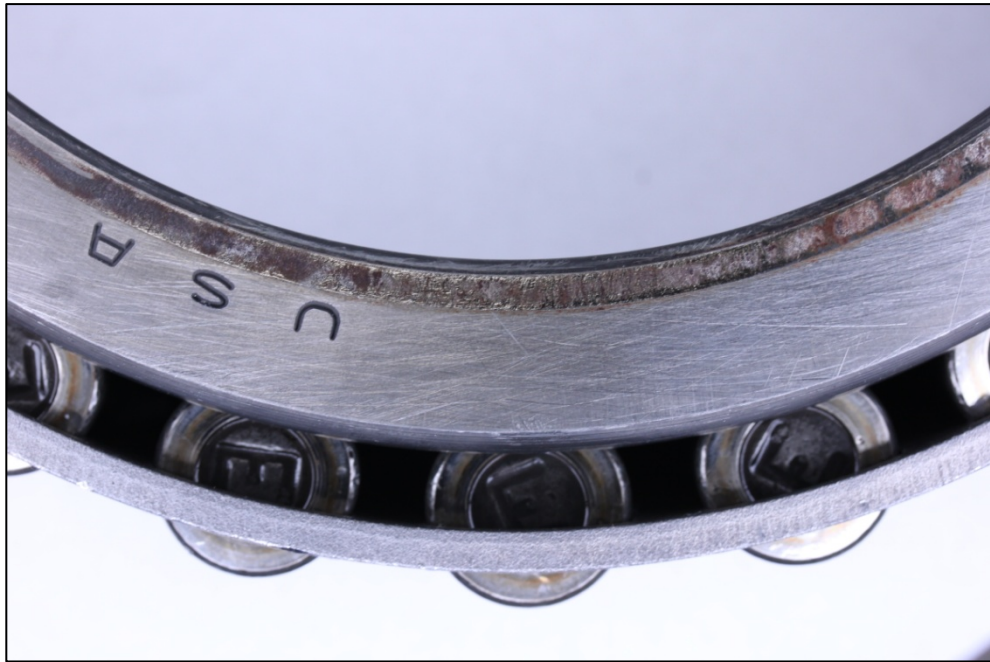
Figure 8: Fretting wear (inboard cone)

The spacer ring showed light fretting between its mating surface with the outer cone and moderate fretting where it mated with the inner cone. Heavier contact fretting was observed on the mating surfaces between the inner cone and the inboard seal wear ring. Similarly, fretting wear was evident between the backing ring, the inboard seal wear ring and the axle shoulder. (Figure 8)

Most of the contact surfaces (that is between spacer ring, cones, wear rings and backing ring) showed evidence of fretting wear, with heavier wear evident between the inboard mating surfaces. The cone bores also showed score marks and corresponding marks were observed on the axle journal. The axial score marks were a result of mounting and demounting of the bearing, while the radial scoring was likely to have been the result of rotational creep.

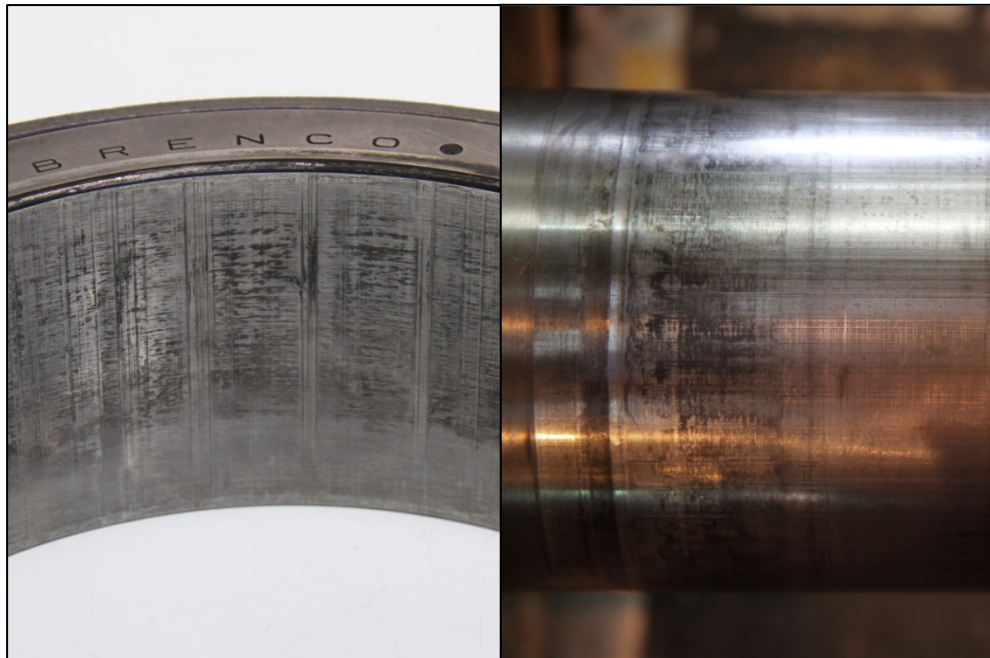
Figure 9: Axial and radial scoring on bore of inboard cone and axle journal

Further examination of the cones showed score marks, both axial and radial, within the bore each cone (more prominent on the inboard cone). Corresponding marks were also observed on the axle journal. While the axial scoring was a result of mounting and demounting of the bearing, the radial scoring was likely to be the result of rotational creep¹⁰. (Figure 9)

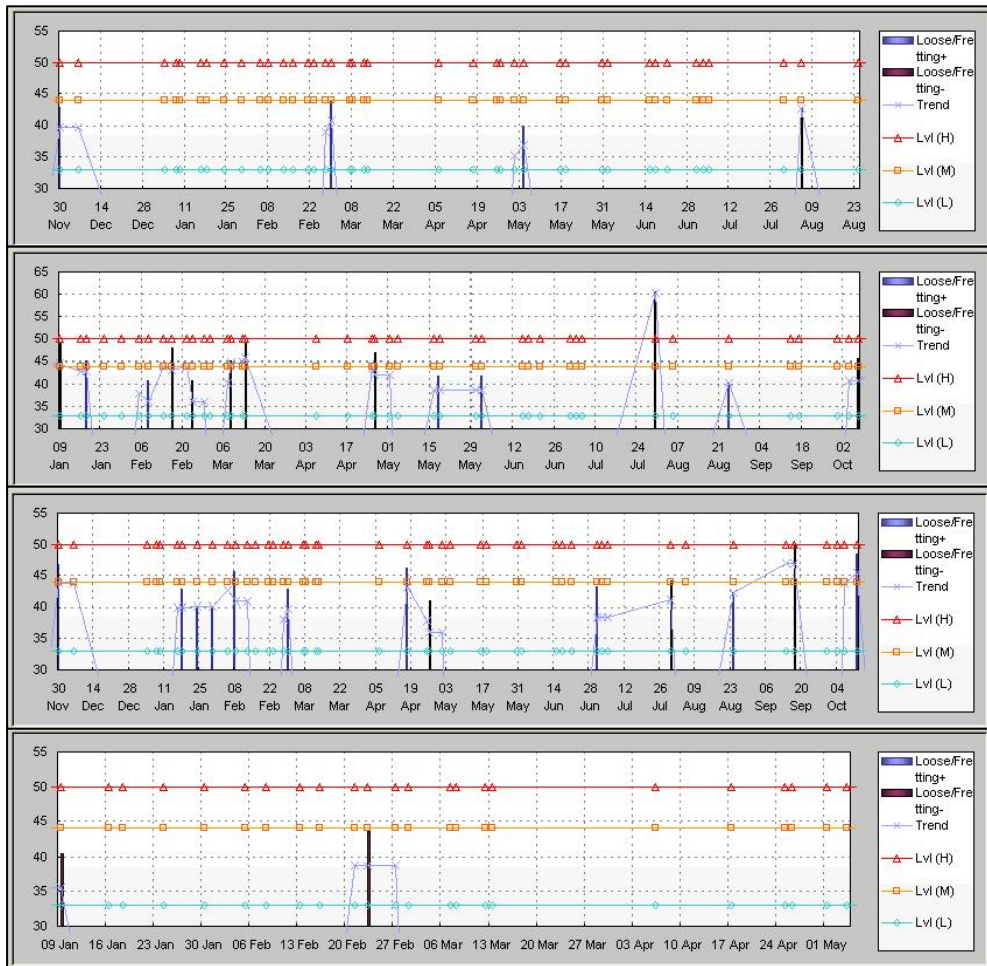
**Figure 10: RailBAM Graph – Looseness or fretting faults
Axle one (top) to axle four (bottom)**

In the 12 months before the derailment, wagon RKWY-4125C travelled through the ARTC RailBAM® site at Nectar Brook 49 times. About 50% of these passes recorded fault levels, almost all of which were level 3 (least severe) looseness or fretting faults. Most of the recorded faults were associated with axles two and three, noting that the bearing that failed was on axle number three. No faults were detected when train3PW4 passed through the RailBAM site at Nectar Brook (South Australia) on 21 October 2010. Figure 10 illustrates RailBAM’s graphical representation of looseness or fretting faults, between November 2009 and October 2010, for each axle on wagon RKWY-4125C.

It was evident from RailBAM data that axles two and three had recorded significantly more potential looseness and fretting faults than axles one and four. However, the data was largely low level indications (level 3) and did not show any significant trend that would indicate a defect was present or becoming progressively worse.
