Rolling stock irregularity on train 5MP9 near Fisher, South Australia

28 May 2011

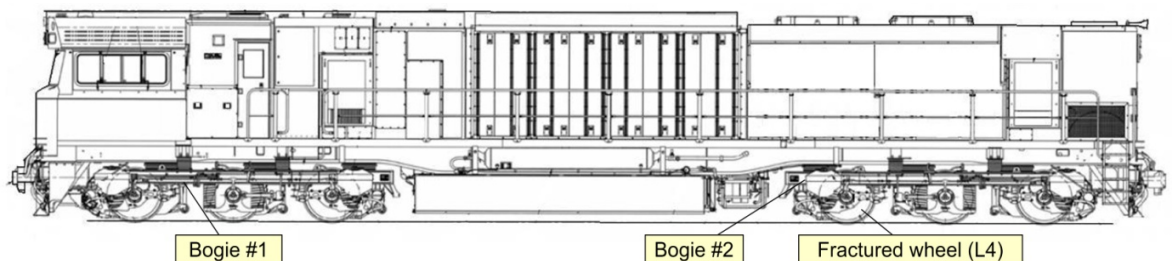
Figure 1: SCT Class locomotive showing the location of wheel failure L4 on SCT 008.

SCT freight train 5MP9 originated in Melbourne Victoria, and travelled to Adelaide where wagons and loading were added to the consist. The train departed Adelaide at 1036 on Friday 27 May 2011 and travelled through Port Augusta at 1446 and Tarcoola at 2026. At 2144 the train stopped at Wynbring to allow opposing train 5PM5 to pass. Train 5MP9 departed Wynbring at 2201 and at 0104 the next day was diverted into the passing loop at Watson to enable freight train 5PS6 to cross their path. At 0118 train 5MP9 departed Watson and at about 0145 while travelling at 111 km/h near the 849.700 track km mark, the crew experienced a violent vibration. The driver made a brake application and 1 minute and 40 seconds later brought the train to a stop near the 851.500 km mark. Inspection by the train crew revealed that the left wheel (L4) on the leading axle in the second bogie (Figure 1) had failed catastrophically.

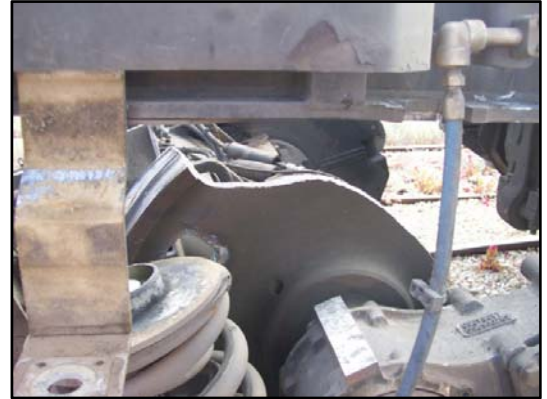
When train 5MP9 came to stop, the driver contacted the Australian Rail Track Corporation (ARTC) train controller to advise that lead locomotive SCT 008 had experienced a catastrophic wheel failure and that about half the wheel had disintegrated (Figure 2). The crew advised that they would contact train control after a further inspection had been made of the track. An inspection by the train crew found the southern rail was broken in four separate locations with wheel impact marks and varying break gaps of

between 25mm and 65mm. The train had passed over the broken rail sections without derailling.

Figure 2: SCT 008 fractured locomotive wheel L4.

After locomotive SCT 008 had been secured in the Fisher passing loop, the damaged traction motor wheel/axle assembly was removed and replaced with a temporary axle/wheel set. On Thursday 2 June 2011 the locomotive was attached to SCT train 4PM9 where it travelled to Port Augusta for further repairs.
