# Derailment of freight train 7AD1

Edith River near Katherine, Northern Territory | 27 December 2011

**ATSB Transport Safety Report**  
Rail Occurrence Investigation  
RO-2011-019  
Final

**27 December 2011**

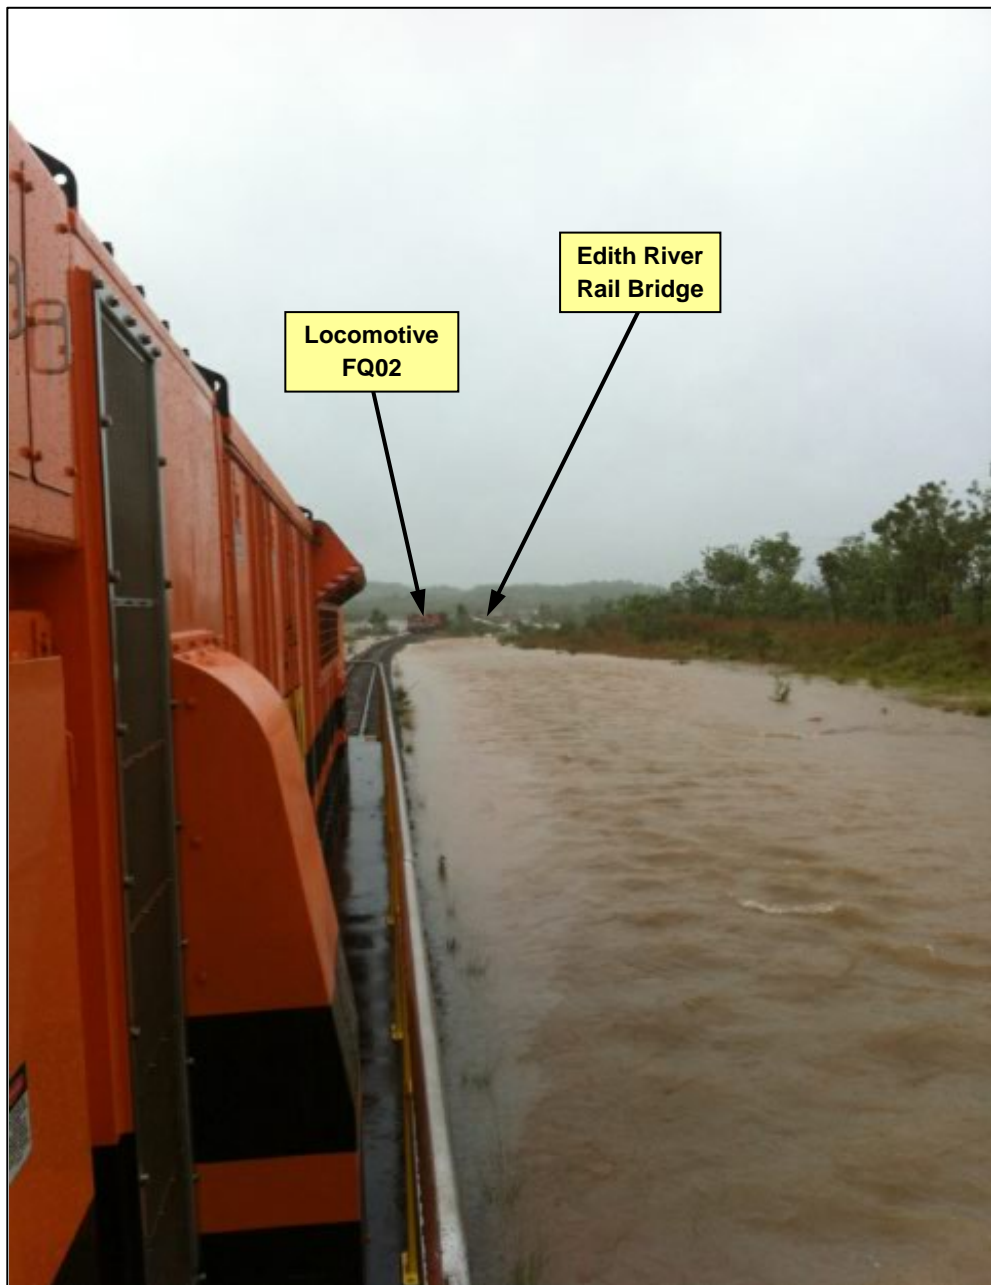
**Figure 3: View from lead locomotive GWA001, looking southeast towards Edith River, about one hour after the derailment**

The driver stated that the train continued towards the bridge, shuddering forcefully as it entered the flooded section of track and then lurching heavily as it advanced onto the bridge structure. The drivers said they were thrown violently in their seats and feared for their safety.

At about 0800 the floodwaters had subsided enough to allow the train driver to leave the locomotive cab and walk back along the track to assess the extent of damage. He determined that the lead locomotive GWA001 had derailed its leading wheel set. Approximately 80 m to the southeast, the second locomotive FQ02 was upright, all wheels derailed and a further 30 m southeast, the third unit CLF6 was upright, all wheels derailed. The crew van and the leading portion of the train had derailed into the Edith River.

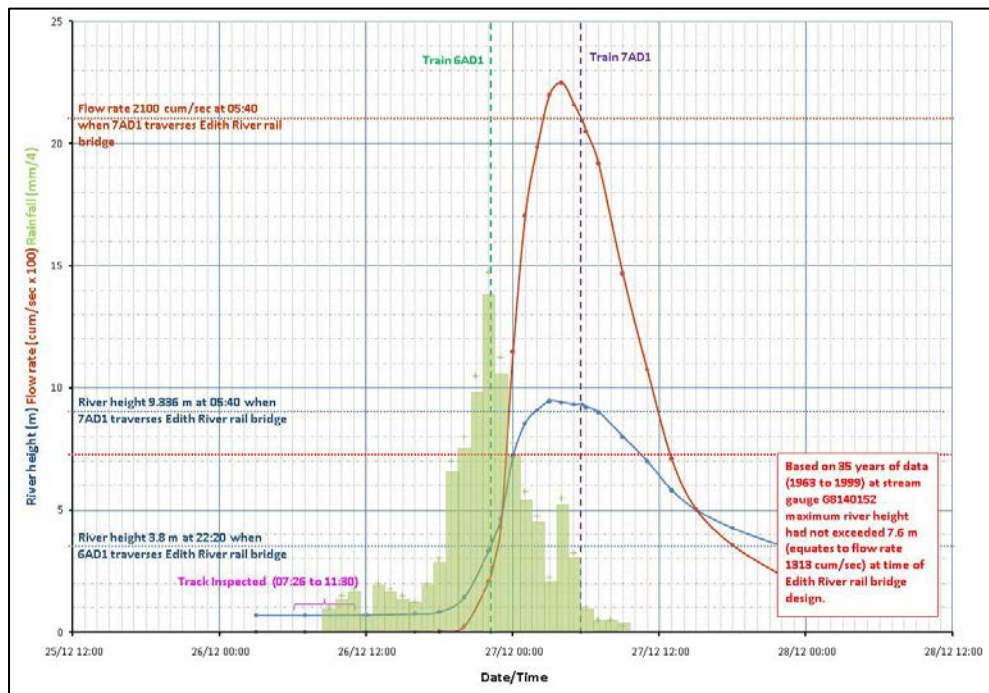
**Figure 5: Plot<sup>13</sup> showing - River height (m), Flow rate m<sup>3</sup>/sec, Rainfall (mm)**

Only light rain had commenced falling near Edith River Falls (Figure 5- green highlighted area) and the height of the river,<sup>14</sup> (Figure 5 - blue line) was quite low at about 0.7 m.

As indicated in Figure 5, the actual height of the Edith River at gauging station G8140152 was 1.68 m at 2020. The green highlighted area of Figure 5 shows that the intensity of the rainfall increased rapidly after about 1700, peaking at 59 mm during the period from 2130 to 2230. At 2120, just before the rainfall had peaked, train 6AD1 passed over the Edith River rail bridge. As the train traversed the bridge the two drivers said they shone their torches onto the river surface. They observed the river height and considered it to be relatively low.

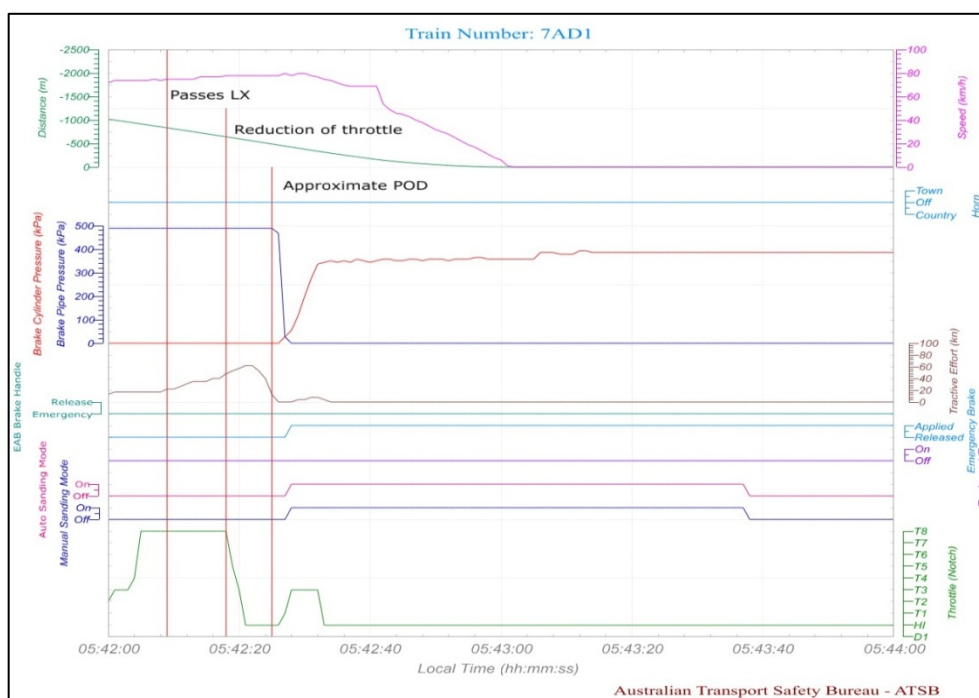
**Figure 9: Loco log plot 7AD1**

The journey from Katherine approaching Edith River was uneventful and proceeded without incident. Examination of the loco log plot (Figure 9) corroborates the driver's recollection of events showing the train as passing over the Edith Falls level crossing (2490.325 km) at 0542:08, in darkness<sup>16</sup>, travelling at a speed of 74 km/h. At about this time (0542:10) the driver said he observed a large expanse of flood water ahead, illuminated by the train's headlights.

The loco log file shows that the driver throttled off at 0542:19. The loco log then shows a significant loss of 'Brake Pipe Pressure' at 0542:24, this probably coincides with the train colliding into the south-eastern face of the bridge causing the train to part. At this stage it was likely that the south-eastern embankment had substantially washed away but the three locomotives fortuitously rode the suspended track and then up onto the bridge before the track collapsed under the weight of subsequent vehicles. The three locomotives traversed the length of the bridge, the crew van and some wagons also partially traversed the bridge until they fully derailed and fell into the flood swollen river. The lead locomotive GWA001 continued along the track coming to a stand about 512 m beyond the initial Point of Derailment (POD) with the south-eastern bridge face.

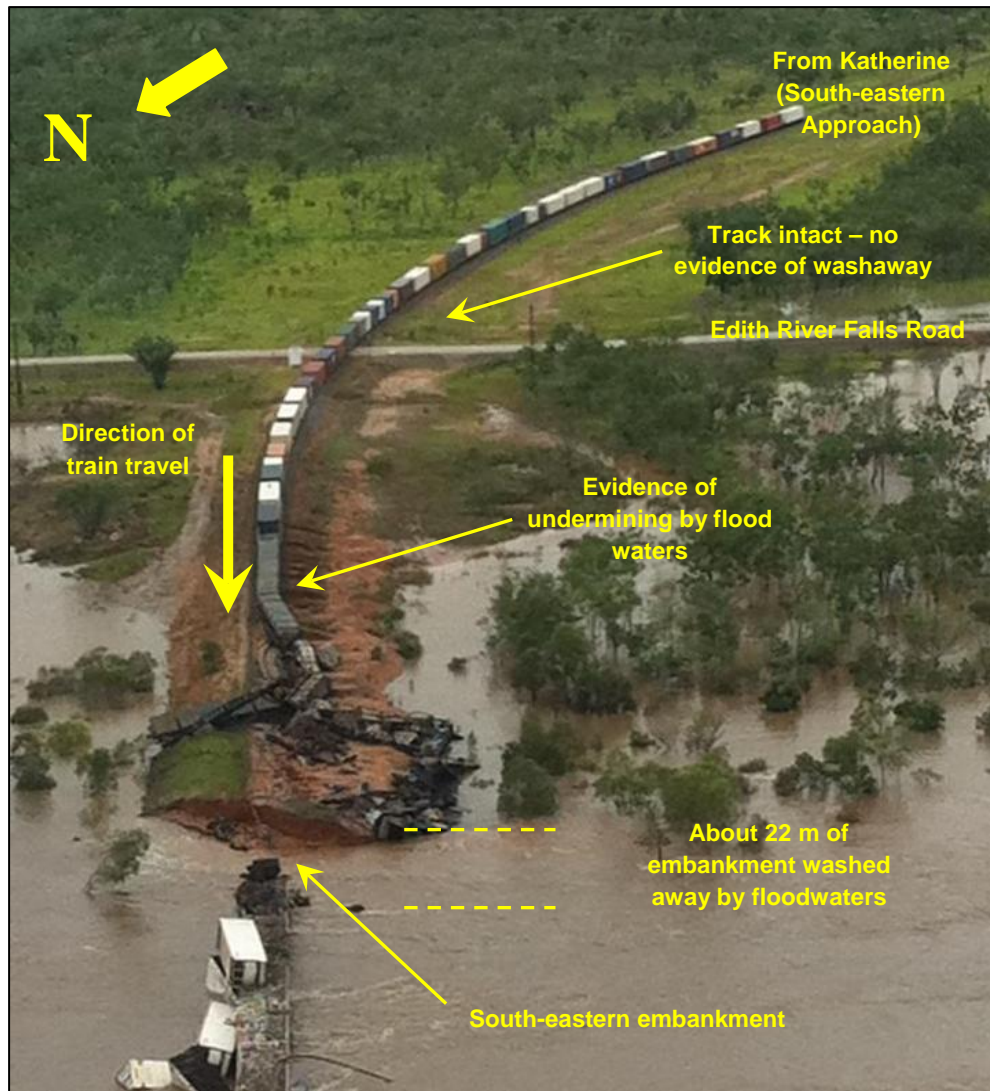
Figure 10: Approach to Edith River rail bridge early on 27 December 2011

When examined by the ATSB, the track on the approach side of Edith River Falls Road level crossing was intact and in good condition with no evidence (Figure 10) of wash-away. The first evidence of any significant undermining of the track by floodwaters was on north-western side of the Edith River Falls road level crossing, about 150 m beyond the crossing. The ballast, formation and embankment (Figure 10 and Figure 11) beyond that point were in many locations noticeably washed away by flood waters. Looking back towards Katherine from the south-eastern bridge abutment, about 22 m of embankment had been washed away by floodwaters.

<sup>17</sup> There was evidence to indicate that the Edith River Falls road level crossing had been overtopped by floodwaters, this probably occurred earlier in the morning before train 7AD1 arrived at the site.

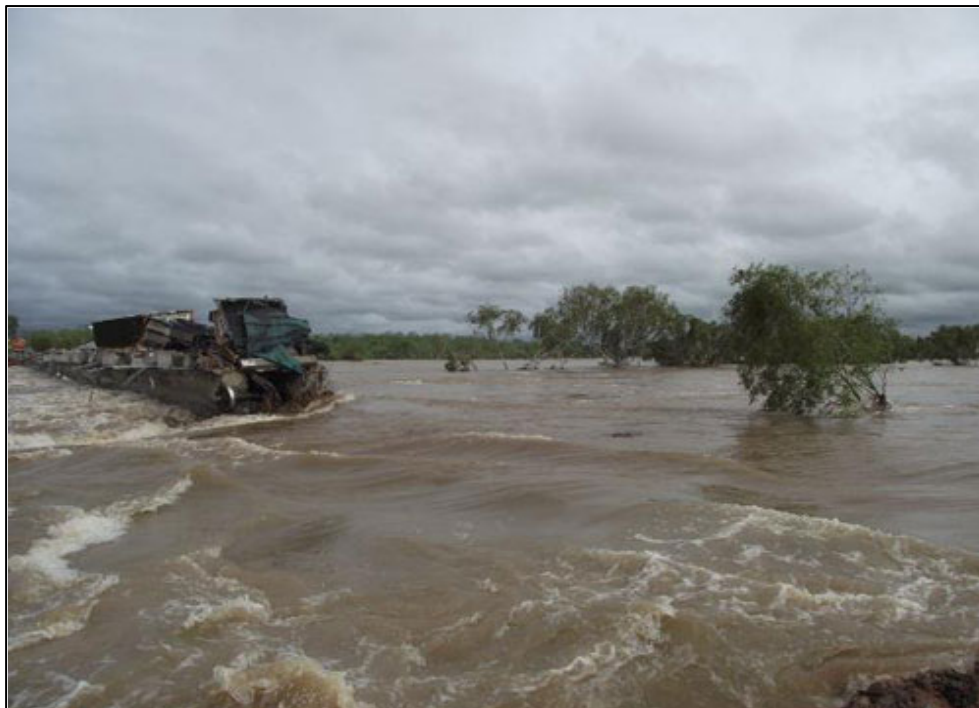
**Figure 13: South-eastern approach to Edith River rail bridge about 1 hour after the derailment**

The ATSB determined that the derailment of train 7AD1 was caused by the wash-away of the south-eastern embankment, associated sub-grade and ballast on the approach side of the Edith River rail bridge. The magnitude of the wash-away meant that the track could not support the weight of train 7AD1 as it passed over the affected track. The track collapsed under the train, initiating the derailment.

The flood event on the morning of 27 December 2011 overtopped the Edith River rail bridge and probably exceeded a height of 10.9 m.

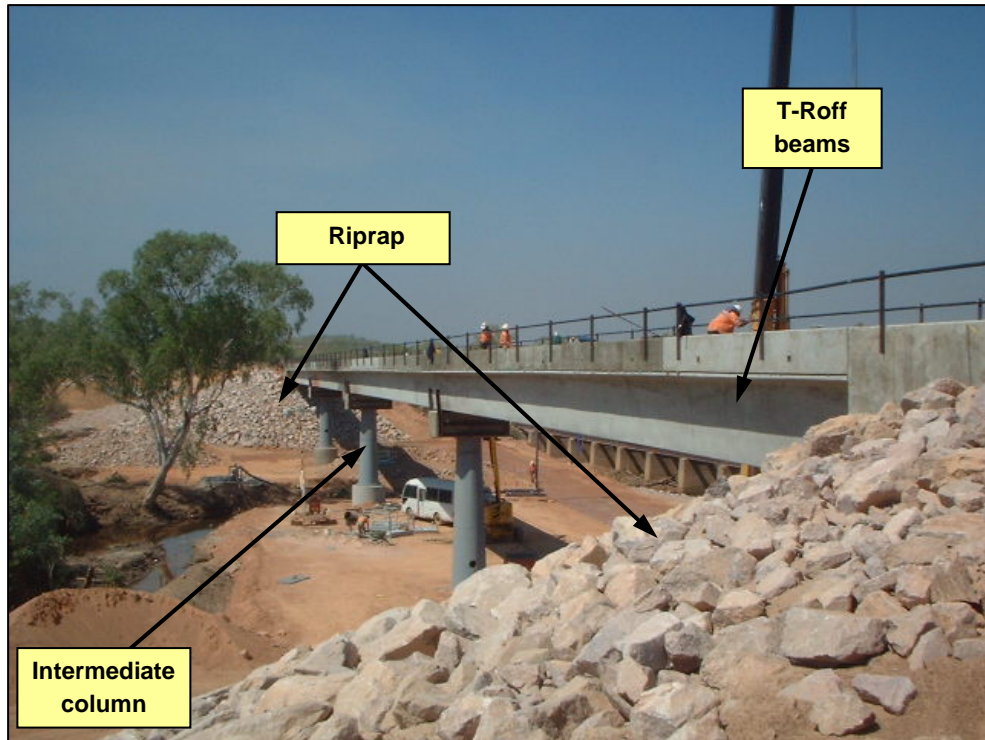
**Figure 16: Edith River rail bridge under construction**

The northwest and southeast bridge abutments and associated track approach embankments were protected by riprap<sup>21</sup> to guard against scour damage caused by water erosion arising from flood events (Figure 16).
