TECHNICAL ANALYSIS REPORT No: 39/01

Examination of a Failed Compressor Blisk

General Electric CT7-9B Turboprop Engine

Saab Aircraft AB, SF-340B, VH-EKX

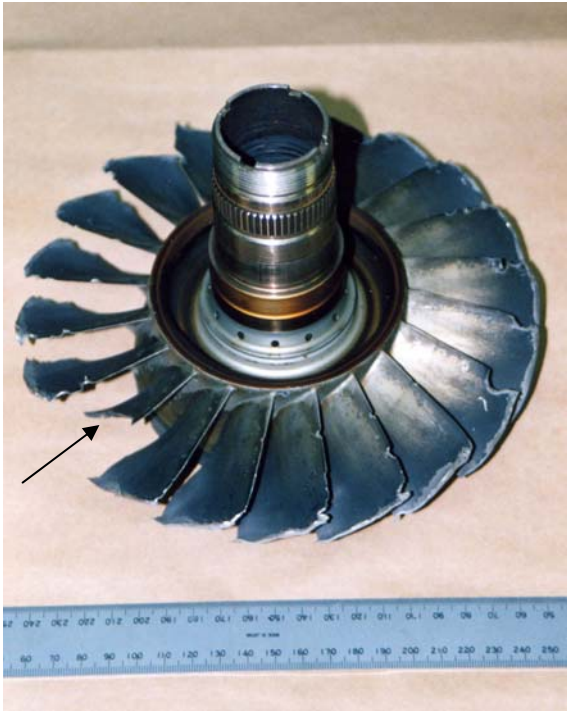
The leading edges and tips of the blisk aerofoil sections had been damaged by multiple impacts (figures 1 & 2). The single fractured aerofoil had separated transversely at a mid-span location, around 29 millimetres above the root transition (figure 3). The rear edges of the blisk hub (adjacent to the stage two compressor wheel coupling) showed appreciable erosion around the full circumference (figure 4). Heat tinting and other evidence indicating rubbing contact against the housing was present over approximately two-thirds of the blisk circumference (figure 5). The forward (convex) surfaces of the aerofoils were coated with an oily, black deposit which increased in density toward the blade tips (figure 6). Beneath the deposit, the surfaces exhibited a bright, lustrous finish, typical of a metallic coating (figure 7). Conversely, the rearward (convex) surfaces exhibited appreciable erosion; being most pronounced toward and along the trailing edges (figure 8). The metallic coating appeared to have appreciably eroded away on this side.

Figure 1. Blisk front view – fractured blade is arrowed.

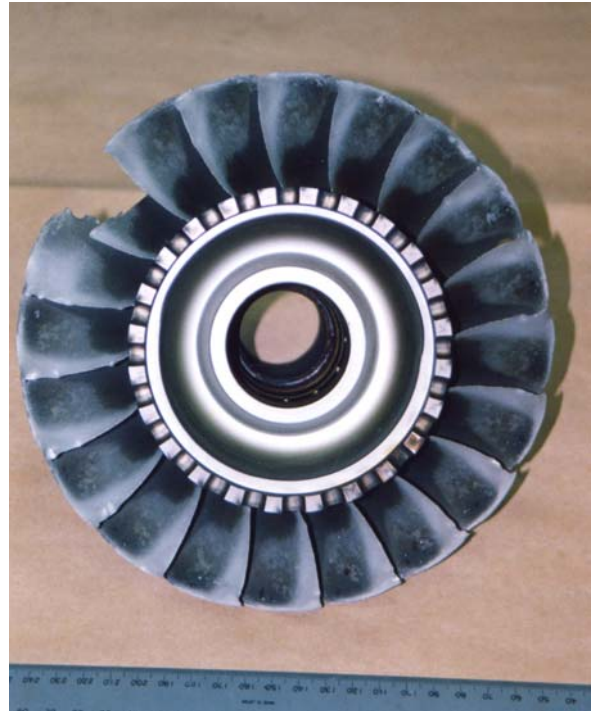
Figure 2. Blisk rear view.

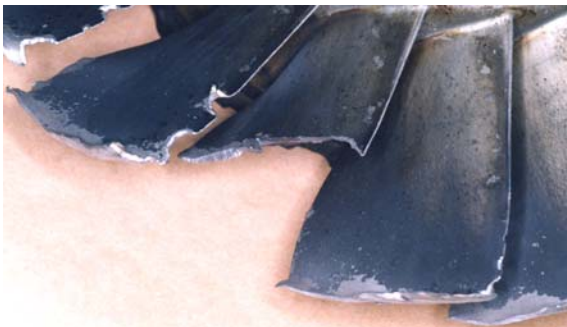
Figure 3. Fractured blade and mechanical damage to other blades.

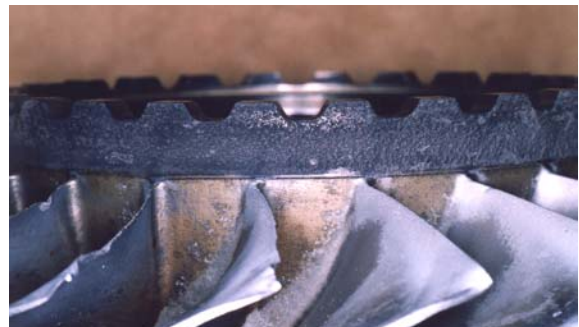
Figure 4. Erosion damage to rear edge of blisk hub.

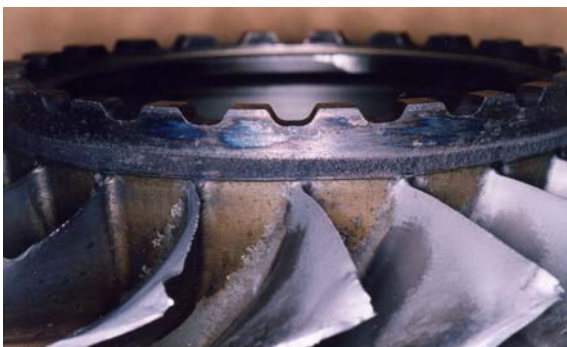
Figure 5. Evidence of mechanical 'rub' on the rear edge of the blisk hub.

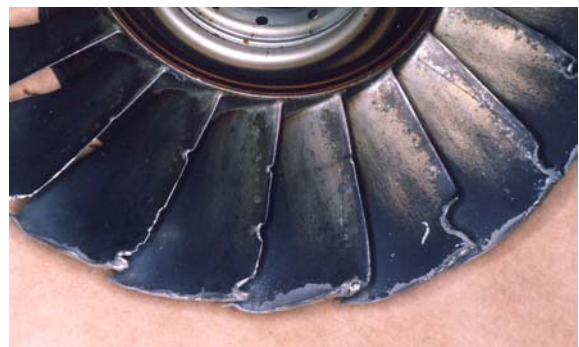
Figure 6. Dark deposit on the forward faces of the blisk aerofoils.

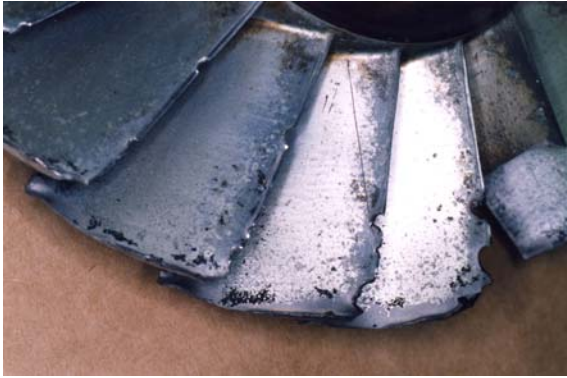
Figure 7. Forward (convex) aerofoil faces after cleaning. Bright finish is typical of a metallic coating.

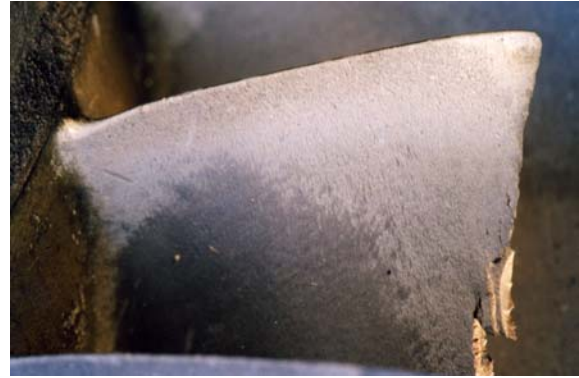
Figure 8. Rear (concave) face of an aerofoil showing the typical eroded appearance.

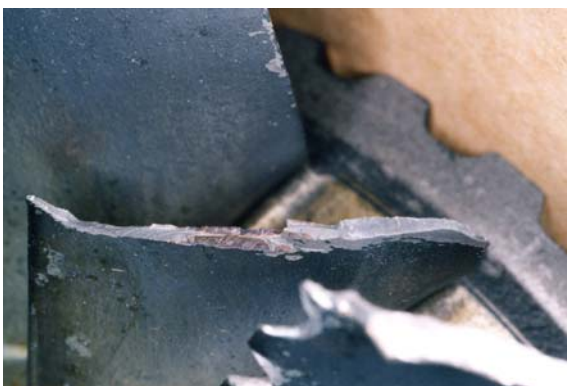
The aerofoil fracture extended over the full section width and was essentially straight from leading to trailing edges; a length of around 40 millimetres (figure 9). Just forward of the mid-chord position, a flat zone of brown stained fracture was present, forming semi-elliptical zones extending into the section from opposing locations on the external surfaces (figure 10). Beyond the stained area, a pattern of conchoidal crack progression marks extended further along the section (figure 11). A distinct step in the fracture path was present just rearward of the central stained zone; this also showed staining and crack progression marks (figure 12). When viewed in profile, the step feature was found to have formed from a second surface crack, immediately inward of the primary defect. Many other similar crack indications were also evident (figure 13).

Figure 9. General view of the fractured blade lower section.

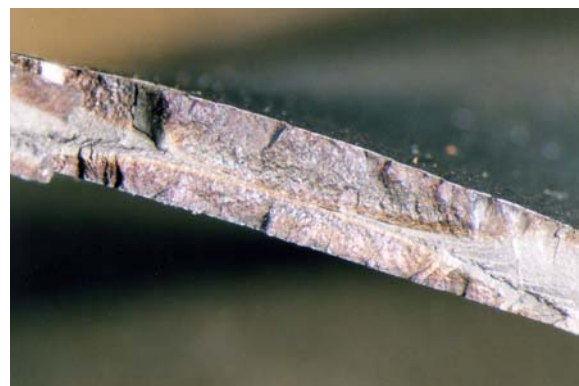
Figure 10. Closer view of the semi-elliptical stained regions at the mid-chord position.

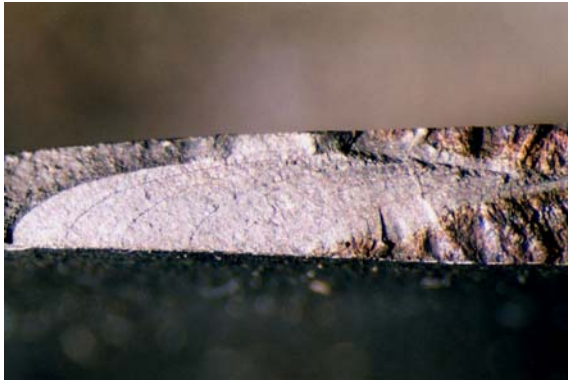
Figure 11. Clear crack arrest marks extending out from the central stained region.

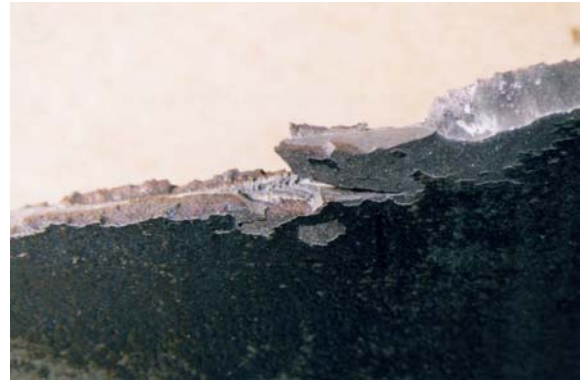
Figure 12. Progression of fracture on two adjacent planes, forming a step feature.

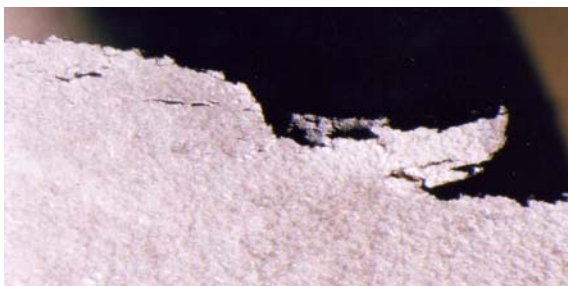
Figure 13. Many small fissures on the blade concave face, adjacent to the main fracture.

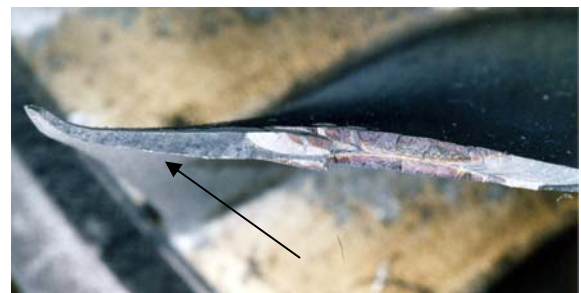
Beyond the central stained and progressive cracking zones, the fracture presented features typical of ductile overload. Angular shear lips extended to the leading and trailing edges of the aerofoil (figure 14).

Figure 14. Area of ductile shear fracture (arrowed) behind the central fatigue zone.

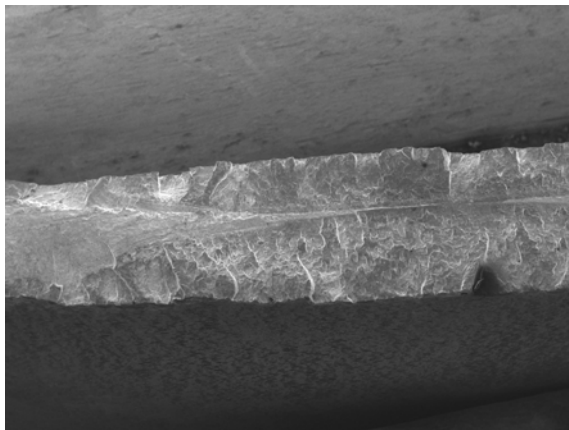
Under examination using the scanning electron microscope, the aerofoil fracture clearly presented the two central zones observed visually (attachment A). The opposing semi-elliptical regions displayed multiple ratchet or step marks extending inward from the surfaces on both sides (figure 15). The marks were indicative of fatigue crack initiation sites. The actions of fatigue cracking were also indicated by the presence of conchoidal crack arrest marks extending away from the inner stained zones (figure 16). Close study revealed around nine such marks between the boundary of the stained region and the commencement of the ductile shear region. Due to the degree of oxidation and staining of the central zone, it was not possible to characterise the fracture features in that area. The transitional regions exhibited clear evidence of a progressive cracking mechanism, changing at the extremities to the dimpled and undulating surfaces that are typical of ductile tensile overload (figure 17).

Figure 15. Low magnification SEM view of the central stained area of fracture.

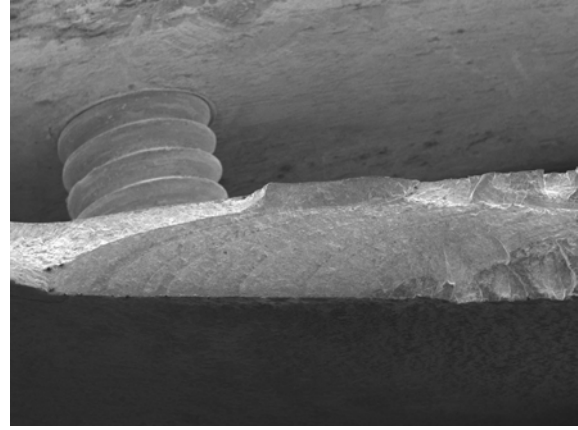
Figure 16. Area of crack arrest marks.

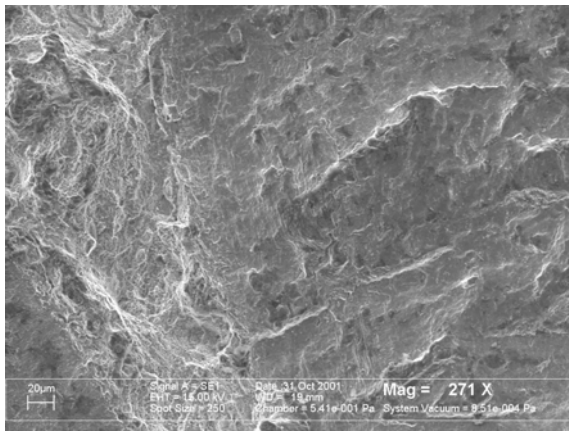
Figure 17. Higher magnification view of the transition between fatigue and overload fracture regions.

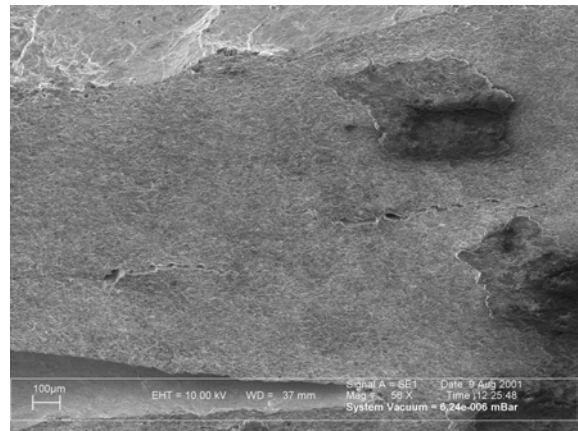
Examination of the aerofoil surfaces adjacent to the fracture found many small fissures, some of which had partially opened (figure 18). Remnants of blade coating were also apparent, although much of the material had spalled away from the area adjacent to and along the fracture path.

Figure 18. Fissures observed on the blade surface, adjacent to the primary fracture.

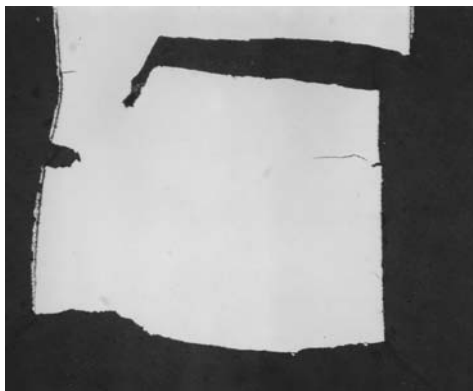
A suitably prepared metallographic section was taken transversely through the fracture (radially along the aerofoil axis), intersecting the central stained region. Examination of the section in the unetched condition revealed many shallow cracks extending into the section from both surfaces (figure 19). The cracks extended to a maximum depth of 370 μ m and several contained a dense product toward the surface (figure 20). Re-examination of the specimen after etching showed the primary fracture and crack morphology to be transgranular (typical of fatigue cracking) and did not exhibit any association with a material or microstructural anomaly. The general microstructure was mostly martensitic throughout with a preferred orientation that was typical of the forged production of the blisk (figure 21). Intermittent bands with an increased proportion of retained austenite were evident throughout the microstructure.

Figure 19. Section through the aerofoil showing the primary fracture and secondary cracking. X40

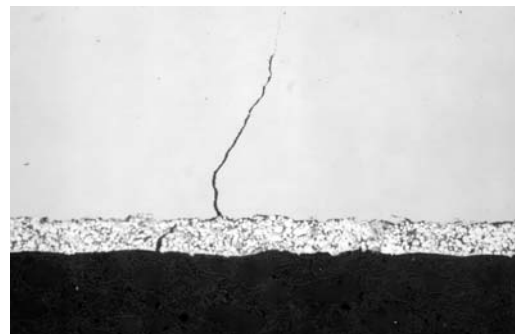
Figure 20. Larger secondary crack with notable oxide contents X320

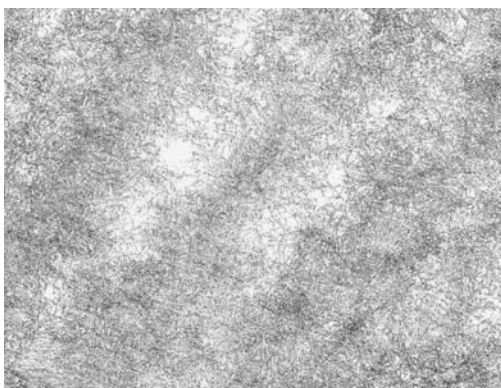
Figure 21. Martensite / retained austenite aerofoil microstructure.

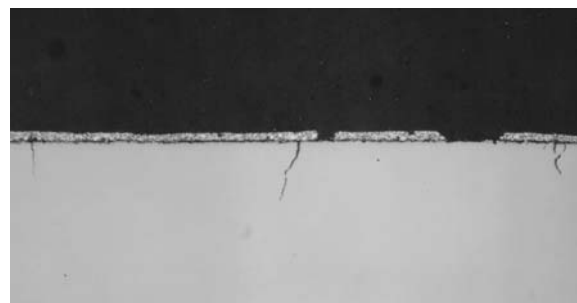
To further evaluate the condition of the blisk, a second blade was removed from the hub and sectioned in the same longitudinal manner as the first (figure 22). Subsequent examination revealed at least eight shallow surface cracks extending into the section from the convex surface. The cracks were measured at between 39 and 70 μ m spacing and extended to a maximum depth of 190 μ m. Cracking was not observed on the concave side.

Figure 22. Cracking found in adjacent aerofoil. X80

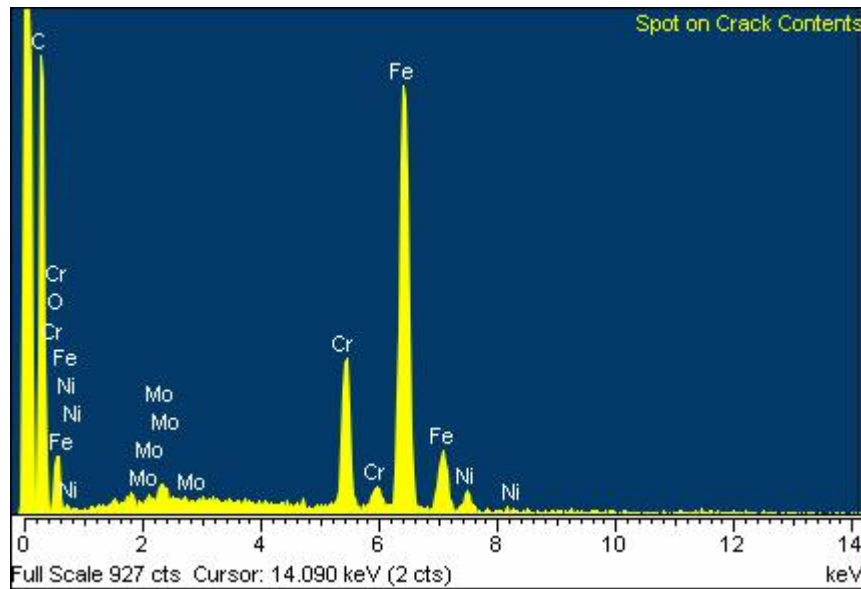
Energy dispersive x-ray analysis of the contents of some of the shallow secondary cracks produced characteristic spectra with major peaks for oxygen, iron and chromium (figure 23). Minor peaks for nickel and molybdenum were also identified. All of the elements were associated with the blisk alloy or with associated corrosion products.

Figure 22. EDS spectra of the crack contents.

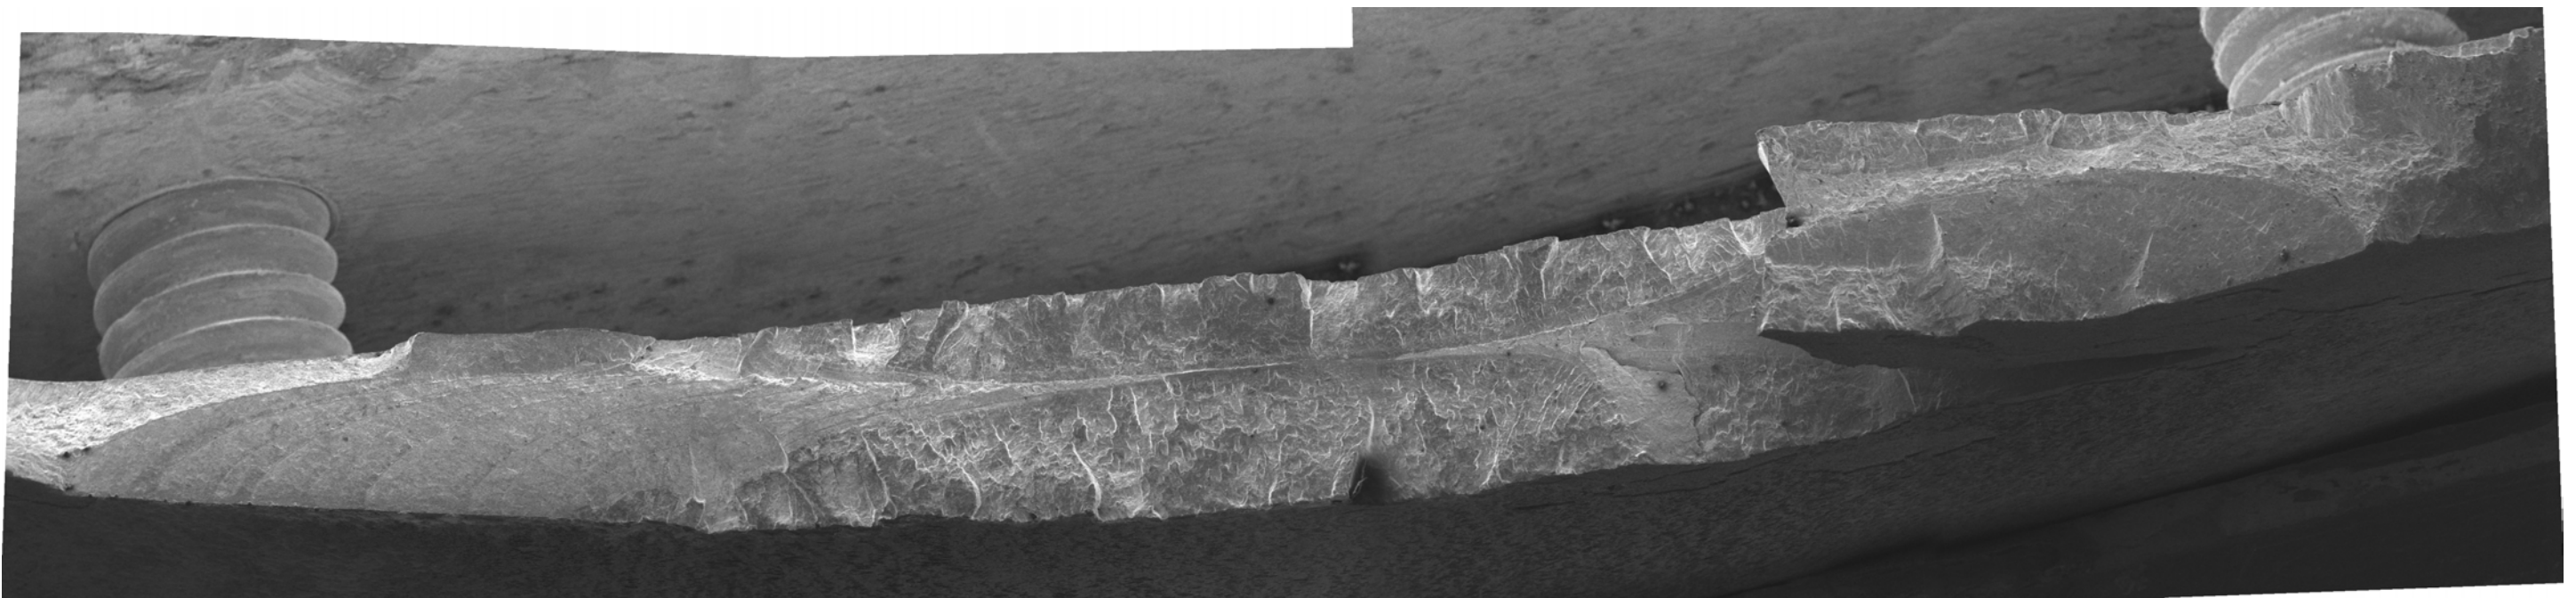
Attachment A. Montage image of the full region of aerofoil fatigue fracture.
