TECHNICAL ANALYSIS REPORT No: 05/02

**Examination of failed components
from a Garrett TPE331-11U
turboprop engine**

**Fairchild Industries Inc. SA227-AC
VH-VEH**

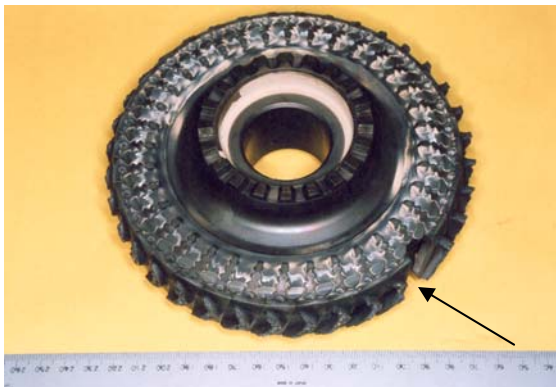
The stage-one turbine assembly comprised thirty-six air-cooled blades, retained within the disk by a tapered firtree connection (figures 1 & 2). While most of the turbine blades showed severe mechanical breakage immediately above the base platform, a single blade had broken away from beneath the platform (figure 3). Occurring at the top of the firtree root, the blade fracture was characterised by a stained and discoloured surface that presented several distinct regions (figure 4). The most dominant of these was a zone of fatigue crack progression-marks extending into the section from a small region on the outer surface of the root (concave blade side, figure 5). The total area of fatigue cracking represented around half of the total cross-section at the point of failure; the remainder showing features consistent with ductile overload fracture.

Fig. 1. Forward face of the stage-one turbine wheel – missing blade indicated.

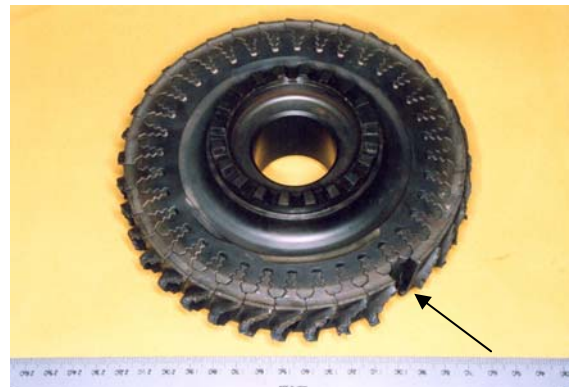
Fig. 2. Rear face of the stage-one turbine wheel – missing blade indicated.

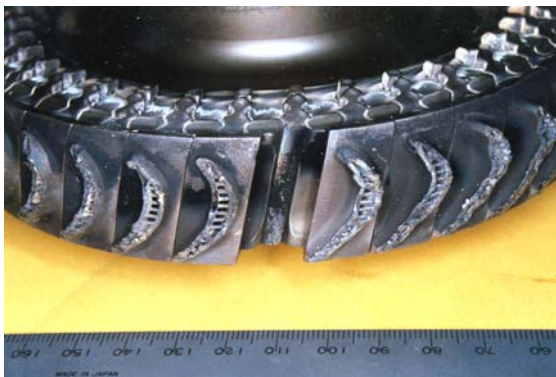
Fig. 3 (Top left). Failure of the turbine blade from beneath the platform base.

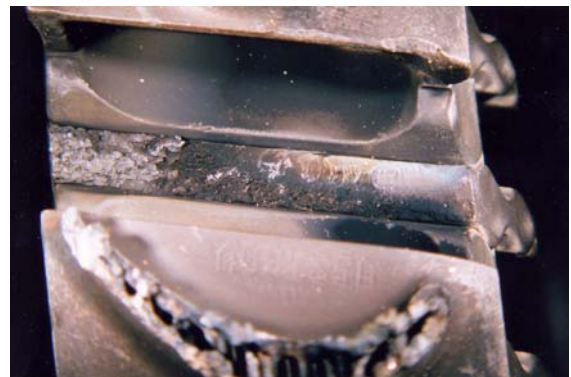
Fig. 4 (Above). Blade fracture surface (as-received).

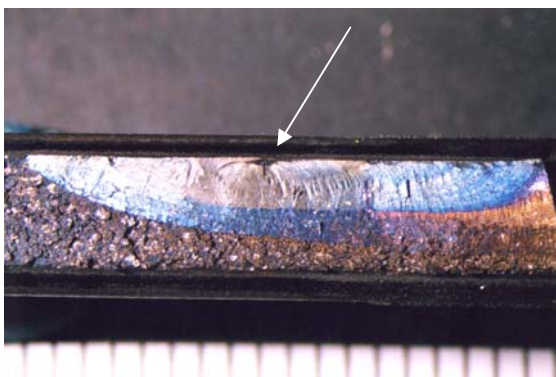
Fig. 5 (Left). Blade fracture surface following cleaning – area of fatigue progression markings clearly visible. Fatigue origin indicated at arrow.

From the results of the investigation, it was evident that the failure of a stage-one turbine blade within the engine assembly was the principal cause of the engine malfunction observed by the aircraft crew. The blade had failed by bending fatigue cracking that had initiated at the top of the firtree root connection. By design, this location was the area of maximum centrifugal and aerodynamic stresses within the blade. Numerous regular arrest marks within the zone of fatigue cracking attested to the propagation of the cracking over multiple flight cycles. Final overload failure of the remaining section occurred after growth of the fatigue cracking to around half of the total root cross-section. The examination found no evidence of pre-existing defects or conditions that could have predisposed the blade to premature failure. The nature of the fatigue damage, with a large area of faceted Stage-I cracking was consistent with high frequency, low-magnitude driving stresses^[1].

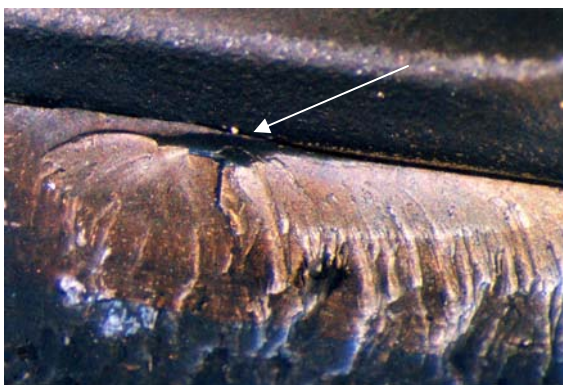
Inspection at low magnification (approx 40X) found the fatigue cracking had initiated from the surface of the root section on the high-pressure (concave) side of the blade. The initial areas of fatigue propagation were characterised as featureless, faceted areas with no visible progression markings and fracture following defined crystallographic planes (figures 6 & 7). Such areas are typical of Stage-I fatigue cracking in nickel alloys. Similar features were observed for some distance along the edge of the fracture (figures 8 & 9). Located at 9.5 millimetres from the forward edge of the blade, the largest faceted area formed the base of several characteristic ‘ratchet’ marks often associated with fatigue crack origins (figure 10). At the higher resolution offered by the scanning electron microscope, the progression of Stage-II fatigue cracking from the base of the faceted area was clearly observed, with regular arrest marks identified (figure 11).

Fig. 6. Close optical view of the fatigue origin (arrowed).

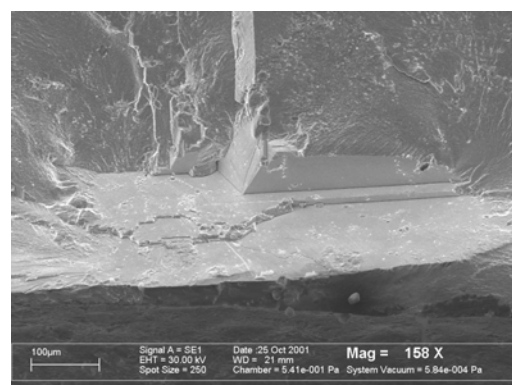
Fig. 7. Faceted appearance of the fatigue origin – typical of Stage-I fatigue crack propagation.

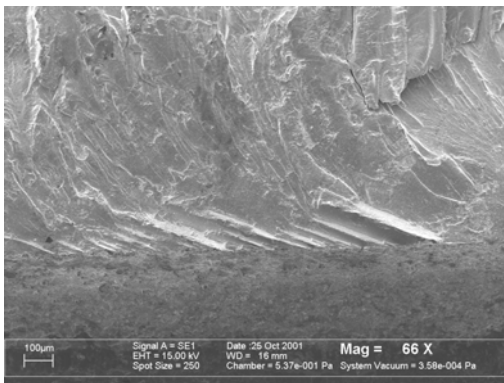
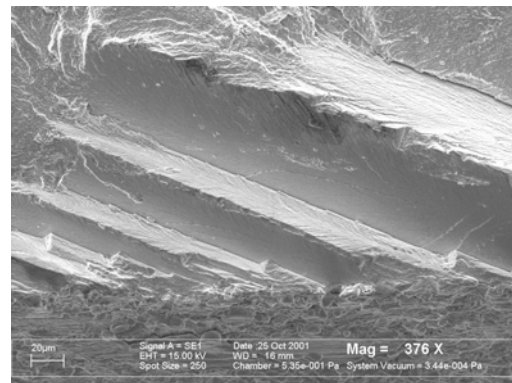
Figures 8 & 9. Other regions of faceted crack formation – again typical of Stage-I fatigue.

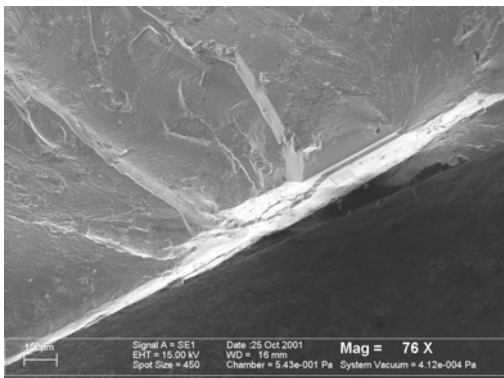
Fig. 10. Electron microscope image of the transition from Stage-I to Stage-II fatigue cracking.

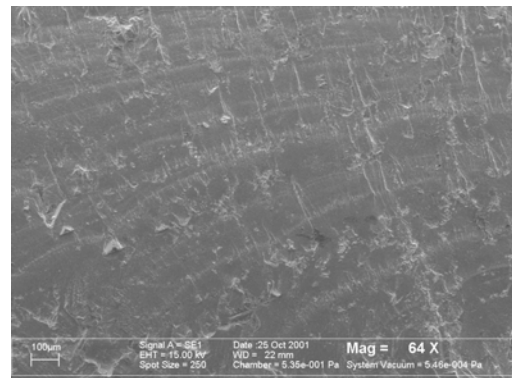
Fig. 11. Electron microscope image of the outer regions of fatigue cracking – regular arrest marks clearly shown.

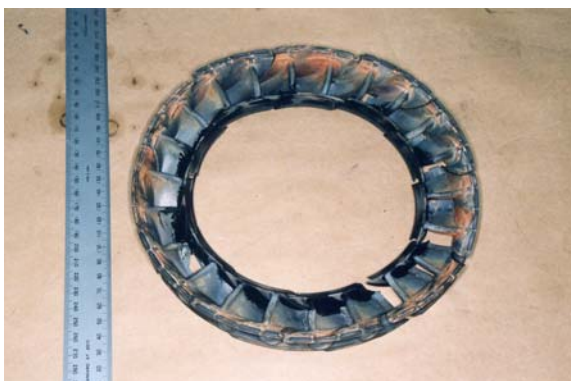
The TPE331-11U turbine inlet guide vane (IGV) assembly comprised of eleven discrete circumferential segments, each containing two guide vanes (figures 12 & 13). As an assembly, the IGV had sustained appreciable mechanical damage during the engine failure – mostly on the outlet side adjacent to the first-stage turbine wheel (figure 14). Many of the guide vanes contained transverse cracking within the leading edge and in some cases, this cracking had developed into appreciable wide-mouthed notching (figure 15). In most areas, cracking of this nature remained confined to a band between six to eight millimetres from the inside platform edge. In the most severe cases, the notching had penetrated the internal air cooling galleries (figure 16).

Fig. 12. Turbine inlet guide vane segments – forward faces.

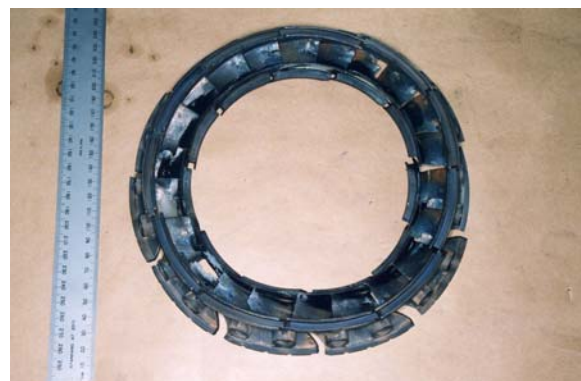
Fig. 13. Turbine inlet guide vane segments – rear faces.

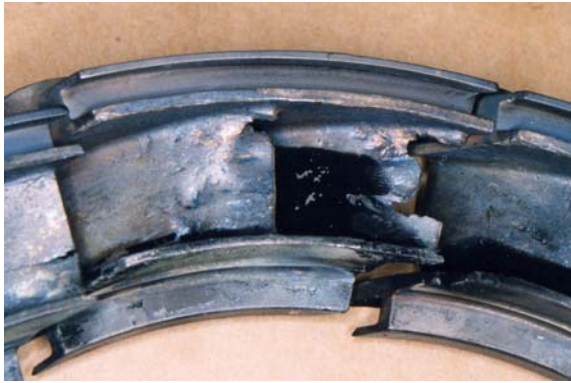
Fig. 14. Mechanical damage to the trailing edges of the inlet guide vanes (typical).

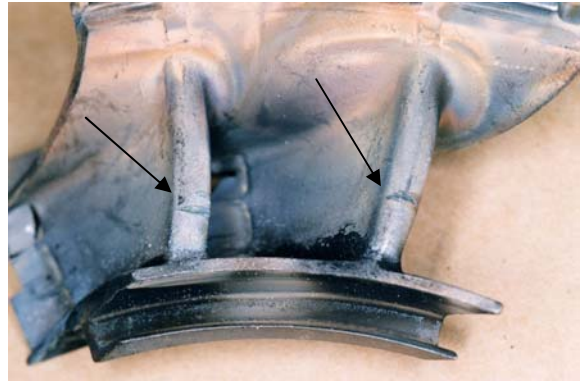
Fig. 15. Thermal fatigue cracking within the leading edges of the guide vanes (arrowed).

The damage to the aerofoil sections of the stage-one IGV assembly was consistent with the effects of thermal fatigue cracking. Expansion and contraction associated with engine temperature changes produces alternating axial stresses in the vanes, which subsequently leads to fatigue crack initiation once sufficient cycles have accumulated.

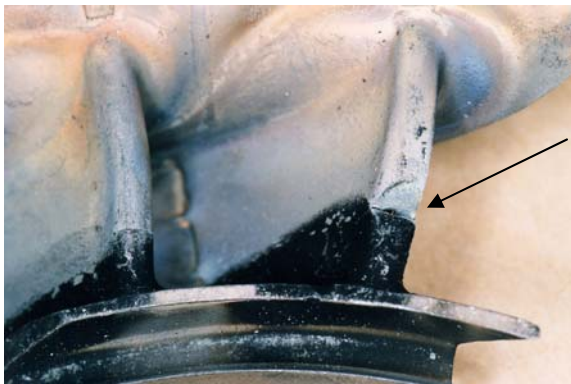
Fig. 16. Advanced thermal fatigue cracking, developed into notches that penetrated the vane cooling galleries.

Growth of these cracks into the aerofoil body leads to the perforation of the internal cooling galleries and the disruption of the circulating airflow. Deprived of cooling, the vanes rapidly overheat, oxidise and fail in the manner observed.

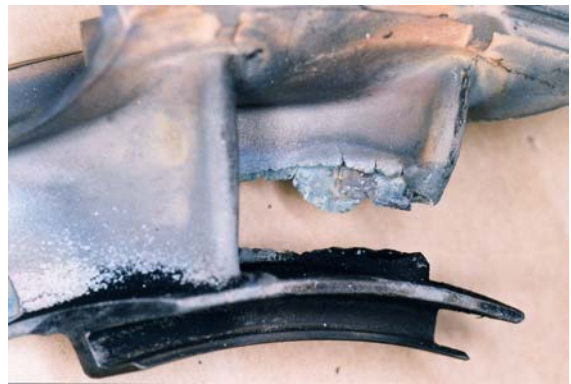
It was apparent from early inspections that one of the eleven IGV segments had sustained the complete ‘burn-through’ failure of a single vane (figure 17). The centre of the affected area was coincident with the location of the leading edge notches found on the other vanes. Consistent with overheating and oxidation, the edges of the affected area were thinned and friable and showed a pronounced discolouration of the surface oxide. The failed segment carried the following identification:

Fig. 17. Destruction of a guide vane from the effects of overheating and oxidation.

The damage and loss of an inlet guide vane would disturb the flow of high-pressure combustion gasses through the assembly. Given that the stage-one turbine is driven by gas flow through the guide vanes, each turbine blade would experience a once-per-revolution impulse on passing the damaged vane. In this situation, the excitation of resonance or vibration is likely, producing the type of high-cycle, low-magnitude stresses necessary for fatigue crack initiation and growth. The nature of the fatigue cracking experienced and the absence of cracking in any of the other blades suggests the stress level was only marginally above the threshold necessary for fatigue development.
