# Collision with terrain

## Proserpine/Whitsunday Coast Airport, Qld

### 2 April 2009

On 2 April 2009, a flight instructor and student pilot in a Robinson Helicopter Company R22, registered VH-YDA, were conducting normal circuit and autorotation training at Proserpine/Whitsunday Coast Airport, Qld. At 1400 Eastern Standard Time, the helicopter collided with terrain on the grass at the side of the departure end of runway 11. The helicopter was seriously damaged and the instructor was seriously injured.

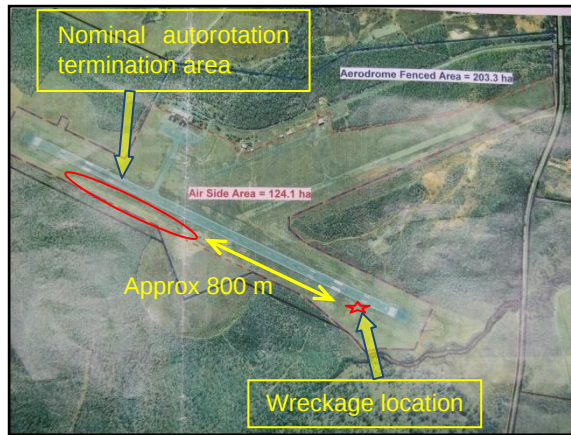
**Figure 1: Proserpine/Whitsunday Coast Airport**

The accident site was located adjacent to the departure end of runway 11, 16 m from the southern side of the runway. The accident site was between 800 and 1,600 m from the area reportedly used for power recovery termination after the autorotations (Figure 1).

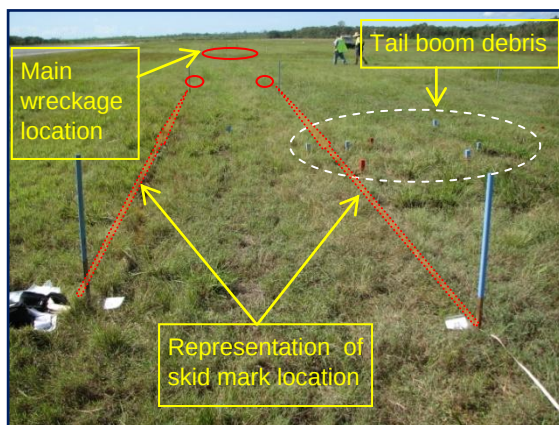
**Figure 2: Ground marks at the accident site**

Parallel skid marks about 10 m long and running parallel to runway 11 were found on the ground at the accident site. The debris from the tail boom section of the helicopter was located about 5 m from the start of the skid marks (Figure 2).

The compression damage to the helicopter structure indicated a high rate of descent, and the distance between the two sets of ground marks indicated significant forward speed at the time of impact.

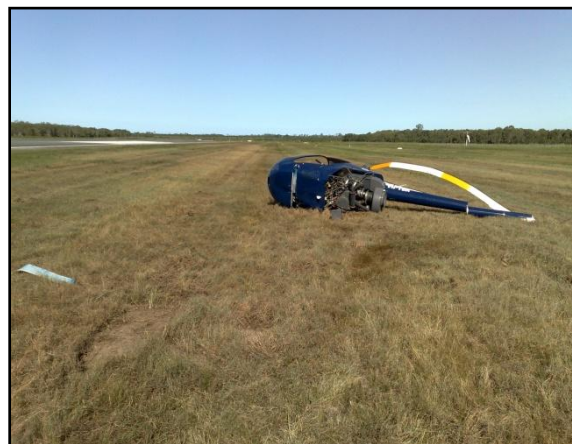
**Figure 3: Helicopter wreckage on site**

About 2 m beyond the end of the skid marks, were two holes 1.98 m apart, consistent with the width of the helicopter's skid landing gear. About 62 m further on, there were impact marks and debris where the helicopter came to rest (Figure 3).

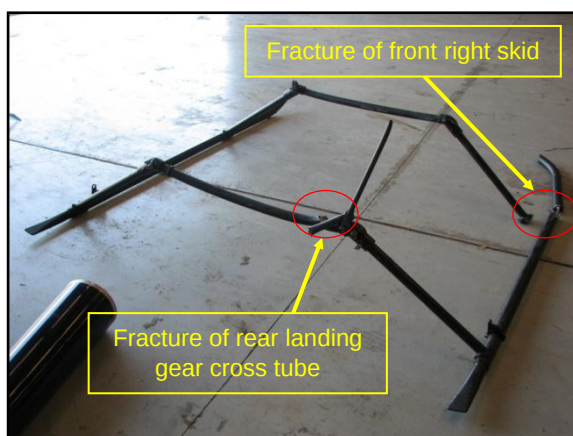
**Figure 4: Skid landing gear assembly**

The landing gear skids displayed vertical impact loads and some torsion damage (Figure 4).

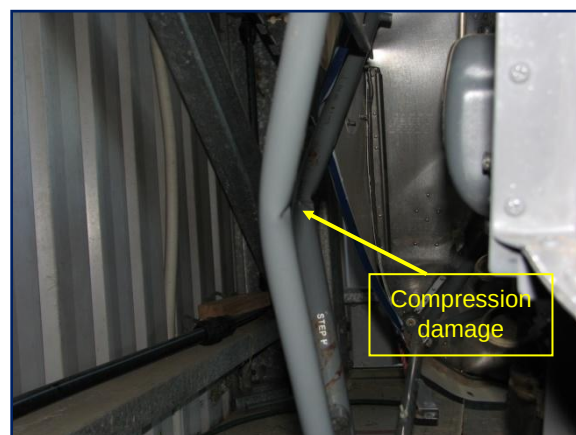
**Figure 5: Compression damage to the left engine frame**

The tubular steel engine frame above the left rear skid attachment had compression damage as a result of high landing energy. The tubular steel frame above the right rear skid attachment had fractured and displayed compression and twisting damage (Figure 5).

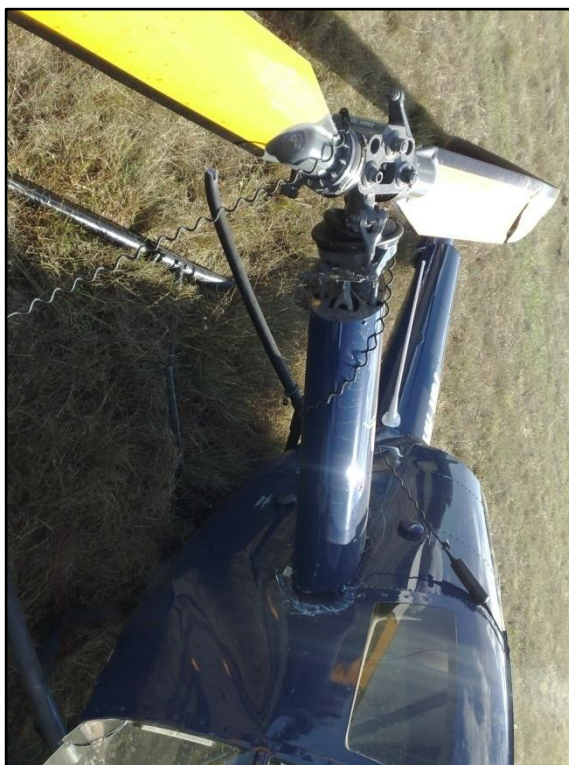
Figure 6: Instructor's headset cable and main rotor mast

The instructor received a full-thickness laceration of the rear section of the scalp, with exposure of the skull. This wound required about 60 stitches. The shape and extent of the injury was consistent with the instructor being struck by a rotating main rotor blade during the accident sequence. That was supported by the instructor's headset cable being found wound around the main rotor mast and hub (Figure 6).

In this occurrence, the helicopter's left door was removed, as permitted by the R22 Pilot's Operating Handbook (POH), and the instructor, who was seated by the open doorway, sustained the more serious injury of the two pilots. Given the instructor was probably struck by a main rotor blade, and that the blades did not enter the cabin, the instructor was probably partially outside the cabin at some time during the accident sequence. If the left door had been installed, the instructor might have been confined to within the cabin during the accident and avoided a serious injury.

The non-availability of a 4-point harness for the R22 means that R22 pilots are afforded less upper body restraint compared with the belt/inertia reel pilot restraints that are fitted. If door(s)-off operation is considered necessary, operators should consider reducing the risk of occupant injury in an accident by requiring the wearing of safety helmets by pilots when engaged in emergency training.

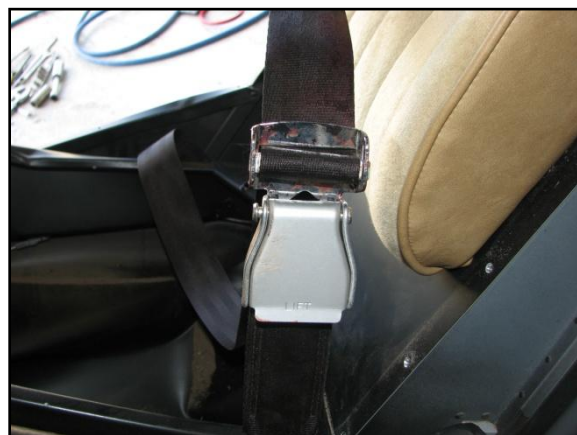
Figure 7: Combined seat belt and inertia-reel shoulder strap.

The standard seat belt installation in the R22 included a combined seat belt and inertia-reel shoulder strap (Figure 7). The helicopter manufacturer confirmed that only the 3-point harness was available on the R22 as the airframe structure did not allow for a 4-point harness.<sup>5</sup>

No damage or defects were found on the seatbelts worn by the instructor and student.
