**ATSB TRANSPORT SAFETY REPORT**  
Occurrence Investigation Report AO-2007-046  
Final

**Collision with terrain**  
**Doongan Station, WA**  
**25 September 2007**  
**VH-HCN**  
**Robinson Helicopter Company R22**  
**Beta II**

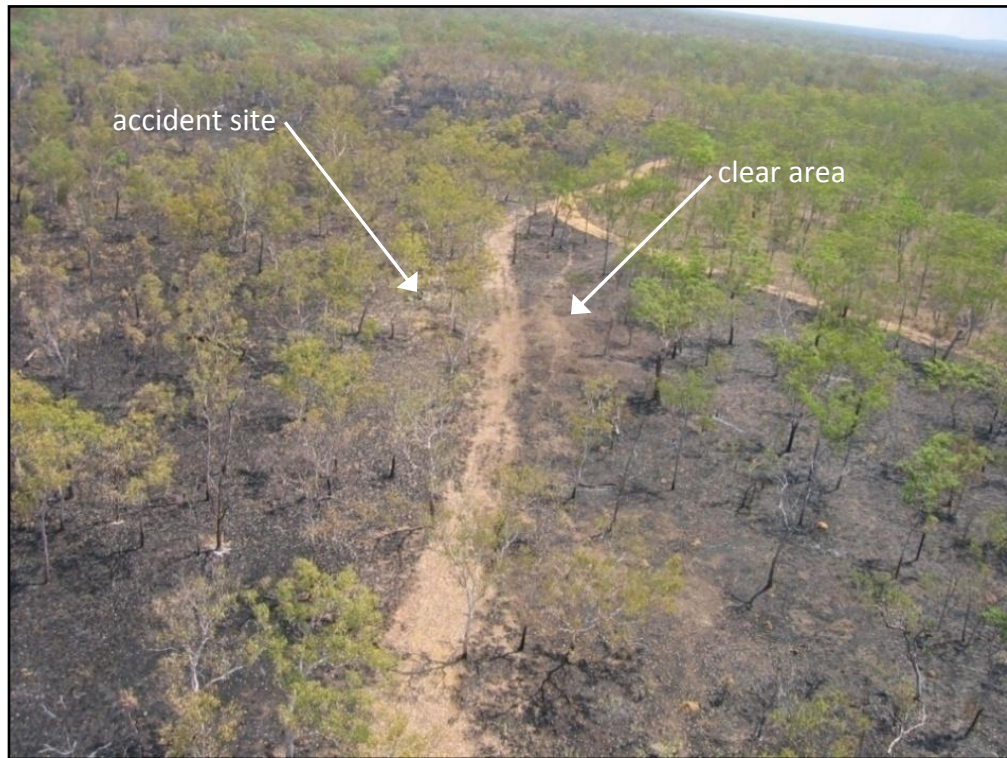
**Figure 5: Accident site looking along the approximate flight path**

The accident occurred over flat terrain with numerous small and medium eucalypt trees covering the site and surrounding area. The elevation of the accident site was about 1,200 ft above mean sea level (AMSL). Due to the surrounding trees, the accident site was not considered suitable to land an R22, although an adjacent clear area could have accommodated the helicopter (Figure 5).

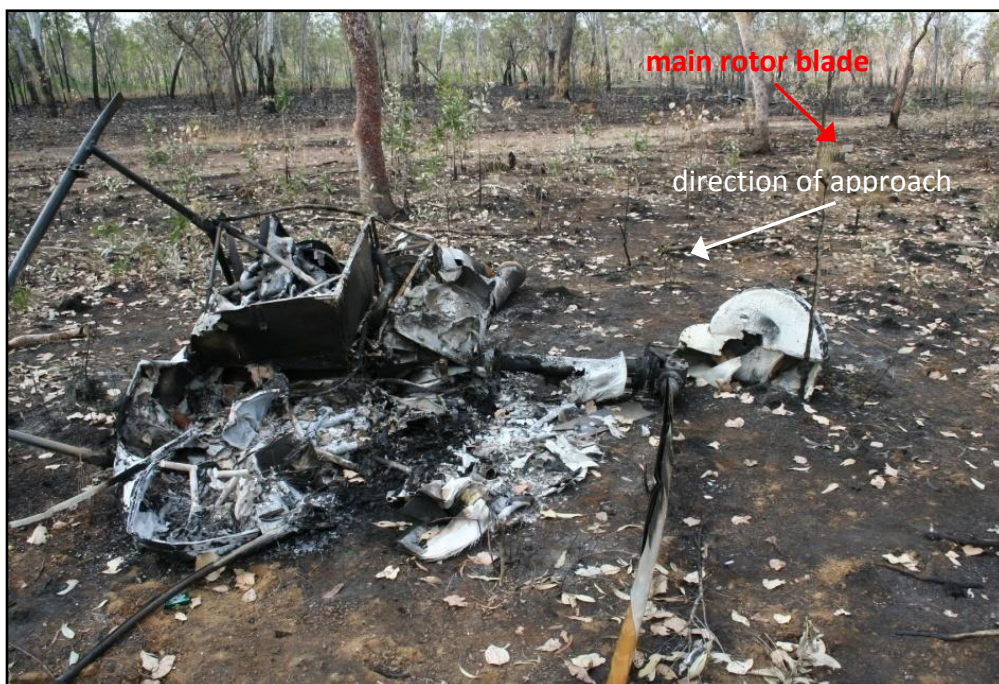
Figure 6: Helicopter wreckage

The helicopter contacted four trees before impacting the ground in a steep nose-down, left skid-low attitude. The helicopter came to rest on its left side a further 13 m along the direction of approach (Figure 6). One of the main rotor blades had fractured and separated from the helicopter and was located about 15 m from the wreckage (Figures 6 and 7). A severe fire consumed the majority of the helicopter and ignited the surrounding vegetation.

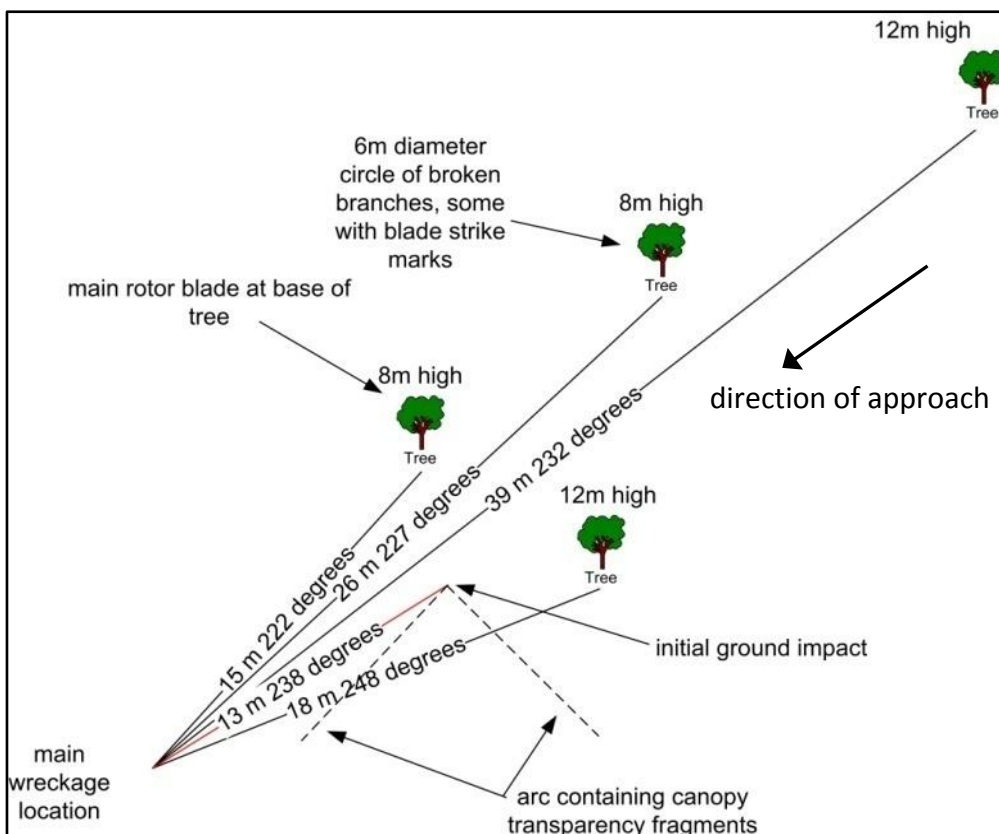
Figure 7: Wreckage diagram

On-site examination of the wreckage accounted for all major parts of the helicopter. It was not possible to verify the integrity of the entire flight control system as sections of the aluminium control tubing were destroyed by fire. However, all steel components associated with the collective, cyclic and tail rotor pedal flight controls

Both V-belts were destroyed by the fire, although charred remains of the V-belts were noted on the ground in the area of the engine and adjacent structure of the main wreckage. No evidence of the V-belts was found within the grooves of either the upper or lower sheaves.

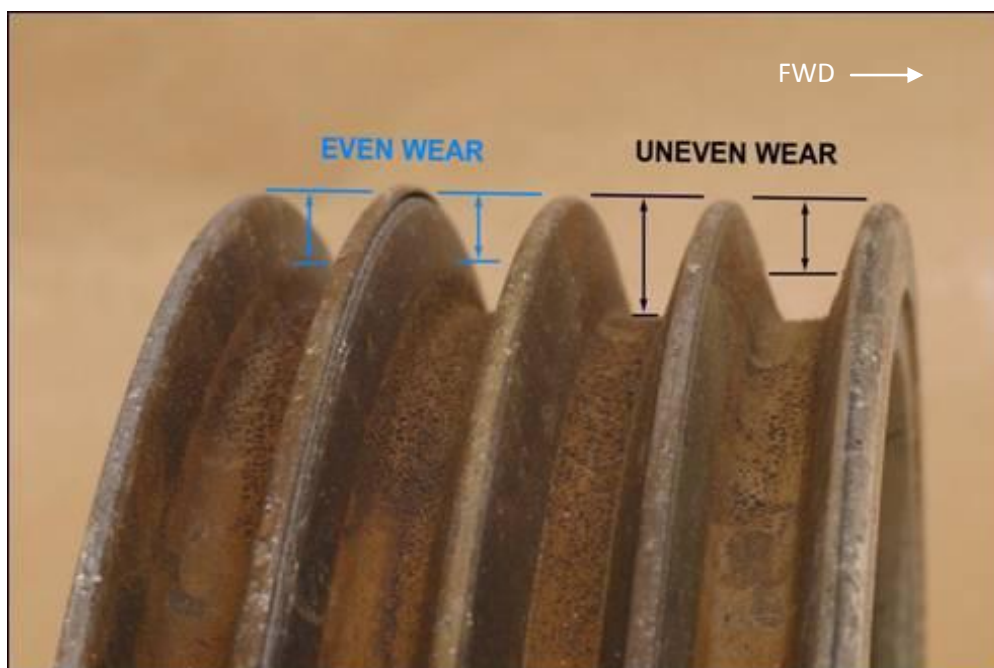
**Figure 8: Upper sheave wear pattern**

Examination of the upper drive sheave identified that the wear-resistant metallised coating was in a generally poor condition, with complete wear through to the aluminium alloy substrate in some areas.

Additionally, there was considerable variation in the primer wear pattern within the grooves of the upper sheave (Figure 8). The helicopter manufacturer advised that such variation in wear pattern was consistent with the front V-belt operating in a significantly damaged condition. The operator advised that the primer had been applied to the sheave as part of the recent replacement of the V-belts.

Sectioning of both sheaves indicated a variation in the thickness of the wear-resistant coating that was indicative of the helicopter's belt drive system operating out of alignment for some period of time. It was not possible to determine if the sheaves were misaligned at the time of the accident as the wear pattern could have been due to previous extended periods of misaligned operation. Examination of the sprag clutch and bearings (see section on *R22 rotor drive system*) did not reveal any damage, other than due to fire, which would have prevented normal operation.
