ATSB TRANSPORT SAFETY REPORT  
Aviation Occurrence Investigation AO-2009-009  
Final

# Collision with terrain

## 8 km NW of Donors Hill Station, Qld

### 24 February 2009

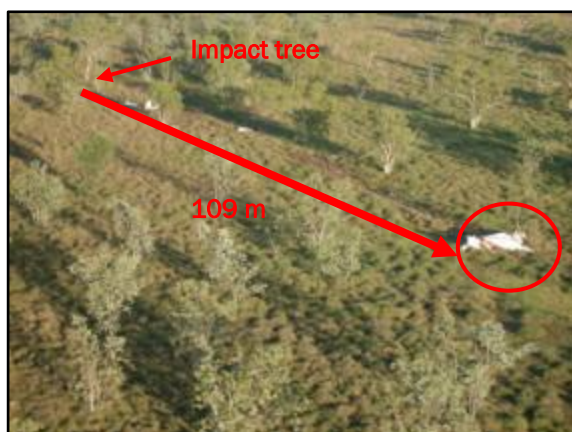
The wreckage trail extended about 109 m from the aircraft's initial impact with a tree to the main wreckage (Figure 1). The wreckage path was oriented on a track of approximately 085° M. The elevation of the wreckage site was 235 ft above mean sea level (AMSL).

**Figure 1: Aerial view of wreckage site<sup>3</sup>**
