**ATSB TRANSPORT SAFETY REPORT**  
Occurrence Investigation Report AO-2007-070  
Final

**Leading edge device failure**  
**Norfolk Island**  
**29 December 2007**  
**VH-OBN, Boeing 737-229**

**Leading edge device failure  
Norfolk Island**

**VH-OBN, Boeing Company 737-229**

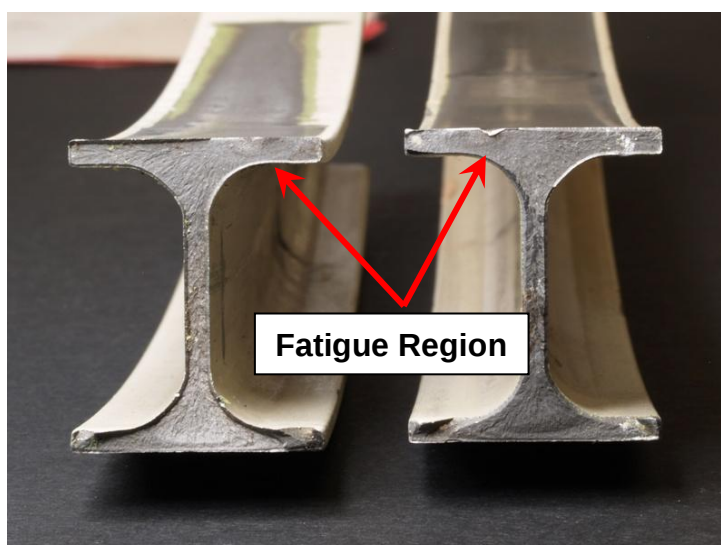
**Figure 3: Inverted mating halves of the Slat Track fracture**

A visual examination of the fracture surfaces showed evidence of a fatigue crack that extended across a substantial portion of the lower flange<sup>15</sup> (Figure 3). A series of machining marks were also observed on the upper and lower track surface. Those marks were considered to be associated with the manufacture of the track. Optical and scanning electron microscopy revealed that the fatigue crack origin was adjacent to the area where two of these machining marks intersected.

The inboard main slat track failed as a result of a fatigue crack that initiated and propagated on the lower rolling surface. Measurements taken of the track indicated that the failure occurred about 15 mm forward of the leading upper track roller,

The orientation of the associated fatigue region along the machining marks indicated that the marks probably acted as a local stress concentrator. The fatigue initiation point was potentially also influenced by the pitting of the rolling surface. The machining marks were a normal product of the manufacturing process, and were also evident on the aircraft's other slat tracks that did not fail.

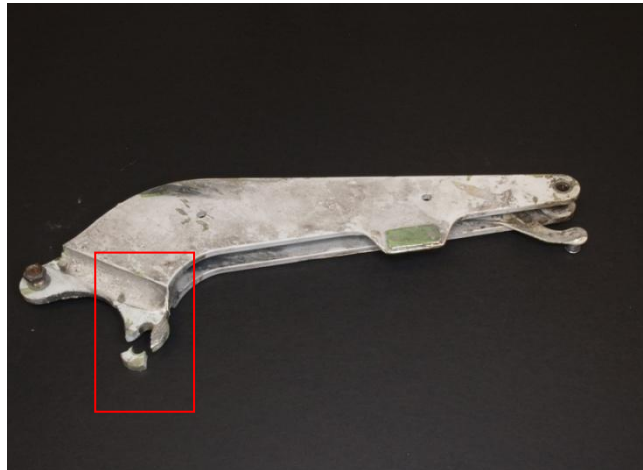
**Figure 4: Inboard auxiliary track showing failed bolt hole (highlighted)**

The inboard auxiliary track was found to have failed in ductile overload through one of its bolt holes. That bolt hole had also elongated in the direction of the liberated section. The material around the bolt hole was scored, consistent with the movement of the track in the support (Figure 4).

Similarly, the appearance of the inboard auxiliary track failure was consistent with a rapid overload fracture.

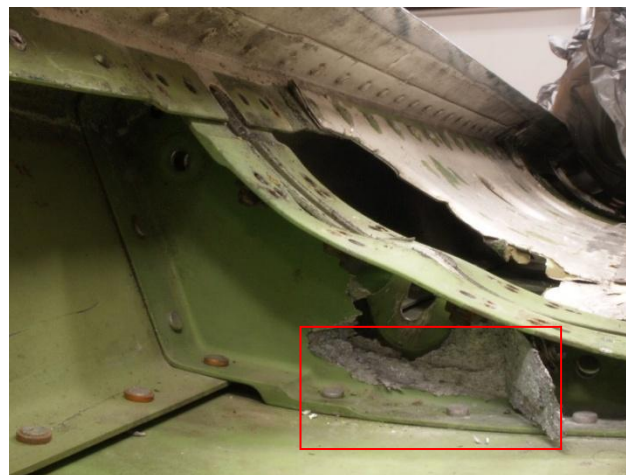
**Figure 5: Outboard auxiliary track attachment corrosion**

One of the support ribs on the outboard auxiliary track had failed as a result of extensive exfoliation corrosion<sup>16</sup>. The corrosion was centred adjacent to the cadmium-plated steel bolt that attached the track to the slat ribs. The remaining rib failed through the bolt hole, which had fractured up to the rib flange. The flanges on both ribs had buckled outwards and were fractured along their length (Figure 5).

The location of the exfoliation corrosion around the outboard auxiliary track bolt hole, indicated that the corrosion protection in and around that hole had broken down, leaving the region susceptible to corrosion damage. The corrosion in the auxiliary track rib had been present for a considerable period of time, but had not been identified in the previous detailed slat inspection, 495 hours prior to the incident. The investigation could not determine if the corrosion originated prior to the last maintenance inspection; however, its detection during that inspection was unlikely, as it was hidden behind a riveted panel.

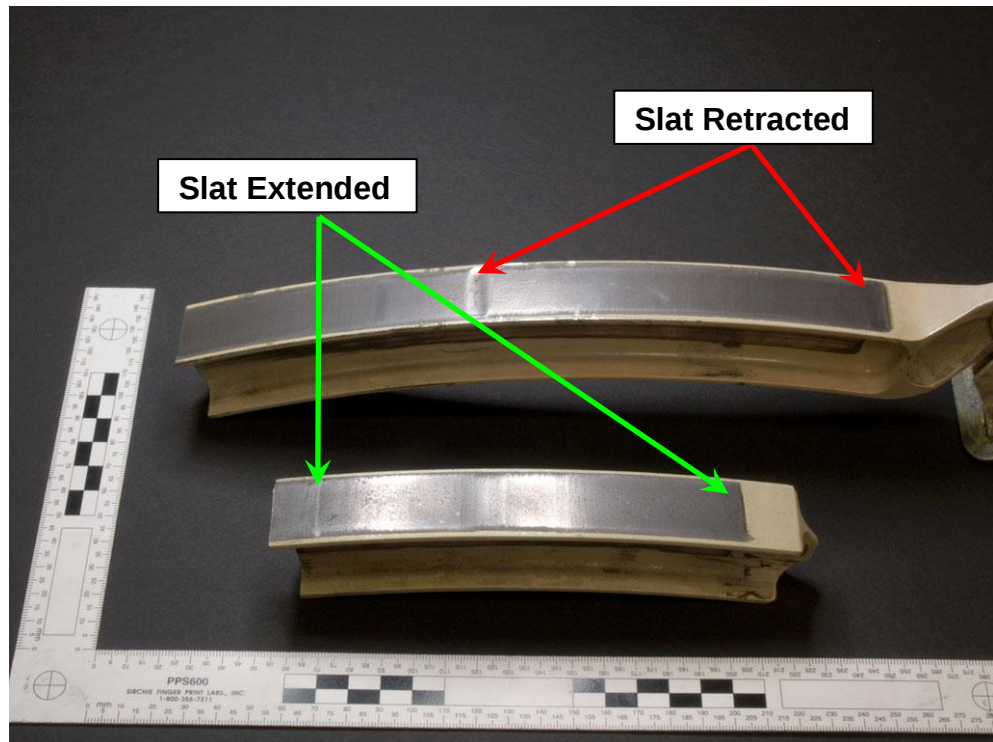
The inboard main track assembly had fractured close to the mid-span position. Areas of heavy wear on the rolling surfaces consistent with the location of the main track rollers were observed. The most significant wear was associated with the upper track rollers when the slat was in the fully-retracted position. The outboard main track showed similar wear patterns, but was otherwise undamaged.

**Figure 3. Main upper track roller wear marks**

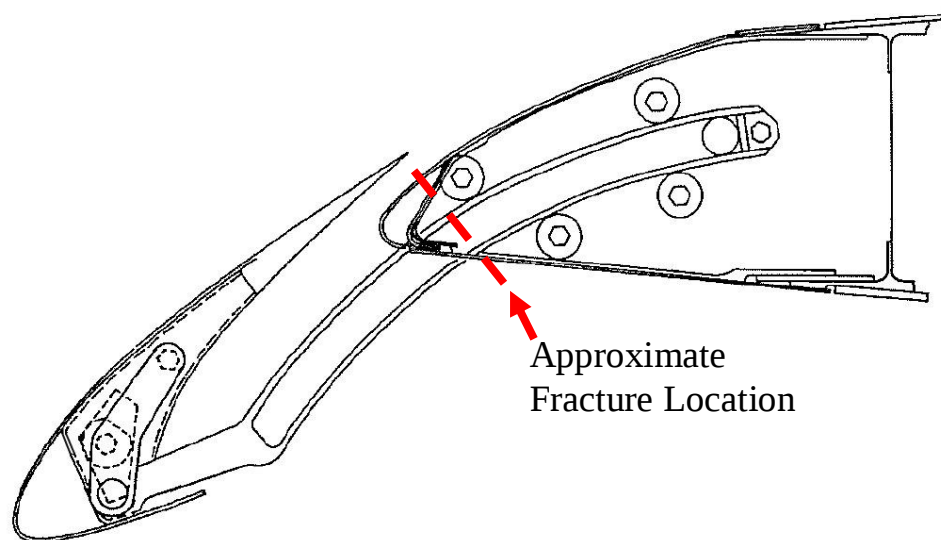
with the slat in the fully-extended position. The failure occurred at a location considered to be the maximum load point when fully extended due to the generation of lift and upward forces acting on the slat in that position.

**Figure 4. Fully extended slat indicating fracture location\***

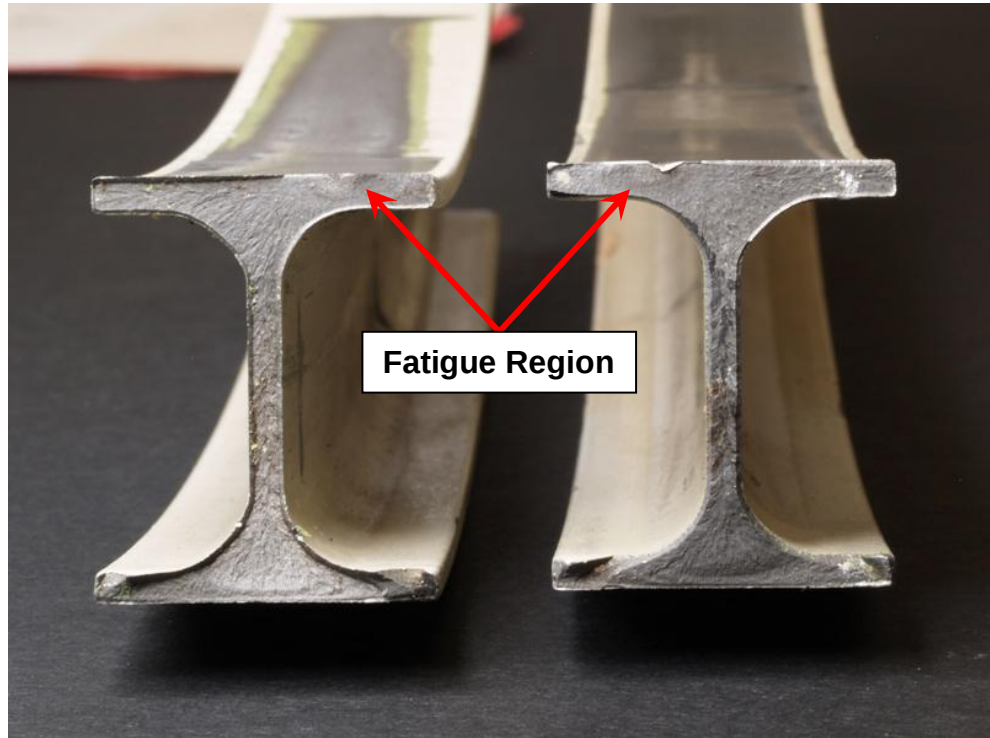
**Figure 5. Mating halves of Slat Track fracture**

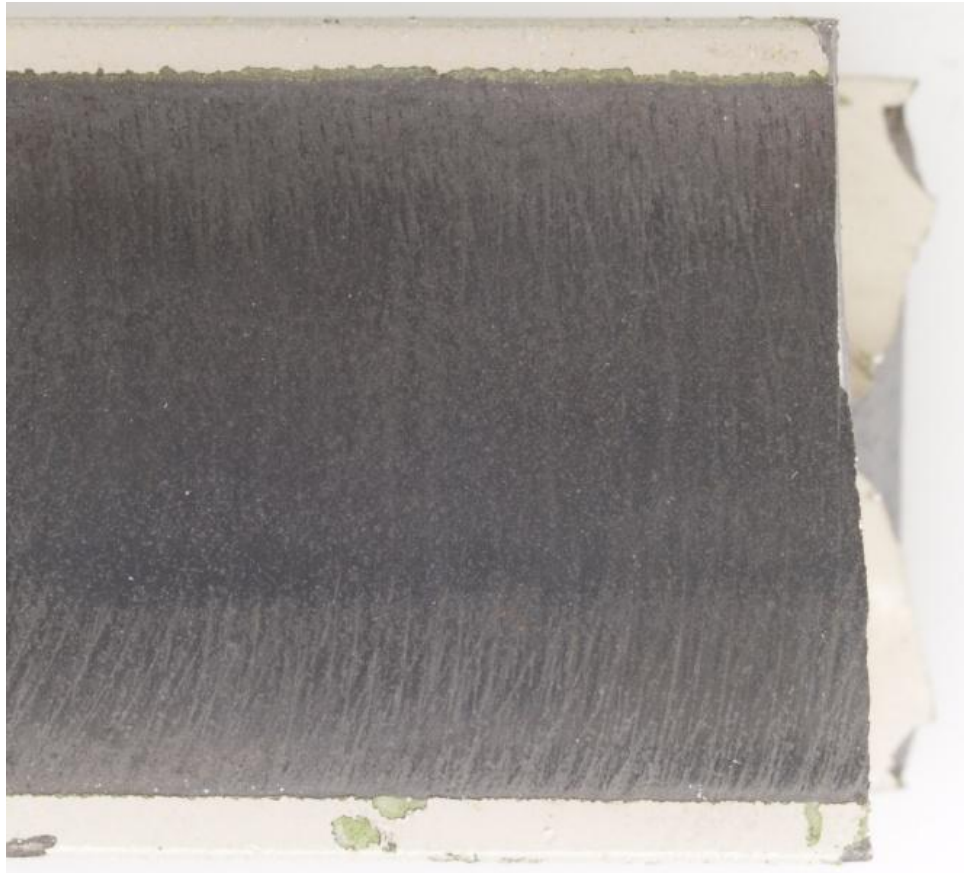
A series of machining marks was observed on the upper and lower track surface (Figure 7). The marks were predominantly visible at the edges of the track, indicating that they had probably been worn away in the centre by the track rollers. The marks were also visible under the paint which indicated that they were probably associated with the manufacture of the track.

**Figure 7. Machining marks on track rolling surface**

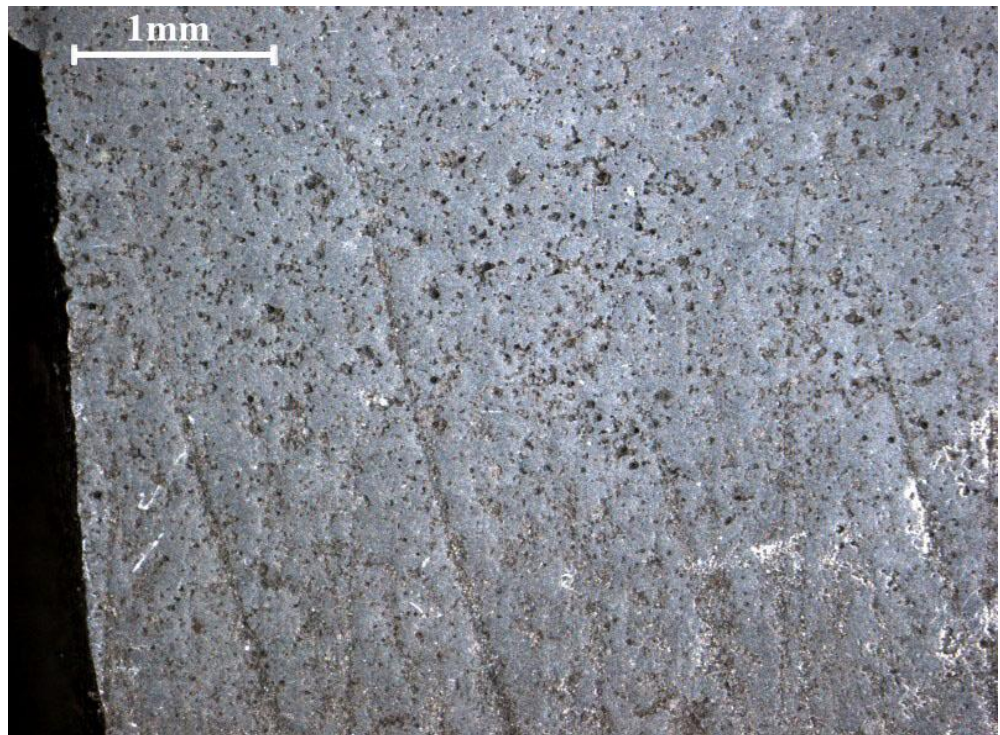
**Figure 8. Pitting on the lower flange adjacent to the fracture surface**

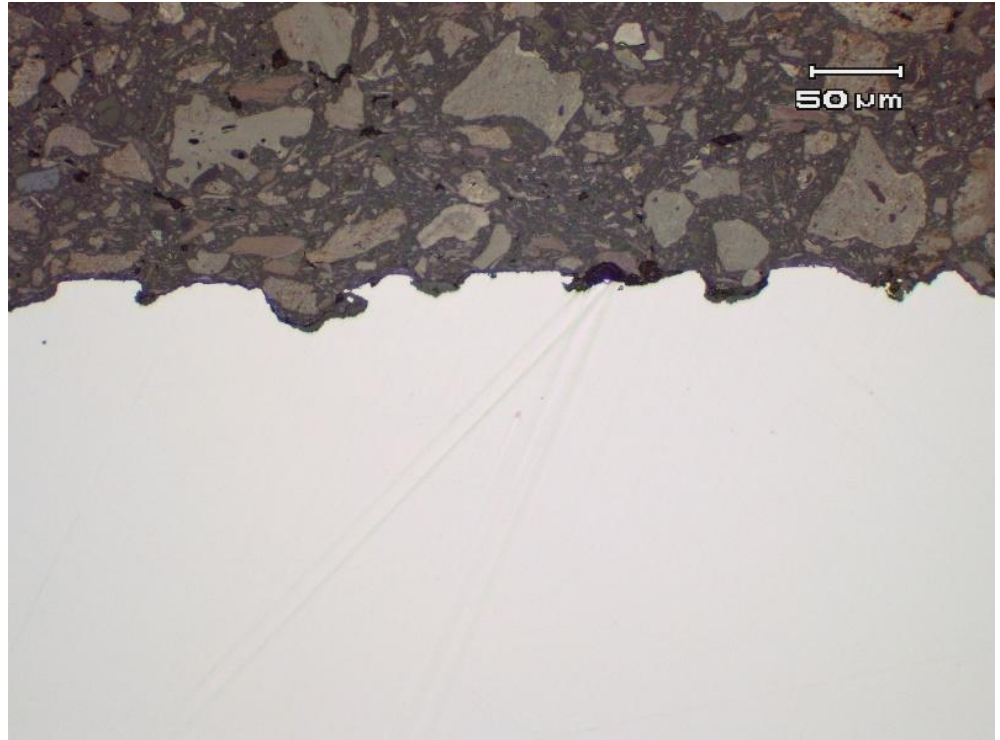
**Figure 9. Cross section showing pitting of rolling surface**

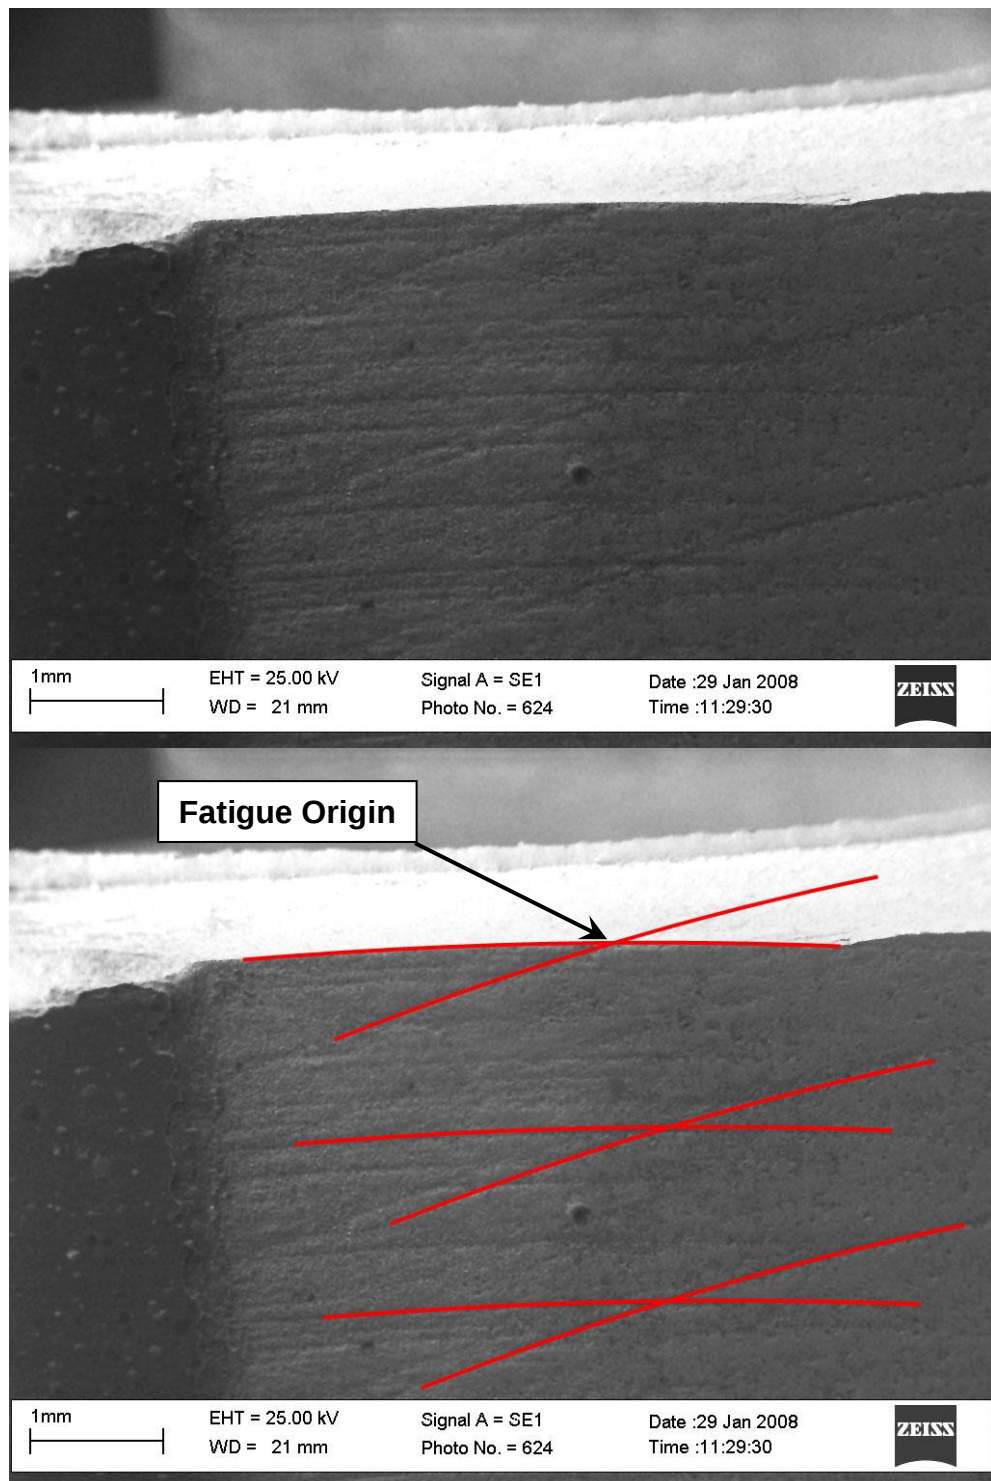
Figure 10. SEM image of machining marks adjacent to fatigue origin.

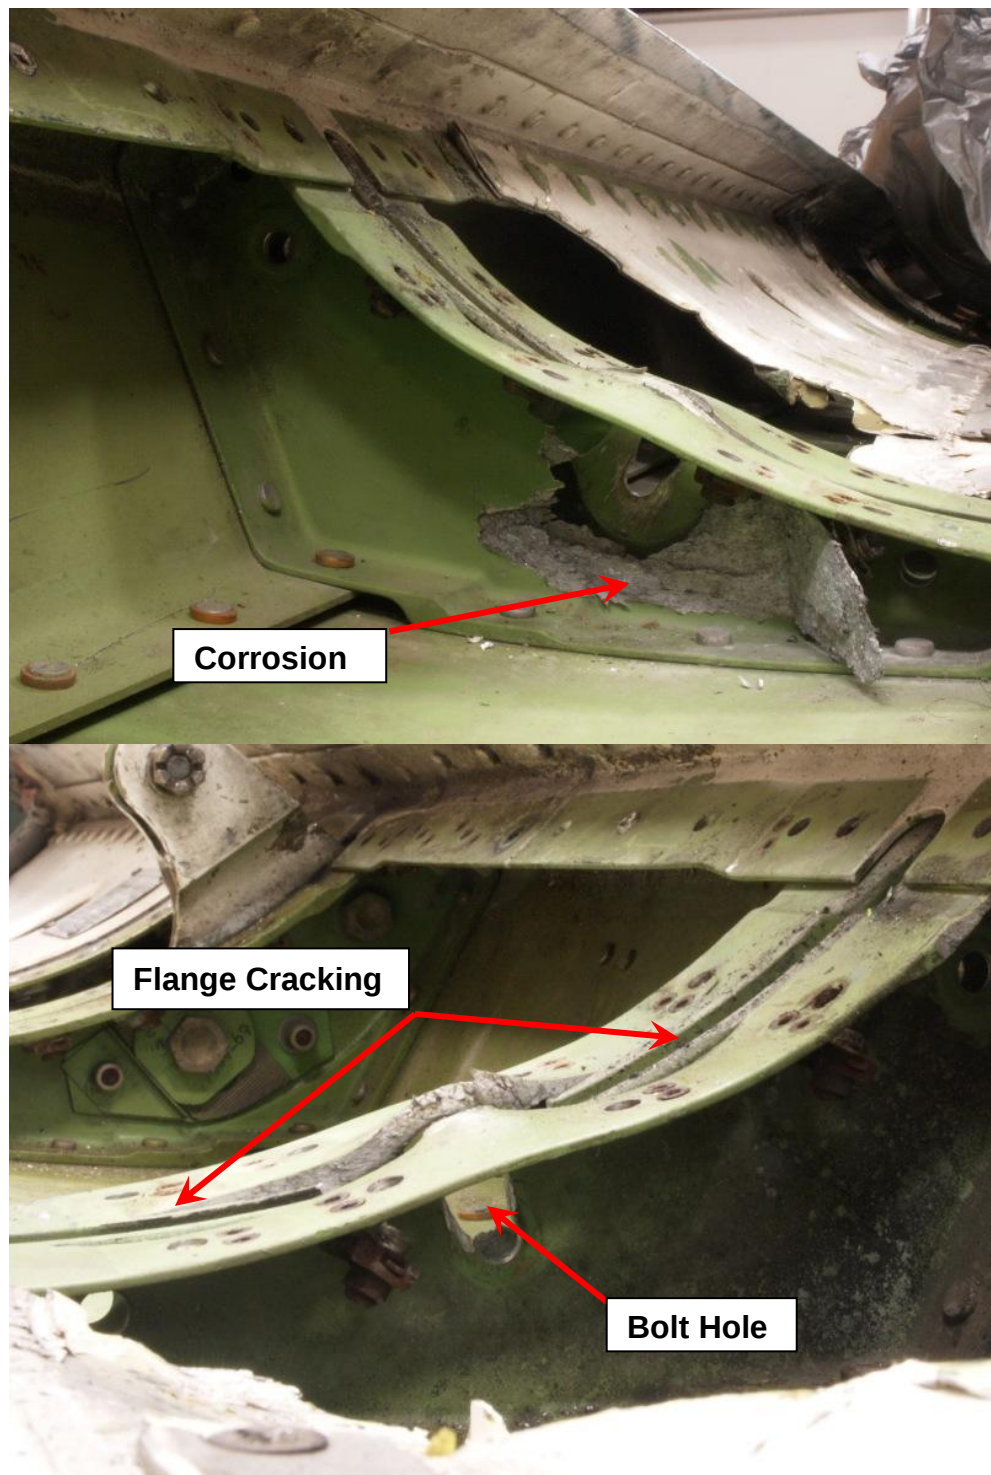
One of the aluminium support ribs for attachment of the outboard auxiliary track had failed as a result of extensive exfoliation corrosion (Figure 13). The corrosion was centred around the cadmium-plated steel bolt attaching the track to the ribs. The remaining rib failed through the bolt hole, which had fractured up to the rib flange. The flanges on both ribs had buckled outwards and were fractured along their length.

Figure 13. Outboard auxiliary track support ribs
