**ATSB TRANSPORT SAFETY REPORT**

Aviation Occurrence Investigation – AO-2008-010

**Mid-air collision**

Mid-air collision - 53 km NNW of Gascoyne Junction, WA - 13 February 2008 - VH-OUS, Piper Aircraft Corporation PA-18 Super Cub, VH-ZDP, Robinson Helicopter Company R44 Raven

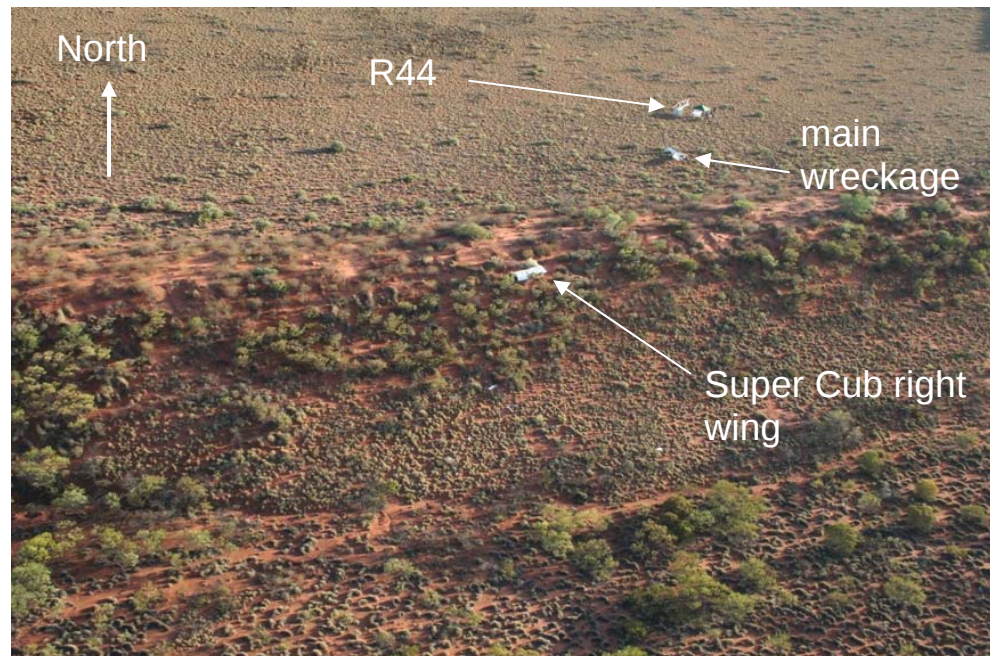
**Figure 4: Accident site**

The accident occurred over relatively flat terrain characterised by regular sand ridges 20 m high and orientated approximately east to west (Figure 4). The elevation of the accident site was about 1,150 ft.

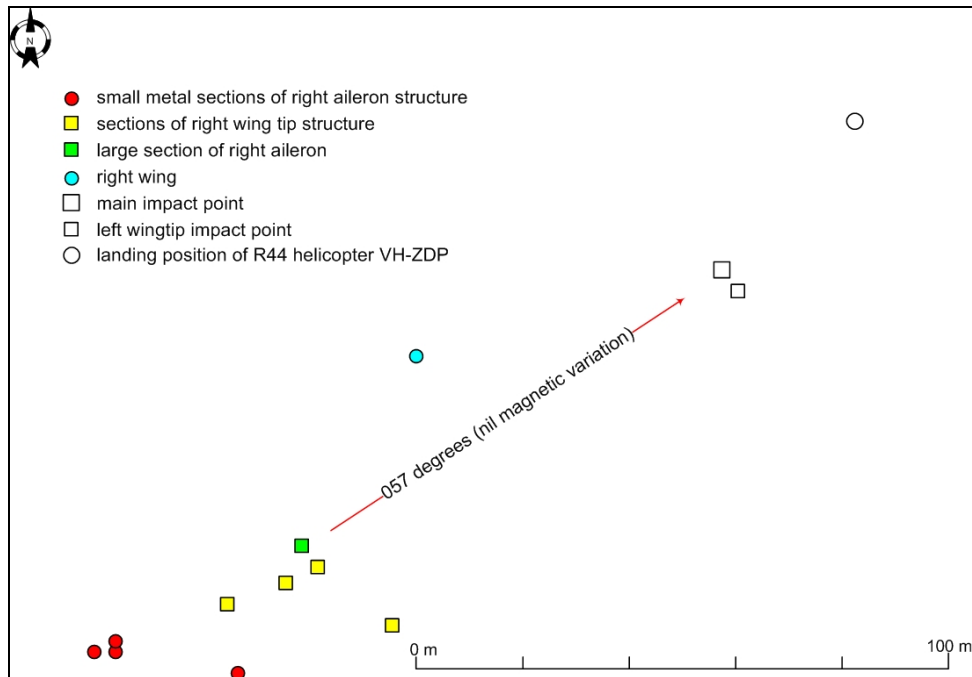
**Figure 5: Super Cub wreckage trail**

The wreckage trail of the Super Cub was orientated about 057° and extended about 130 m across a sand ridge. The wreckage trail comprised the right wing and associated aileron and wing tip structure, and the main wreckage (Figure 5).

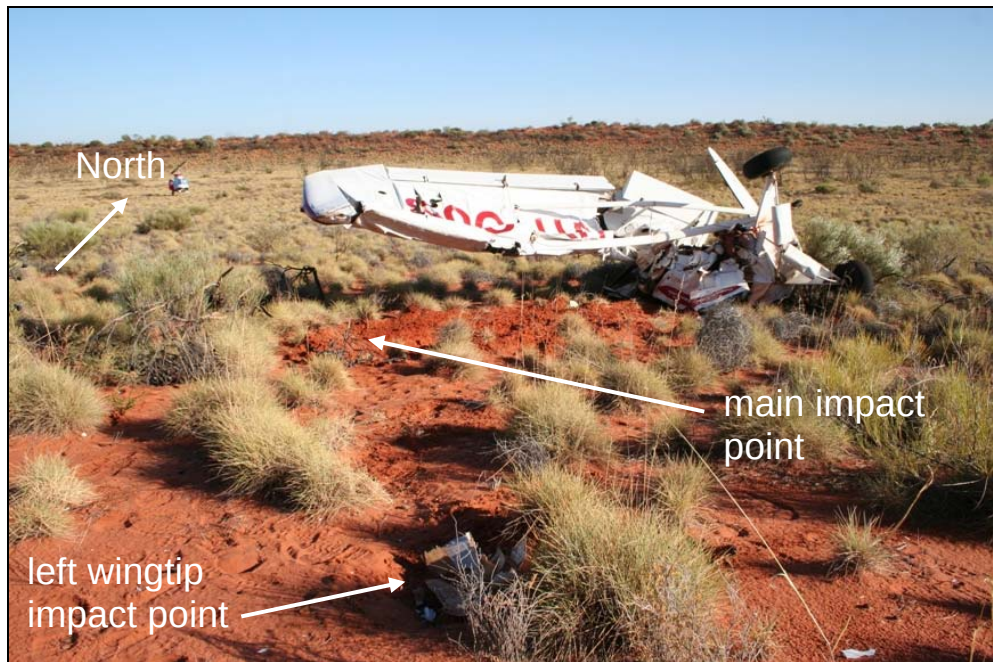
**Figure 6: Super Cub wreckage**

The aircraft impacted the ground inverted in a steep, nose-down attitude. Following the initial impact, it rotated to the right before coming to rest inverted, a short distance from the initial impact point (Figure 6). Upon landing after the collision, the R44 occupants observed fuel was leaking from the left wing fuel tank of the Super Cub.

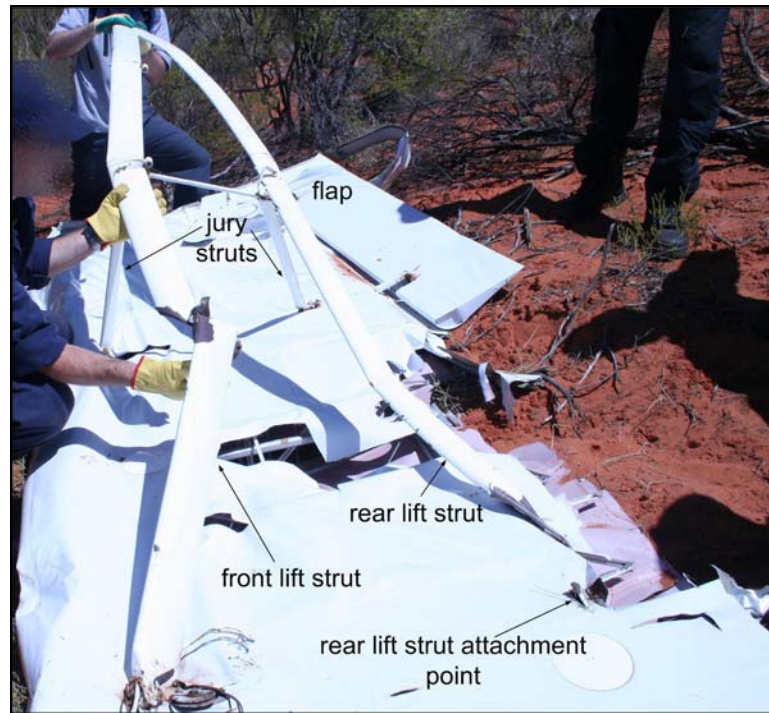
**Figure 7: Wing and lift strut damage**

The contact damage to the Super Cub was limited to the right wing and associated support struts, with the R44 main rotor blades severing both wing lift struts and impacting the wing rear spar, aileron and wing tip (Figures 7 and 8). Following the severing of the lift struts, the wing fractured at the inboard attachment fittings and detached from the fuselage in flight.

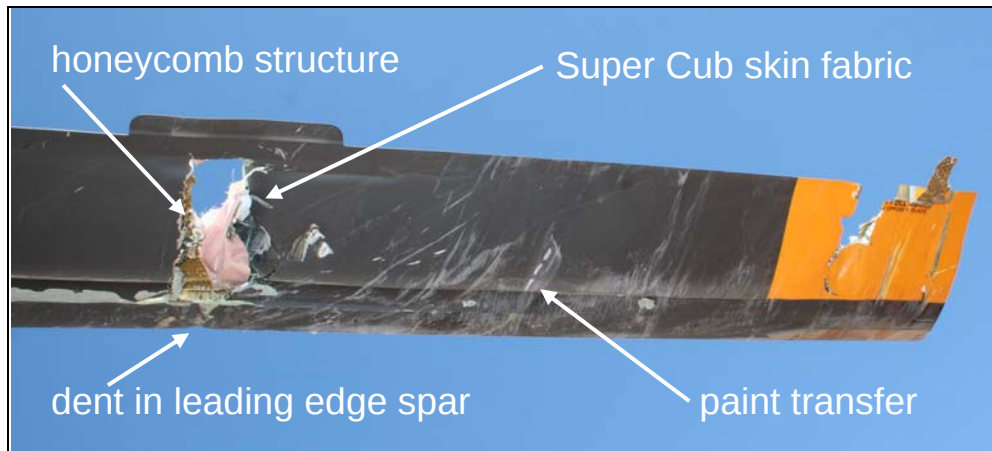
**Figure 9: Main rotor blade damage**

There was substantial damage to one of the main rotor blades consistent with the in-flight contact with the Super Cub's right wing (Figure 9). A section of the blade's skin and honeycomb structure was forced upwards between the leading

edge spar and the trim tab, with part of the Super Cub's wing fabric retained within the blade. In addition, the blade tip had a section of the skin and honeycomb missing at the trailing edge. Both main rotor blades showed paint transfer along most of their length, and there were creases on the lower surface of the blades' skin.

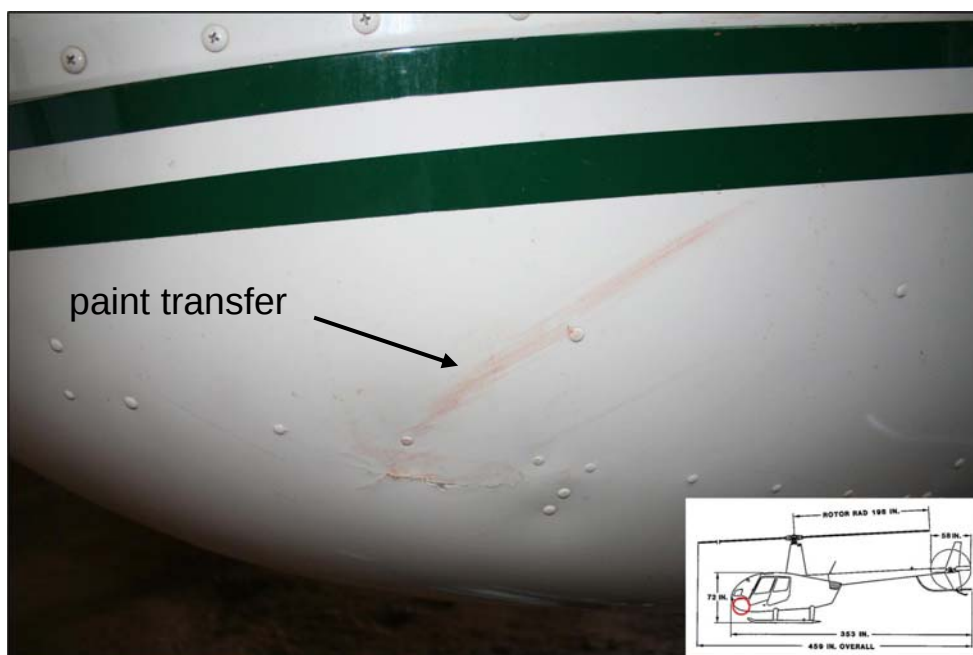
**Figure 10: Chin bubble paint transfer**

There was also evidence of paint transfer and impact damage on the lower left area of the R44's chin bubble (Figure 10), consistent with contact between the helicopter and the Super Cub's right wingtip. The R44 pilot reported that that contact resulted in buckling of the floor pan.

The investigation was unable to determine at what point in the collision sequence the contact occurred between the R44 chin bubble and the aeroplane.

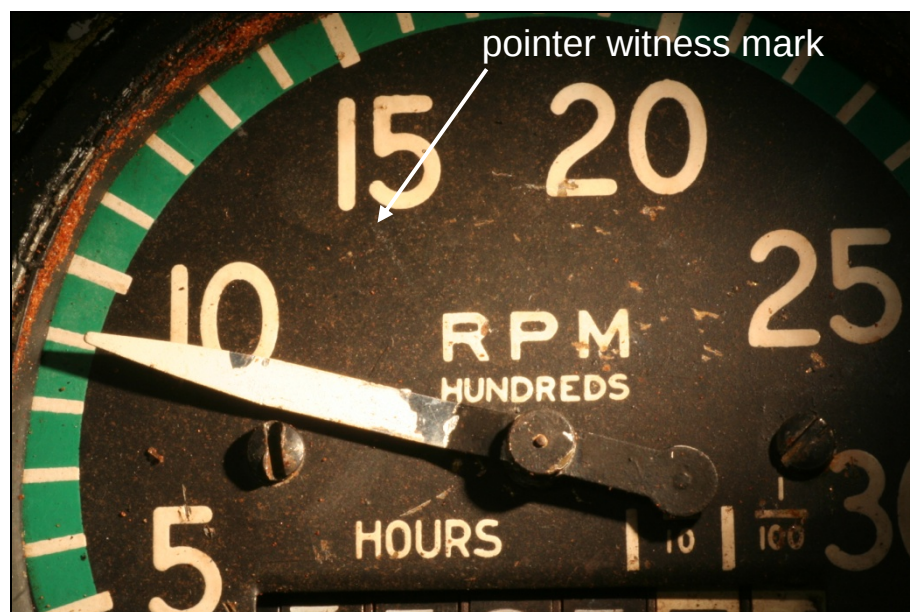
**Figure 11: Engine tachometer**

An examination of the engine tachometer indicated that, at the time the aeroplane collided with terrain, the engine and propeller were rotating at about 1,450 RPM (Figure 11). That rotational speed was less than would be expected for cruise flight.

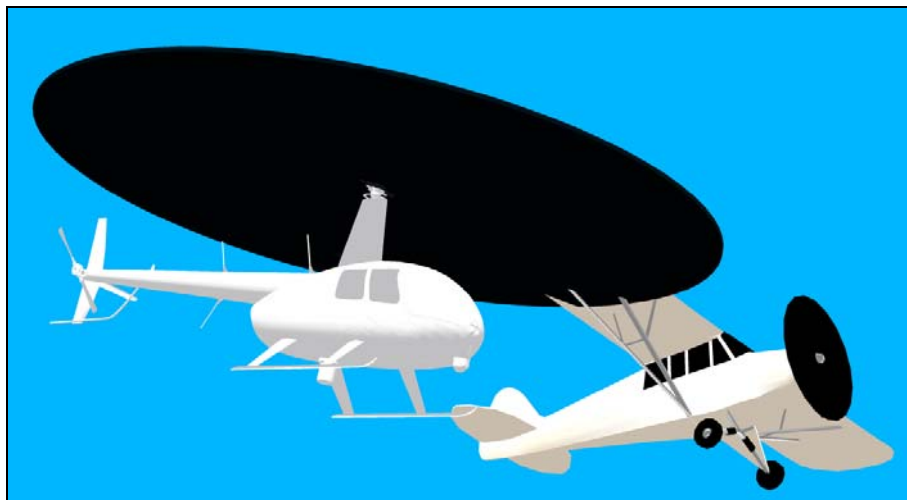
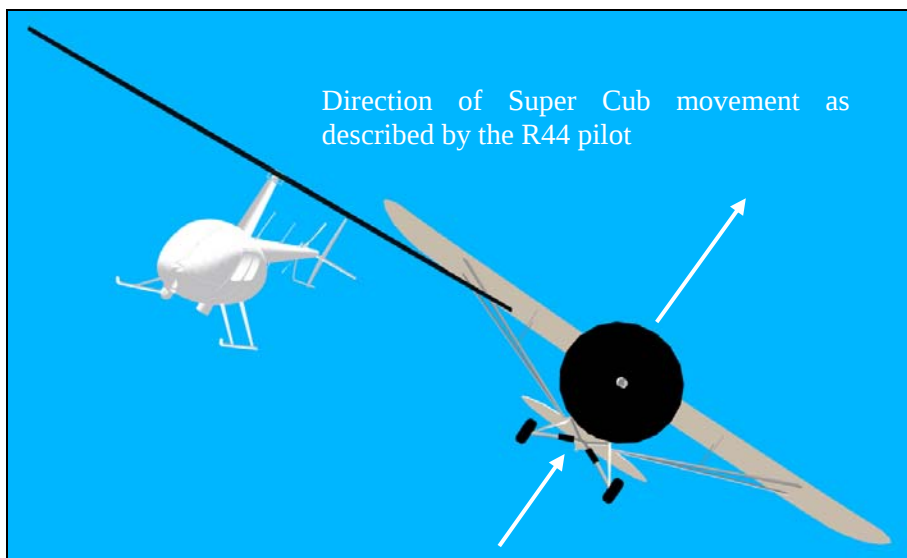
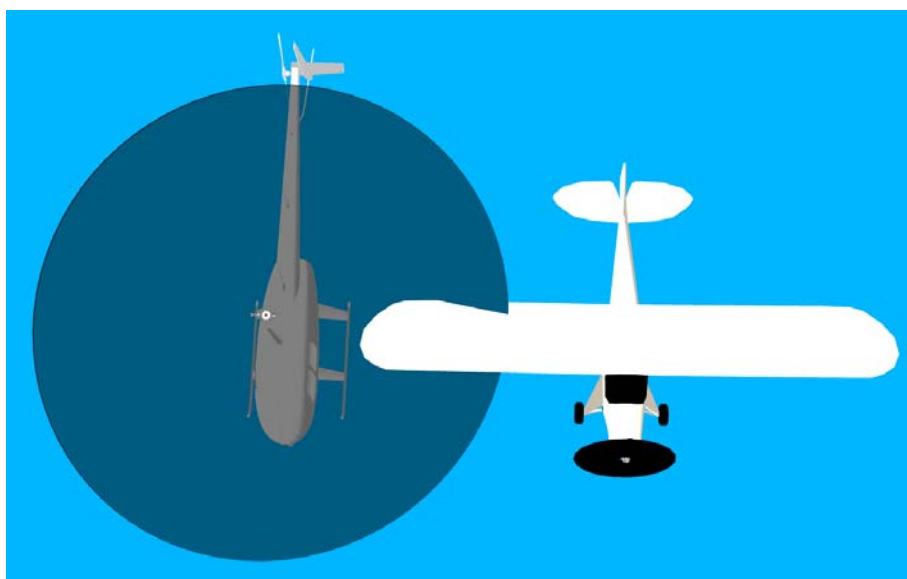
## APPENDIX A: RELATIVE AIRCRAFT POSITIONS AT IMPACT

An assessment of the relative position of the two aircraft at impact was undertaken using the contact marks on both the Super Cub wing structure, including the wing lift struts, and the substantially damaged R44 main rotor blade. The results of that analysis, which did not take into account the contact marks on the R44 chin bubble, are shown at Appendix A.
